SAIB: CE-11-37
Date: May 31, 2011

SUBJ: Engine Oil: Oil Filter Interference

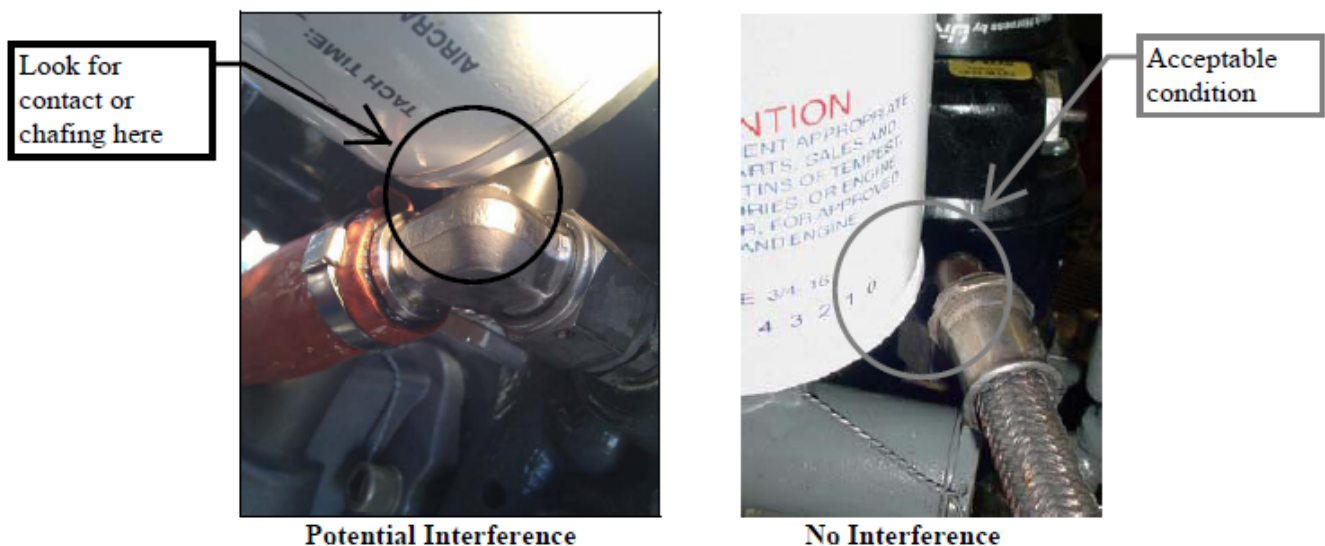
Two Malfunction or Defect reports were filed indicating interference between the oil cooler hose fittings on the pressure outlet to the oil cooler and the rolled metal lip on the oil filter. Interference during installation of the oil filter could lead to an improperly installed oil filter. Such interference could result in loss of oil, loss of oil pressure and other related problems. This interference is not related to any one brand of filter. Interference could result from using after market or PMA components with features or dimensions that differ from the OEM components as shown in the LH photo below. The interference could also be the result of a combination of any oil filter and oil cooler hose assembly fittings and how they are oriented when installed. See pictures below of two different installations – one with the larger, forged hose end fitting and potential interference; the other with the smaller, tube type hose end fitting with no interference.

- Check to see if interference exists or could exist between the oil filter housing and the oil cooler hose assembly.
- If interference is found, reposition the oil cooler hose assembly in accordance with manufacturer's data by qualified maintenance personnel to ensure clearance is present and no interference exists prior to further flight. Lacking any manufacturer's clearance data, the FAA recommends that a minimum of 0.125" clearance exist between an installed oil filter and the closest feature of the oil cooler hose or related oil cooler hose fittings.
- Correct all unsatisfactory conditions found during inspection prior to further flight.
- File a Malfunction or Defect Report or Service Difficulty Report (SDR). The SDR system is available at <http://av-info.faa.gov/sdrx/>.
