Best Practices Guide

Maintaining Exhaust System Turbocharger to Tailpipe V-band Couplings / Clamps

JASC 8100 Exhaust Turbine System (reciprocating) JASC 8120; Exhaust Turbocharger

April 2018

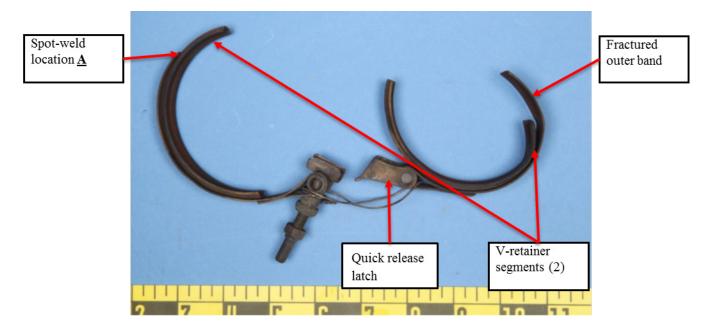
Figure 18
Spot-welded, 2-segment Coupling with Quick Release Latch

The above failure started as a crack that originated out of the spot-weld. The crack grew to a full transverse outer band crack that caused separation of the coupling. The above failure resulted in loss of the tailpipe, smoke in the cockpit, in-flight fire and fatalities. Note the safety wire is still in place.

- f. If any Unsatisfactory Conditions per Section 5 is found to exist on any coupling/clamp, the coupling/clamp should be considered un-airworthy and should be removed and replaced prior to further flight with a new, zero hours TIS, FAA approved coupling/clamp as applicable.

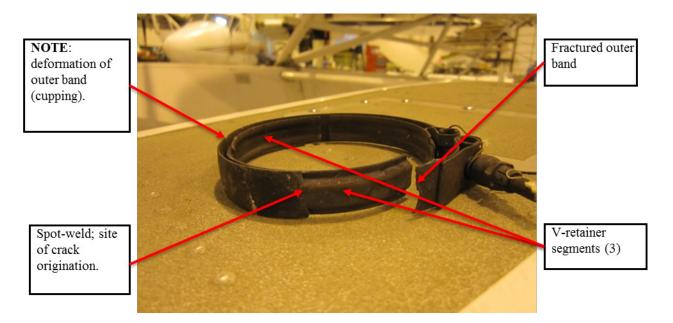
Figure 20
Spot-welded, 3-segment Coupling

The above failure started as a crack that originated out of the spot-weld. The crack grew to a full transverse outer band crack that caused separation of the coupling. The above failure resulted in loss of the tailpipe, smoke in the cockpit, in-flight fire and a very quick, direct in approach and landing on fire. There were no fatalities. Note again the safety wire is still in place.

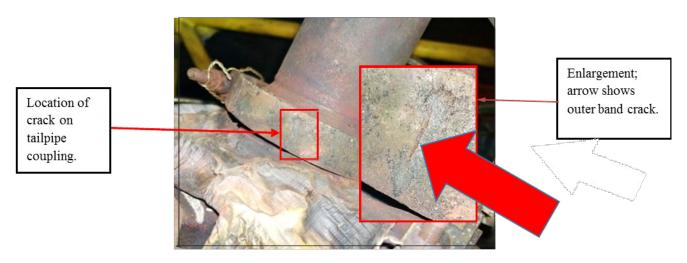
Figure 21
Spot-welded, Multi-segment Coupling

The above crack originated at a spot-weld. However, the crack had not grown across the outer band and the coupling had not separated yet. Found on inspection for another issue.

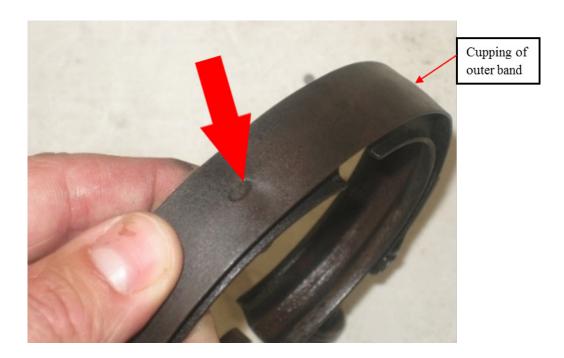
Figure 22
Spot-welded, 3-segment Coupling

The red arrow shows where the coupling is deformed at a spot-weld where the crack originated. The crack had not yet grown across the outer band and the coupling had not separated. Found on inspection for another issue.

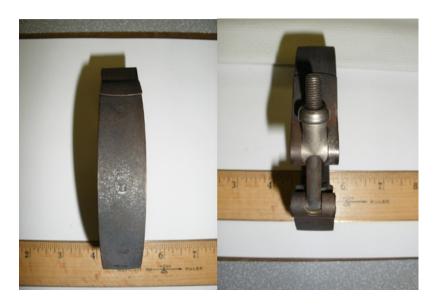
Figure 24
Spot-welded, 3-segment, Coupling

Figure 25 is the same coupling as in Figure 24 above. This photograph was taken on a bench with a white top, using back lighting from a flashlight. There is a crack in the V-retainer segment inner corner radius. With the condition of the coupling, this crack was difficult to find with the coupling in-hand. This crack could not be found with the coupling installed. Found during inspection after tailpipe removal. Note the corrosion from salt-water operations.
