SUBJ: Flight Controls; Cable Terminals Used on 14 CFR Part 23 and CAR Part 3 Airplanes with Mechanical Flight Control Cables

SAIB: CE-19-13
Date: July 2, 2019

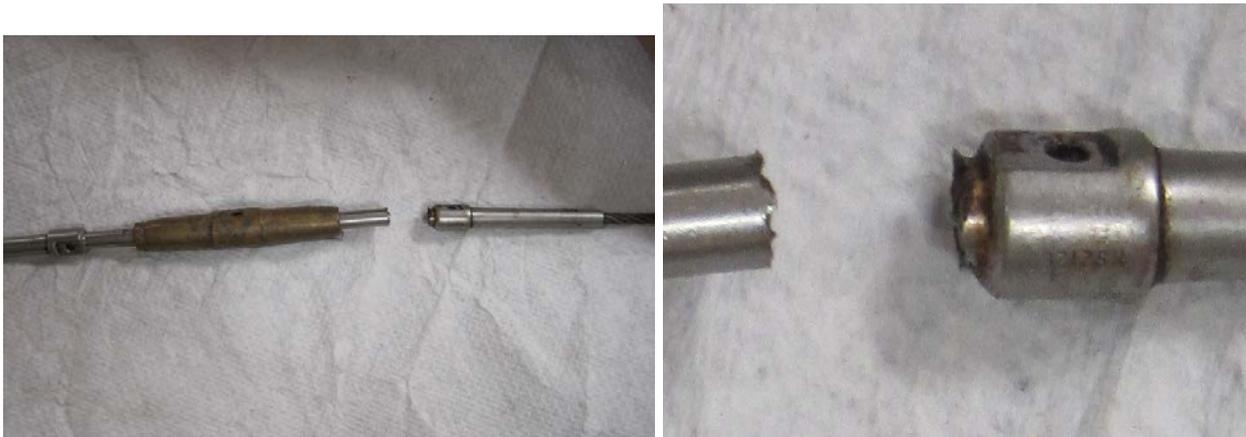
The specific focus of this SAIB is on the connecting fittings that are attached (swaged) to the flight control cables and threaded onto the turnbuckles. These fittings are typically manufactured from a type of stainless steel that is susceptible to stress corrosion cracking under certain conditions over time. Based on multiple part examinations, the stress corrosion cracking originates at general corrosion pits on the surface of the parts. Because the cracks are primarily below the surface, they can be extremely difficult to detect. Because stress corrosion cracking is usually preceded by or accompanied with visible corrosion, any presence of even light or moderate corrosion on these fittings is cause for concern.

Factors that contribute to stress corrosion cracking for stainless steel fittings of this type are exposure to contamination (chlorides) along with being under sustained tensile stress. Heat is also a contributing factor. It is therefore likely to occur more quickly in a warm, humid, salt air environment, and progresses based on calendar time rather than flight time. A number of failures have occurred in areas of the airplane adjacent to heating and ventilating ducts, thus raising the possibility that elevated temperatures and/or condensation associated with the ducting was an aggravating factor. Owners and operators of certain Beechcraft Bonanza and Debonair airplane models should be aware that multiple failures of an aileron cable terminal have occurred in a location just forward of the rear spar and underneath a ventilation/heating duct. This applies to most airplane Models 33, 35, and 36 manufactured between approximately 1964 and 1977, after which the aileron

A picture from a recent incident involving failure of such a fitting is shown in the photographs below. Note the small amount of corrosion adjacent to the fracture location.

- b. Replace any removed safety wire with new safety wire in accordance with normal procedures.
3. If any sign of corrosion, pitting or cracking is present on any fitting, replacement of the associated fitting and/or cable assembly is recommended.

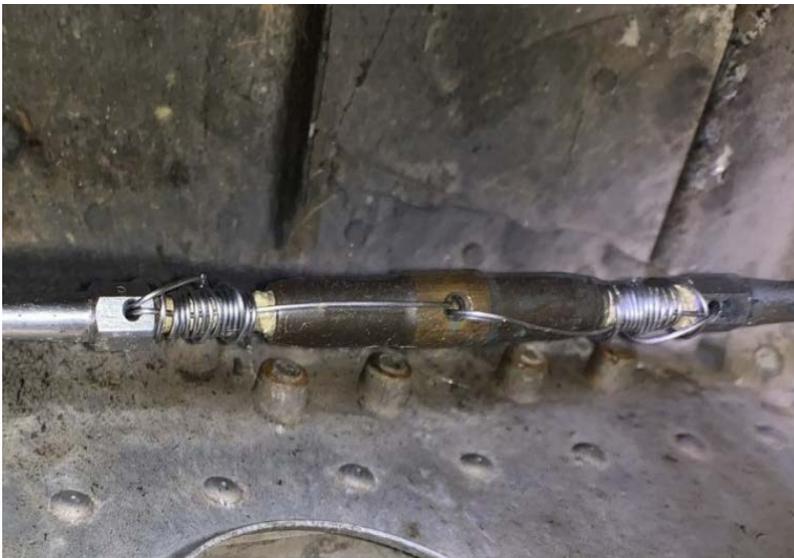
Depending on whether safety wire or a safety clip is used to secure the turnbuckle, any corrosion such as this may be hidden from view by the safety wire, which needs to be removed in order to perform an adequate inspection. The following photograph shows a typical safety wire configuration.

- a. If safety wire is installed such as to prevent examination of the fitting surface, the safety wire must be removed.
Caution: Care should be taken to avoid any adjustment of the turnbuckle relative to the fittings. Otherwise, re-rigging of the affected flight control cables per the manufacturer's instructions should be done before further flight.

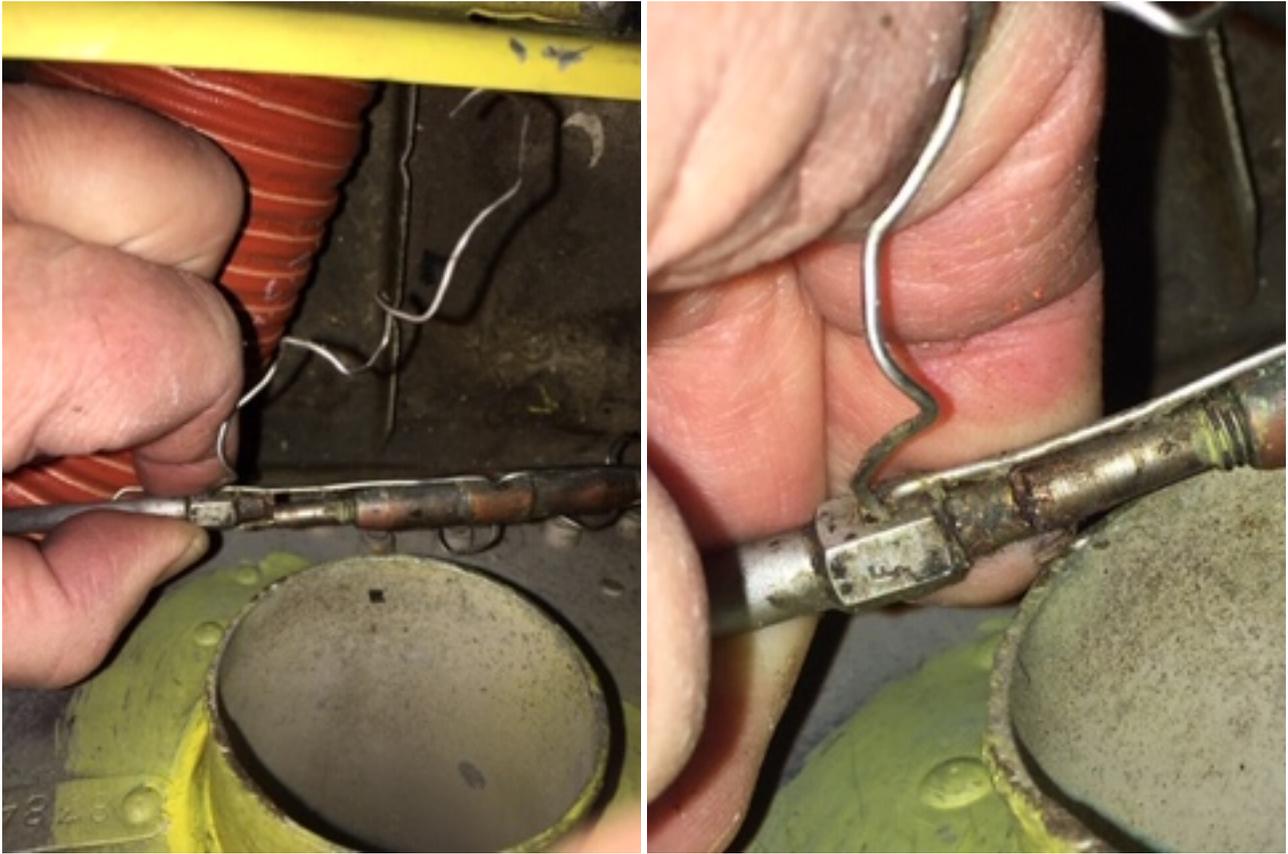
The following photograph shows a failure that occurred on a cable fitting located under a ventilation/heating duct on a Beechcraft Bonanza airplane.

4. For those airplanes with a history of significant exposure to warm, humid, salt air environments, replacement of all primary flight control cables that have been in service for 15 years or longer is recommended. Additionally, replacement of any cable that has a turnbuckle fitting located in an area of the airplane subject to elevated temperatures, the prevalence of condensation, or in close proximity to the airplane battery, and has been in service for 15 years or longer is recommended.

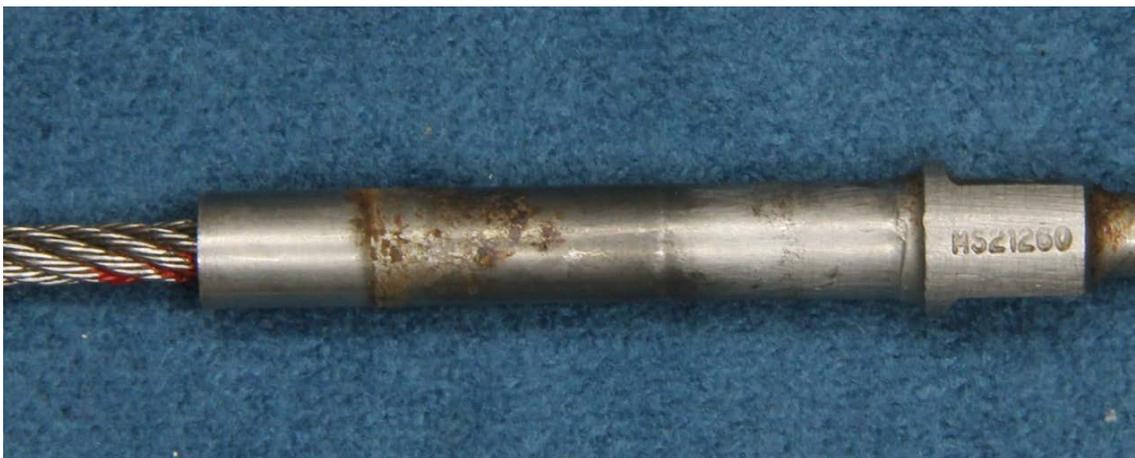
Another aggravating factor is the presence of sleeving or tape that is sometimes installed on the fitting shank for identification as an aid during initial airplane assembly. Corrosion can form more quickly underneath this material and be hidden from view during an inspection as shown in the following photograph. This material has no functional purpose on an assembled airplane.

- b. Examine underneath any sleeving or tape that is installed on the fitting shank.
 - i. Remove and discard any such tape or sleeve material while exercising care not to gouge or scratch the fitting surface. Removal of this material is considered a minor alteration to the airplane and should be documented by an appropriate logbook entry.
