**SERVICE INFORMATION LETTER****SIL26-02**

**SUBJECT:** New Riveted V-Band Coupling (Clamp) 672127  
Replacing 653332**PURPOSE:** Notification of new part number and clarification on features of new part number**COMPLIANCE:** Informative Only**MODELS****AFFECTED:** Continental Aerospace Technologies new and rebuilt LTSIO-360-E, EB, KB; TSIO-360-E, EB, F, FB, GB, KB, LB; TSIO-520-T engines**I. GENERAL INFORMATION**

**DOC NO** REVISION  
SIL26-02**PAGE**  
1 of 2

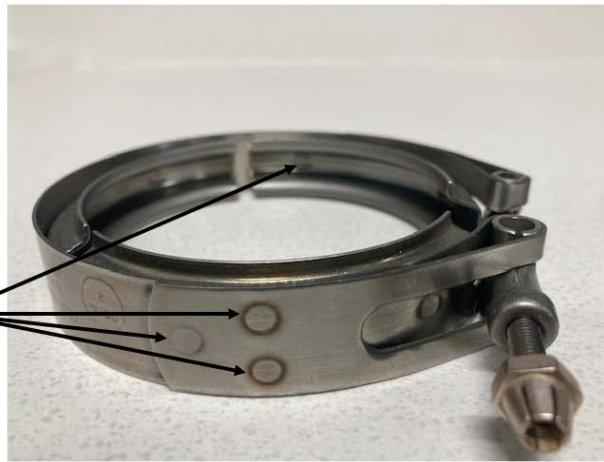
Witness marks  
from welds used for  
structural integrity  
of clamp

**Figure 1. 653332 Welded V-Band Coupling (Welds used for structural integrity)**

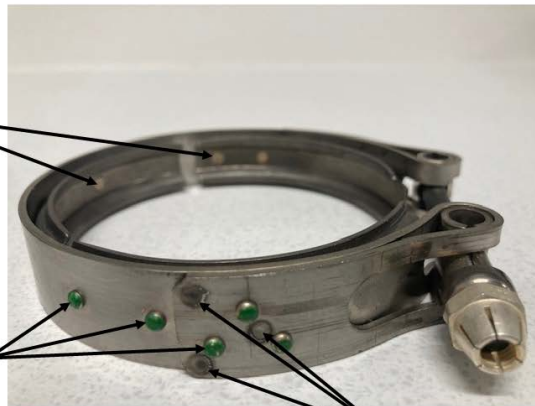
672127 uses rivets to carry the clamping loads; spot welds found on the clamp are used during assembly for fixturing only—the welds do not serve structural function.

Rivets used for  
structural integrity  
of clamp

Witness marks from  
welds used for assembly  
fixturing purposes only

**Figure 2. 672127 Riveted V-Band Coupling (Welds used for fixturing only)**

Install clamp in accordance with the instructions in M-0 Standard Practice Maintenance Manual and make the appropriate logbook entry. After installation of the 672127 clamp, resume inspections according to the engine's Instructions for Continued Airworthiness (ICA).
