SERVICE NO. 1377 BULLETIN

Date: January 9, 2024

MAIN WING SPAR INSPECTION AT THE MAIN LANDING GEAR TRUSS BRACKET

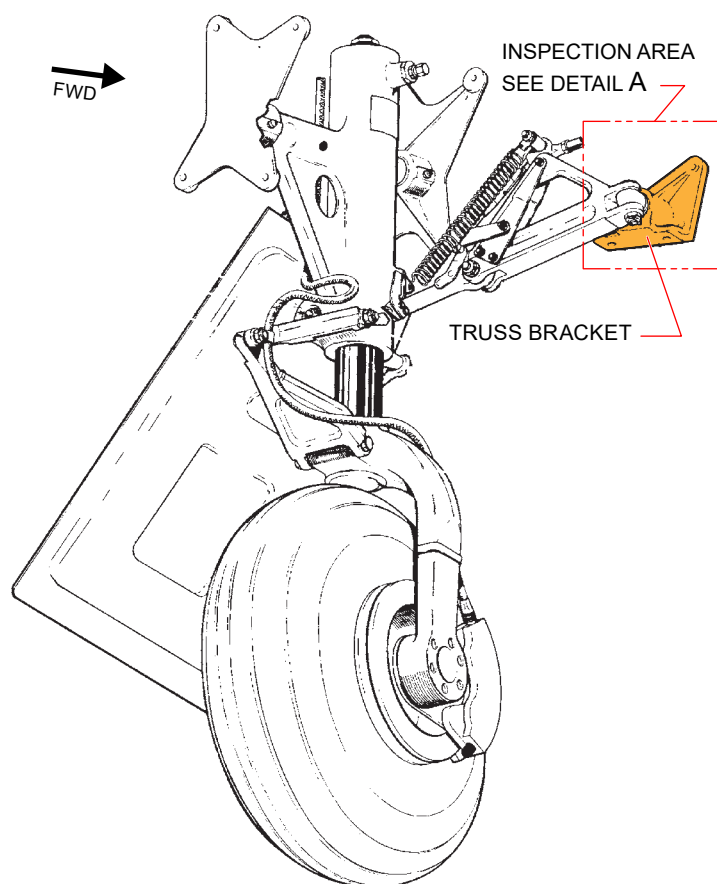
MAIN LANDING GEAR ASSEMBLY
ISOMETRIC VIEW
LEFT SIDE SHOWN (RIGHT SIDE OPPOSITE)

1. Place the airplane on jacks.
2. Remove the MLG truss brackets, two (2) each per aircraft, as shown in Figure 1. Replace any truss bracket hardware (bolts, nuts, and washers) on condition. Other components, including lubricator fittings, that are in serviceable condition may be retained for reinstallation.

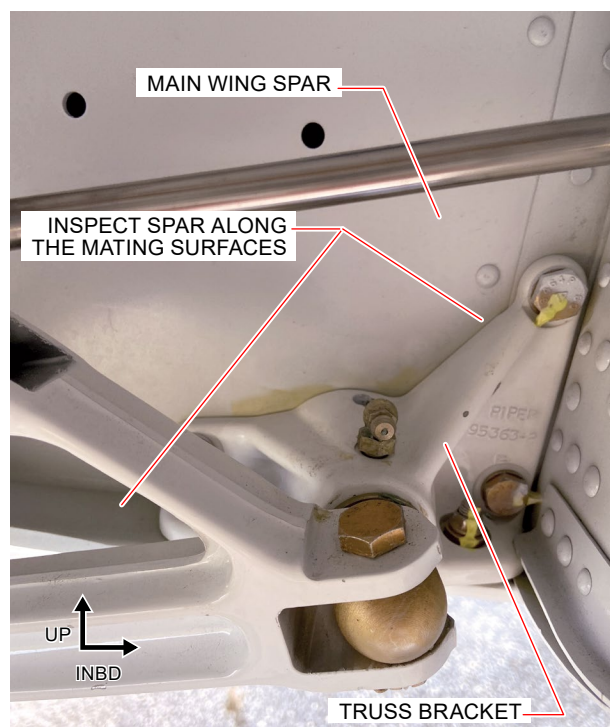
DETAIL A
INSPECTION AREA
LOOKING FORWARD AT
MLG TRUSS BRACKET AND MAIN WING SPAR
LEFT SIDE SHOWN (RIGHT SIDE OPPOSITE)

- a. If there is paint on the inspection area of the main wing spar, as shown in Detail A of Figure 1, remove it from the area specified using only chemical processes. Abrasives or other mechanical methods for paint removal may hide the existence of any cracks, making it impossible to do an accurate inspection. Use isopropyl alcohol to wipe clean where paint was removed in the inspection area.

- b. After paint is removed from the inspection area, perform a fluorescent penetrant inspection for cracks as described in FAAAC 43.13-1B, "Acceptable Methods, Techniques, and Practices – Aircraft Inspection and Repair," Chapter 5, Section 5.

- c. Any cracks that are discovered must be reported to Piper. Regardless of findings, the inspection results must be reported to Piper electronically as described in step 5, below. If no cracks are found, wipe clean with isopropyl alcohol and apply primer to bare metal surfaces using MIL-PRF-85582D Type I Class C2 primer. Alternatively, use any primer conforming to MIL-PRF-23377 and apply per the primer manufacturer's instructions.

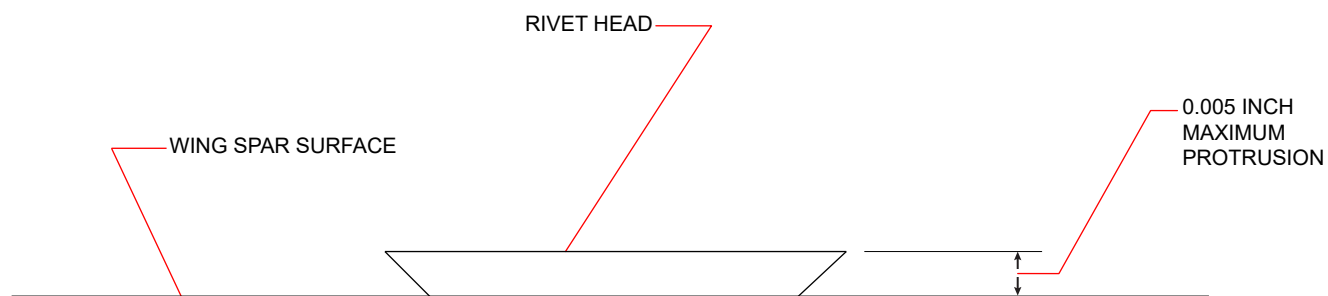
Figure 2
Truss Bracket Rivet Head Protrusion

Identify all countersink rivet heads in the main wing spar that are covered by the MLG truss brackets when installed. Depending on the aircraft model, these rivets could be associated with a wing rib, a nut plate, or some other airframe component.

Measure the height of each rivet head above the local surface as shown in Figure 2. If the rivet head protrusion exceeds 0.005 inches, rework is required. Remove the nonconforming rivet and rework the 100° countersunk hole to achieve a rivet installation that is flush (+0.005 / -0.003 inch) to the adjacent surface. Install replacement MS20426AD-series rivet (NAS523 Code: BB), procured locally. Alternatively, use a rivet shaver to achieve the flushness requirement.
