# ALERT SERVICE BULLETIN

ASB273C

A-20028 IDLER GOVERNOR GEAR BEARING INSPECTION INSTRUCTIONS

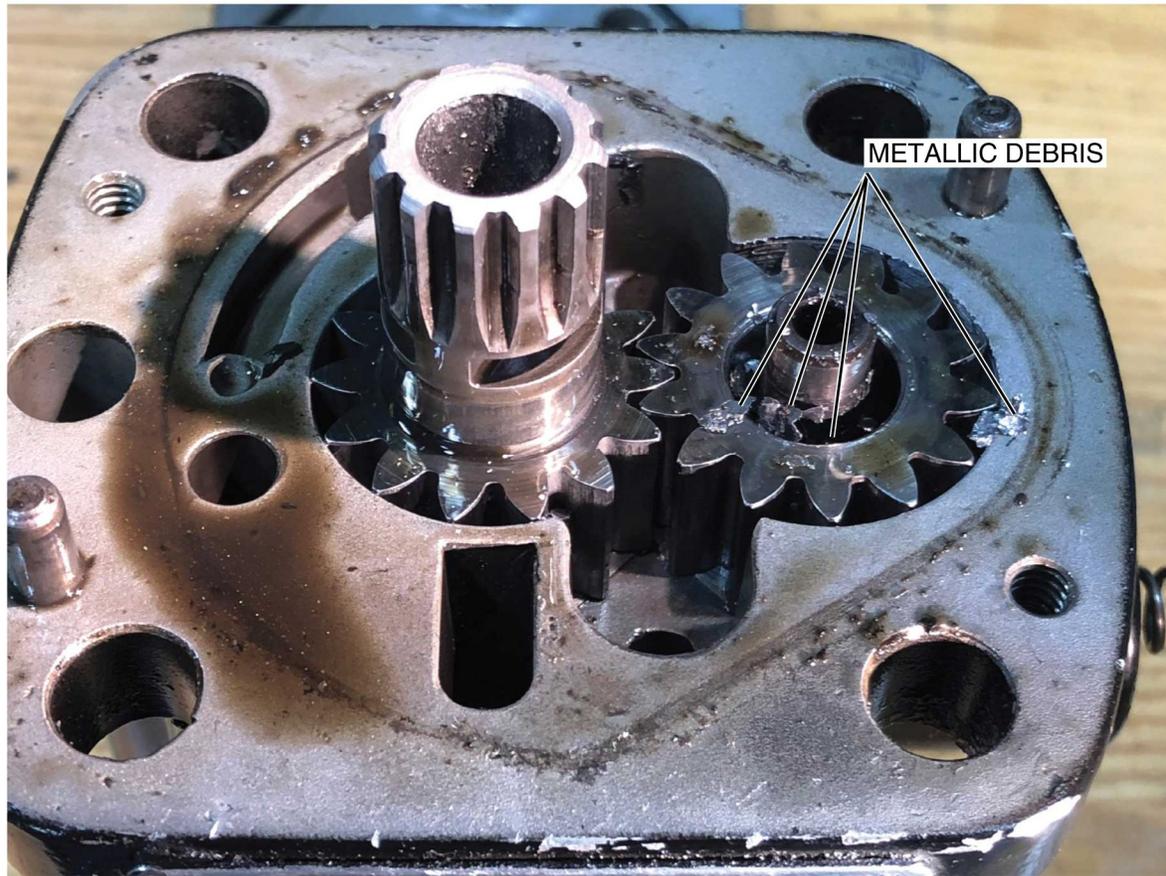
C2759

1. DO THE A-20028 IDLER GOVERNOR GEAR BEARING INSPECTION
  - A. Governor Evaluation, do the following:
    - (1) Remove the affected governor from the engine in accordance with the aircraft manufacturer or applicable STC holder's instructions.
    - (2) Remove the C-20943 cover-pump housing from the governor assembly. Examine the inside of the housing and the base of the exposed governor (Refer to Figure 1). Note and photo document any signs of metallic debris.

Figure 1. Metallic Debris Example (Sheet 1)

- D. If Metallic Debris **WAS** Observed/Noted, refer to the McCauley Governor Manual 780401 and do the following:
- (1) Remove and retain the A-20107 idler gear assembly.

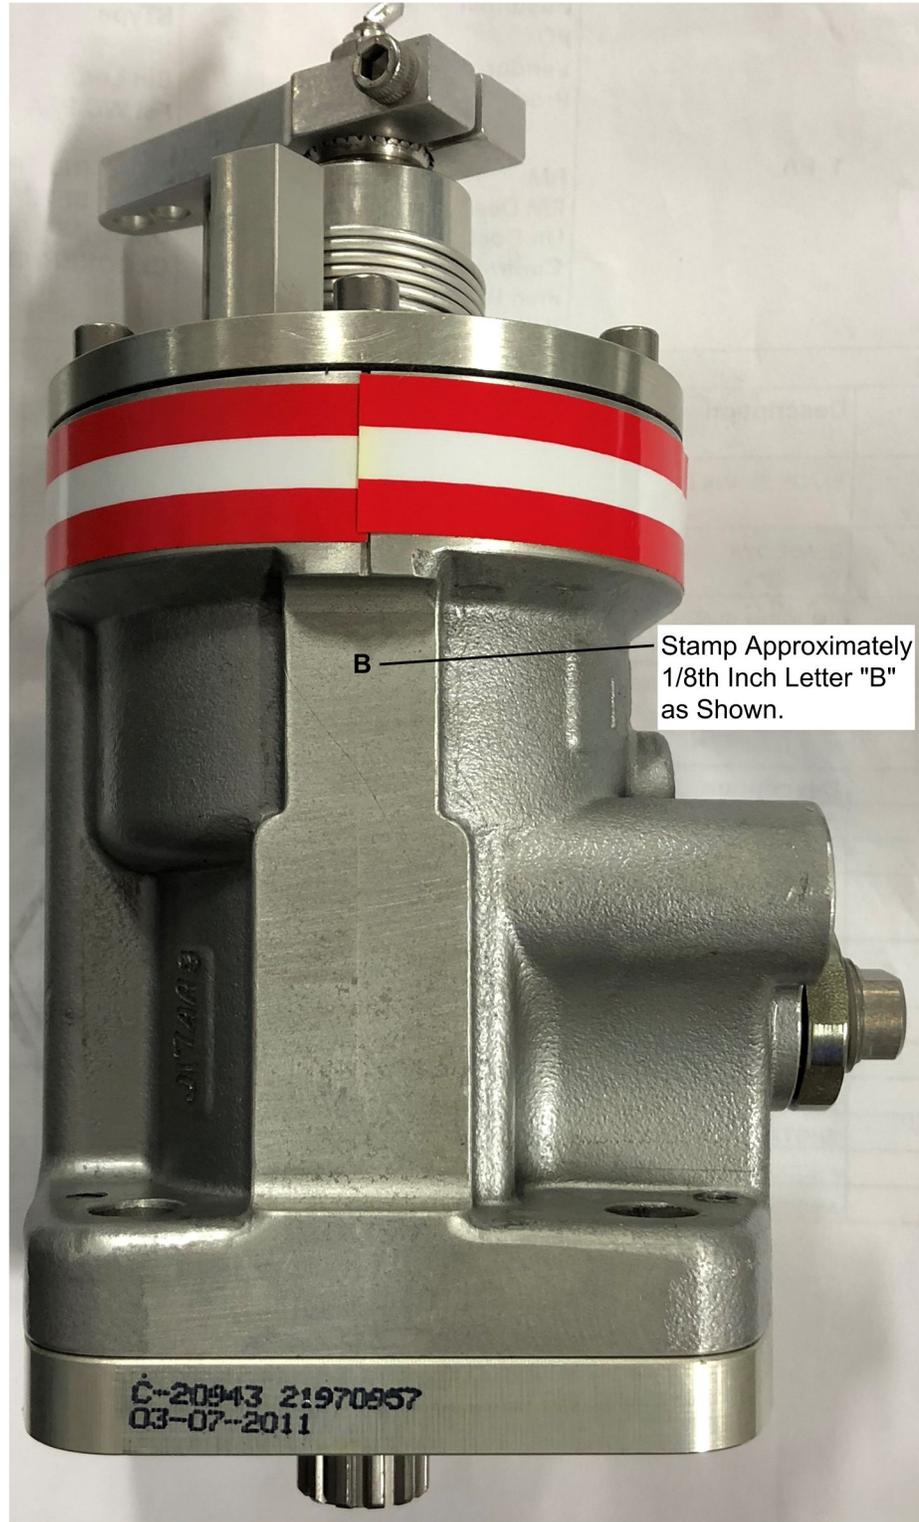
C2760

Figure 2. Governor Stamping (Sheet 1)

- (2) Overhaul the governor and complete associated actions as indicated in McCauley SB215C
- E. Stamp the letter "B" (Approximately 1/8th of an inch character) on the governor body as shown in Figure 2.

**NOTE:** Governor stamping can be on the side shown in Figure 2, or on the data plate side.
