Piper Aircraft, Inc.
2926 Piper Drive
Vero Beach, FL, U.S.A. 32960

SERVICE *NO. 1095A* LETTER

Date: September 24, 2020

CLASSIFICATION AND DISPOSITION OF DENTS CAUSED BY HAIL DAMAGE

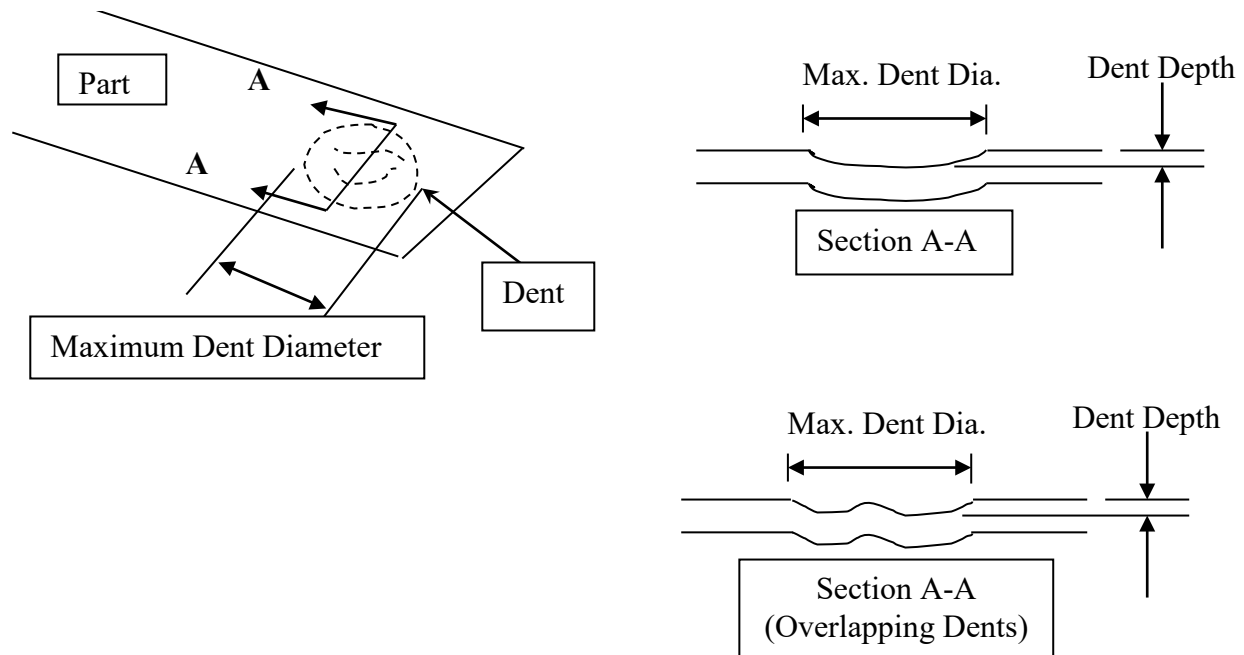
Figure 1
Dent Profile Definitions

- a. Determine the locations where dents are present.
 - Metal skin of the fuselage, wings or empennage
 - Control surfaces
 - Composite component
- b. Measure the maximum depth and circumscribable diameter of the dents from the aircraft exterior. For depth measurements on curved surfaces, measure the maximum depth of the dent from the general contour. The dent diameter is measured to the point where the skin material rejoins the general contour. See Figure 1.
