PILOTS: Ensure Your Fuel Selector Works

Worn components can lead to fuel starvation and sudden loss of engine power

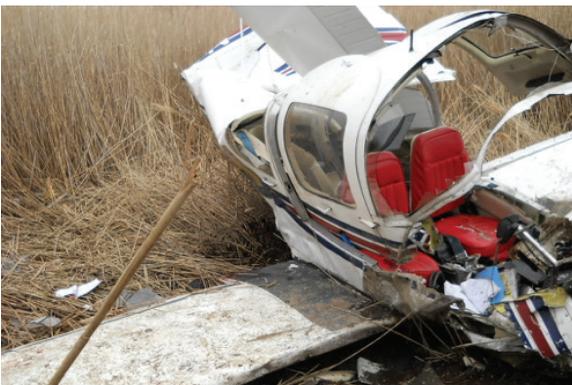
Figure 1. Photograph of accident airplane.

- During the initial climb after a touch-and-go landing in a Piper PA-38-112, the flight instructor reported an emergency and indicated that he would return to the airport. The airplane then spun to the left and impacted a marsh. The airplane was destroyed (figure 1); the flight instructor sustained serious injuries, and the student pilot died. Although the fuel selector handle was positioned to the right main fuel tank, an insert in the fuel selector had fractured into multiple pieces that showed overstress and wear (figure 2, next page). The fuel selector handle likely had been difficult to move for some time, and excessive force would have been required to move the handle from one position to another, thus causing the wear.

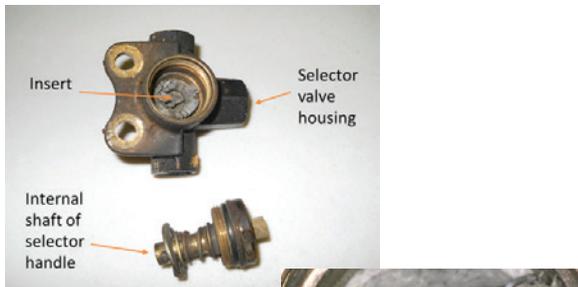
The failure of the fuel selector valve in a position that

restricted fuel flow to the engine led to the total loss of engine power due to fuel starvation. The operator failed to detect and resolve the wear of the fuel selector valve. (ERA17FA112)

Figure 2. Fuel selector valve housing and section of selector handle (above) and fuel selector insert with fractured pieces (right).

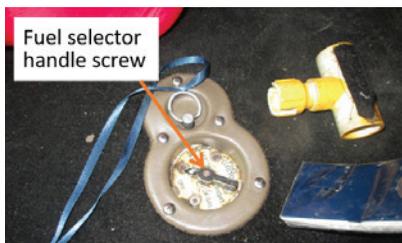
■ The pilot of a Mooney M20 airplane reported that, during the initial climb from the airport, he noted the engine power slowing, turned on the boost pump, checked the magnetos and fuel mixture, and then attempted to switch the fuel selector to the other fuel tank, which had usable fuel. The engine experienced a total loss of power, and the airplane impacted the ground. A passenger sustained minor injuries, and the pilot and another passenger were uninjured. **The fuel selector handle screw was loose and prevented the fuel selector from moving to the fuel tank position for the tank with usable fuel, resulting in fuel starvation and the subsequent total loss of engine power** (see figure 3). (GAA17CA260)

Figure 3. Photograph of fuel selector. (Source: FAA)
