# MECHANICS: Be Wary of Worn Fuel Selectors

## Worn components can lead to fuel starvation and sudden loss of engine power

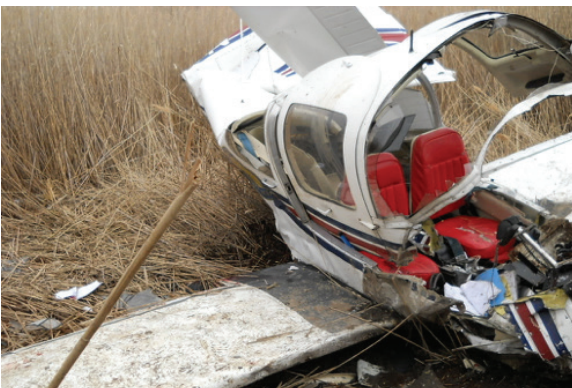
Figure 1. Photograph of accident airplane.

- During the initial climb after a touch-and-go landing in a Piper PA-38-112, the flight instructor reported an emergency and indicated that he would return to the airport. The airplane then spun to the left and impacted a marsh. The airplane was destroyed (figure 1); the flight instructor sustained serious injuries, and the student pilot died. Although the fuel selector handle was positioned to the right main fuel tank, an insert in the fuel selector had fractured into multiple pieces that showed overstress and wear (figure 2, next page). The fuel selector handle likely had been difficult to move for some time, and excessive force would have been required to move the handle from one position to another, thus causing the wear.

**The failure of the fuel selector valve in a position that**

**restricted fuel flow to the engine led to the total loss of engine power due to fuel starvation.** The operator failed to detect and resolve the wear of the fuel selector valve. (ERA17FA112)

- **Inspect fuel selectors according to the airplane maintenance manual, checking the operation, condition, and security of the fuel selector.**
- **Ensure that stops or detents for the fuel selector valve position the valve properly.**
- **Service or replace any worn components, as necessary, according to the airplane maintenance manual and check your work to ensure accuracy.**
- **Be informed and review and comply with any applicable airworthiness directives and service bulletins regarding the fuel selector and components.**

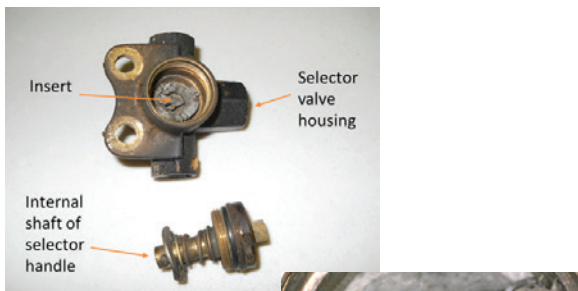
**Figure 2.** Fuel selector valve housing and section of selector handle (above) and fuel selector insert with fractured pieces (right).

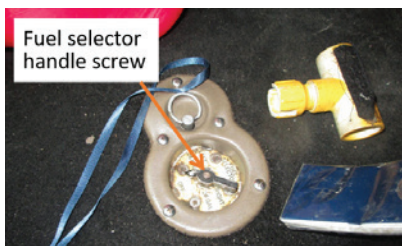
■ The pilot of a Mooney M20 airplane reported that, during the initial climb from the airport, he noted the engine power slowing, turned on the boost pump, checked the magnetos and fuel mixture, and then attempted to switch the fuel selector to the other fuel tank, which had usable fuel. The engine experienced a total loss of power, and the airplane impacted the ground. A passenger sustained minor injuries, and the pilot and another passenger were uninjured. **The fuel selector handle screw was loose and prevented the fuel selector from moving to the fuel tank position for the tank with usable fuel, resulting in fuel starvation and the subsequent total loss of engine power** (see figure 3). (GAA17CA260)

**Figure 3.** Photograph of fuel selector. (Source: FAA)
