NATIONAL TRANSPORTATION SAFETY BOARD

MATERIALS LABORATORY FACTUAL REPORT

Report No. 18-061

Place : Daytona Beach, Florida
Date : April 4, 2018
Vehicle : Piper PA-28R-201, N106ER
NTSB No. : ERA18FA120
Investigator : Aaron McCarter, AS-ERA / Clinton R. Crookshanks, AS-40

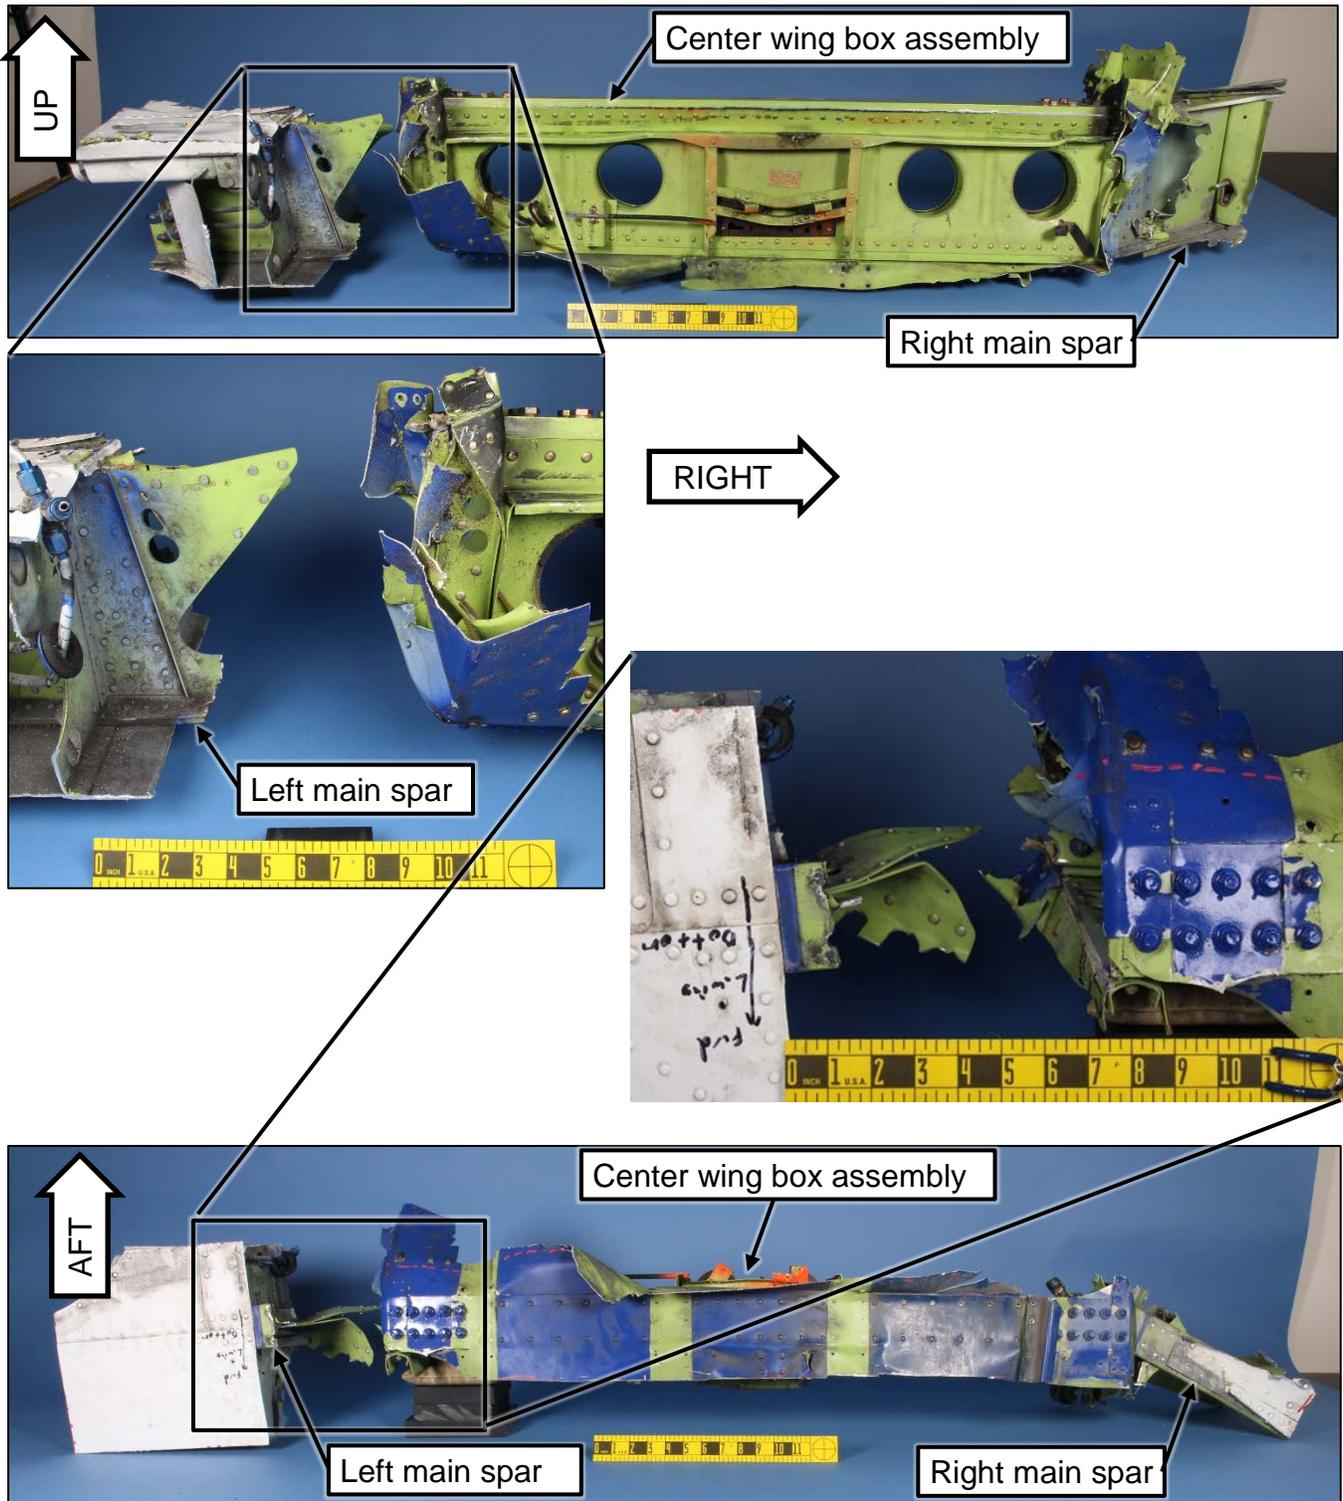
Overall views of the submitted center wing box assembly with attached right wing main spar piece and fractured left wing main spar piece are shown in figure 1. The right main spar was cracked at the inboard attachment location and the outboard end of the piece was deflected forward. The left main spar was fractured at the inboard attachment location. A group examination of the components was conducted on April 10 through 12, 2018 at the NTSB Materials laboratory with Structures Group representatives from the NTSB, Federal Aviation Administration, Piper Aircraft, Inc., and Embry-Riddle Aeronautical University (ERAU) present.

Figure 1. Overall views of the submitted components from the accident airplane showing the aft (upper images) and lower (lower images) surfaces.

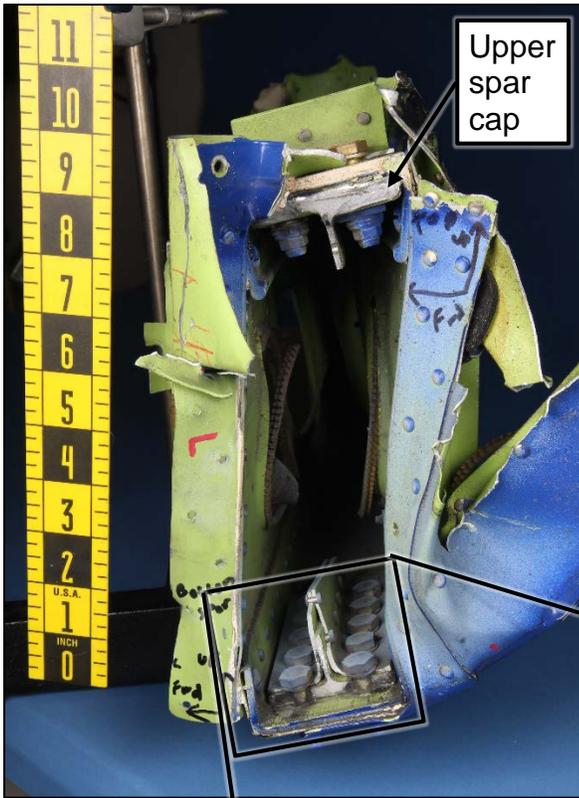
Views of the fracture in the left spar are shown in figures 2 and 3. The lower spar cap shown in figures 2 and 3 had a fracture that intersected holes for attachment bolts LC-1 and LD-1. Portions of the fracture surface had relatively smooth features in a plane perpendicular to the longitudinal axis, features consistent with fatigue fracture. Crack arrest lines were visible on the fracture surfaces of the lower spar cap and the forward and aft doublers, also consistent with fatigue fracture. Some of the fracture features were obscured by black-colored deposits, particularly in the areas near the apparent fatigue origins. The upper spar cap displayed rough matte-gray features consistent with ductile overstress fracture. Deformation associated with the fracture in the upper spar cap was consistent with an upward bending load.

Figure 2. Inboard side of the fracture in the left wing main spar viewed looking toward the center section.

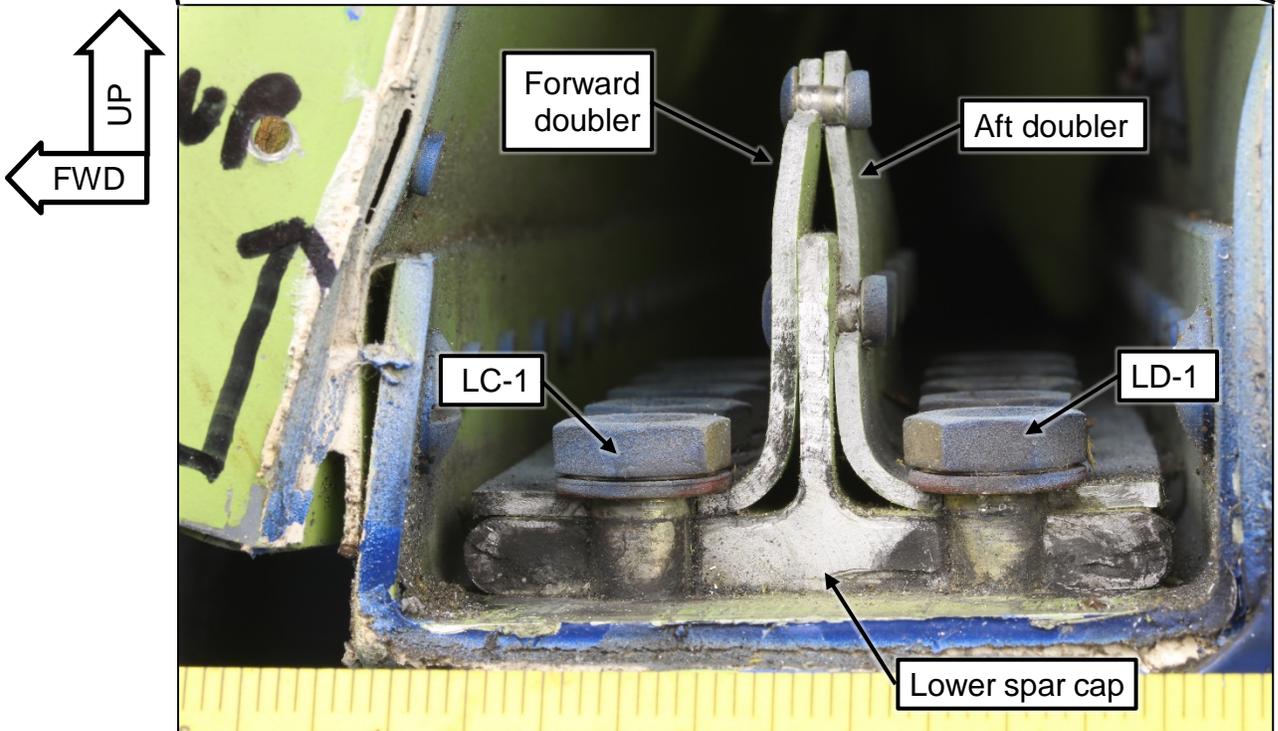
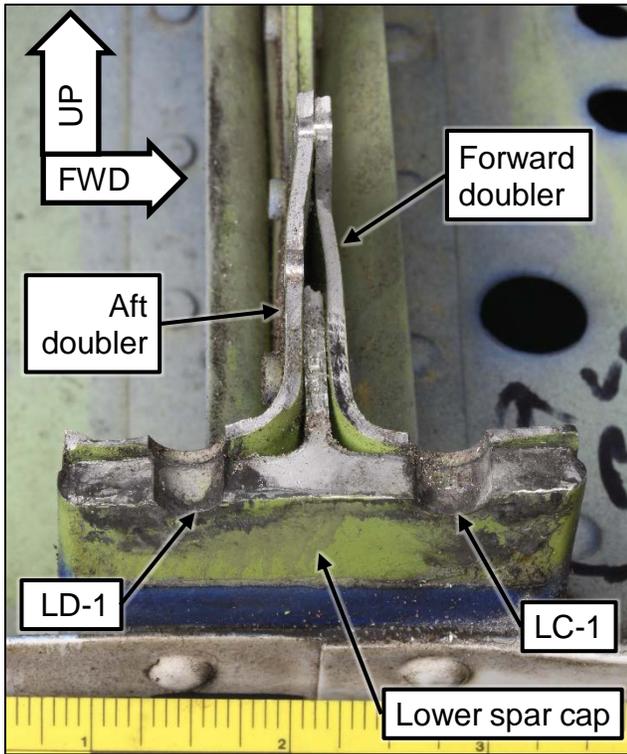
The outboard side of the fracture shown in figure 3 was cut from the rest of the spar to facilitate further examination. Additionally, the forward and aft doublers were removed from the sectioned piece by drilling out several rivets. To remove the black deposits from the surface, acetate replica tape was applied to the surface and removed after drying. After several applications of the replica tape, the pieces were placed in a bath of acetone and cleaned using an ultrasonic cleaner. A view of the lower spar cap and doubler pieces after sectioning, separating, and cleaning is shown in figure 4 with closer views in figure 5.

Figure 3. Outboard side of the fracture in the lower spar cap and attached doublers of the left wing main spar.

Figure 4. Pieces of the left wing lower spar cap and doublers shown in figure 3 after sectioning and removing rivets to facilitate examination of the fracture surfaces. The surfaces were also cleaned using acetate tape and acetone.

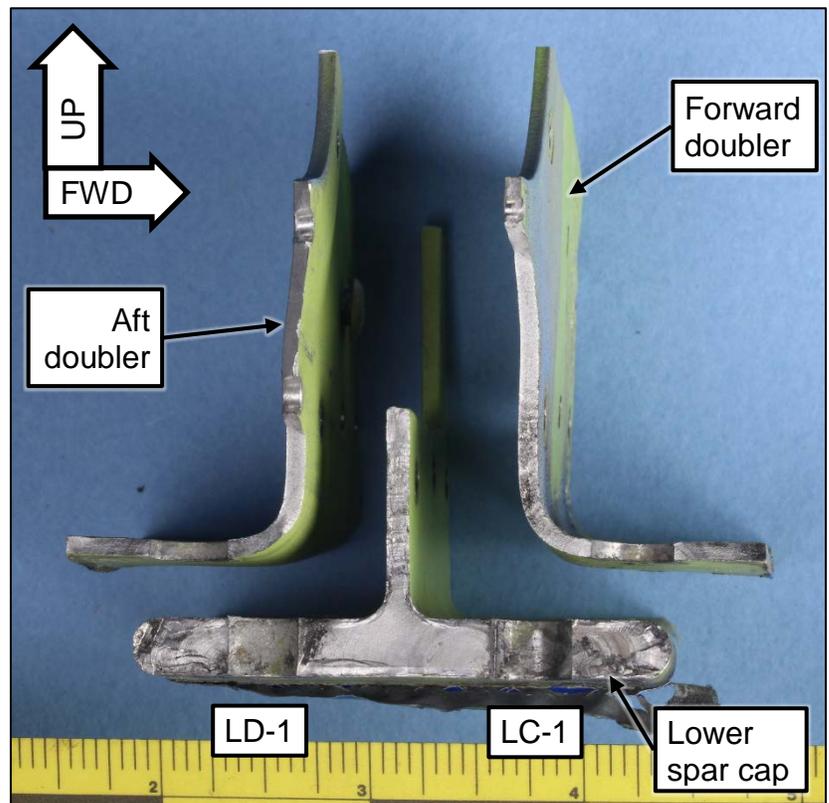
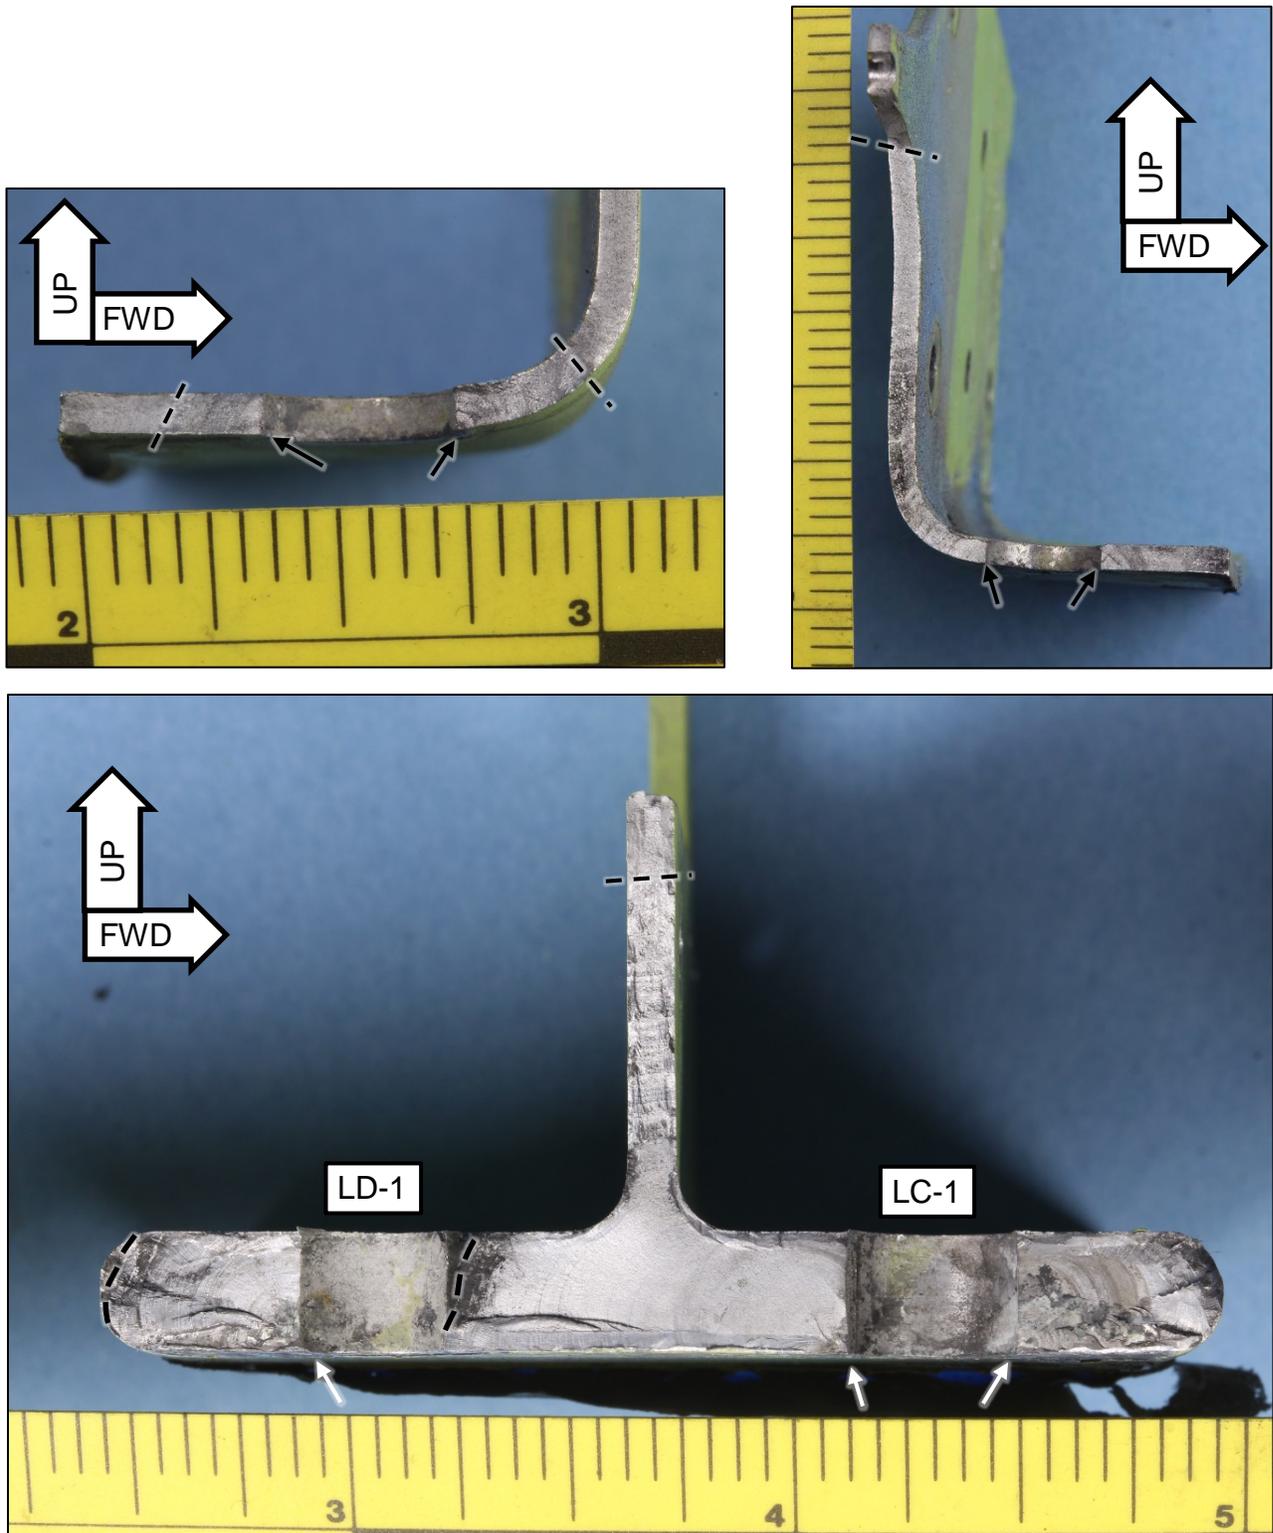
Unlabeled arrows in figure 5 indicate locations of fatigue origins, and dashed lines indicate fatigue boundaries. In the lower spar cap, origins were located at the lower surface both forward and aft of hole LC-1 and at the aft side of hole LD-1. Forward of hole LC-1, fatigue features extended to the forward edge of the lower spar cap as shown in a closer view of the fracture surface in figure 6. Aft of hole LC-1, fatigue features extended aft through the spar cap, intersecting the lower side of hole LD-1, and upward into the web to the boundary located approximately 0.75 inch above the spar cap. From

the aft side of hole LD-1, fatigue features extended to the boundary near the upper aft side of the lower spar cap as shown.

In the doublers, fatigue origins were noted on the lower sides of the doublers both forward and aft of the attachment holes. The fatigue region in the forward doubler was larger, extending forward to the forward edge of the doubler and upward approximately 1.25 inches from the aft side of the hole. In the aft doubler, the fatigue regions extended to the boundaries shown in figure 5 where the boundaries were approximately 7/8 inch apart.

Figure 5. Closer views of the fracture surfaces in the doublers (upper images) and the lower spar cap (lower image) after cleaning. Unlabeled arrows indicate fatigue origin areas, and dashed lines indicate fatigue boundaries.

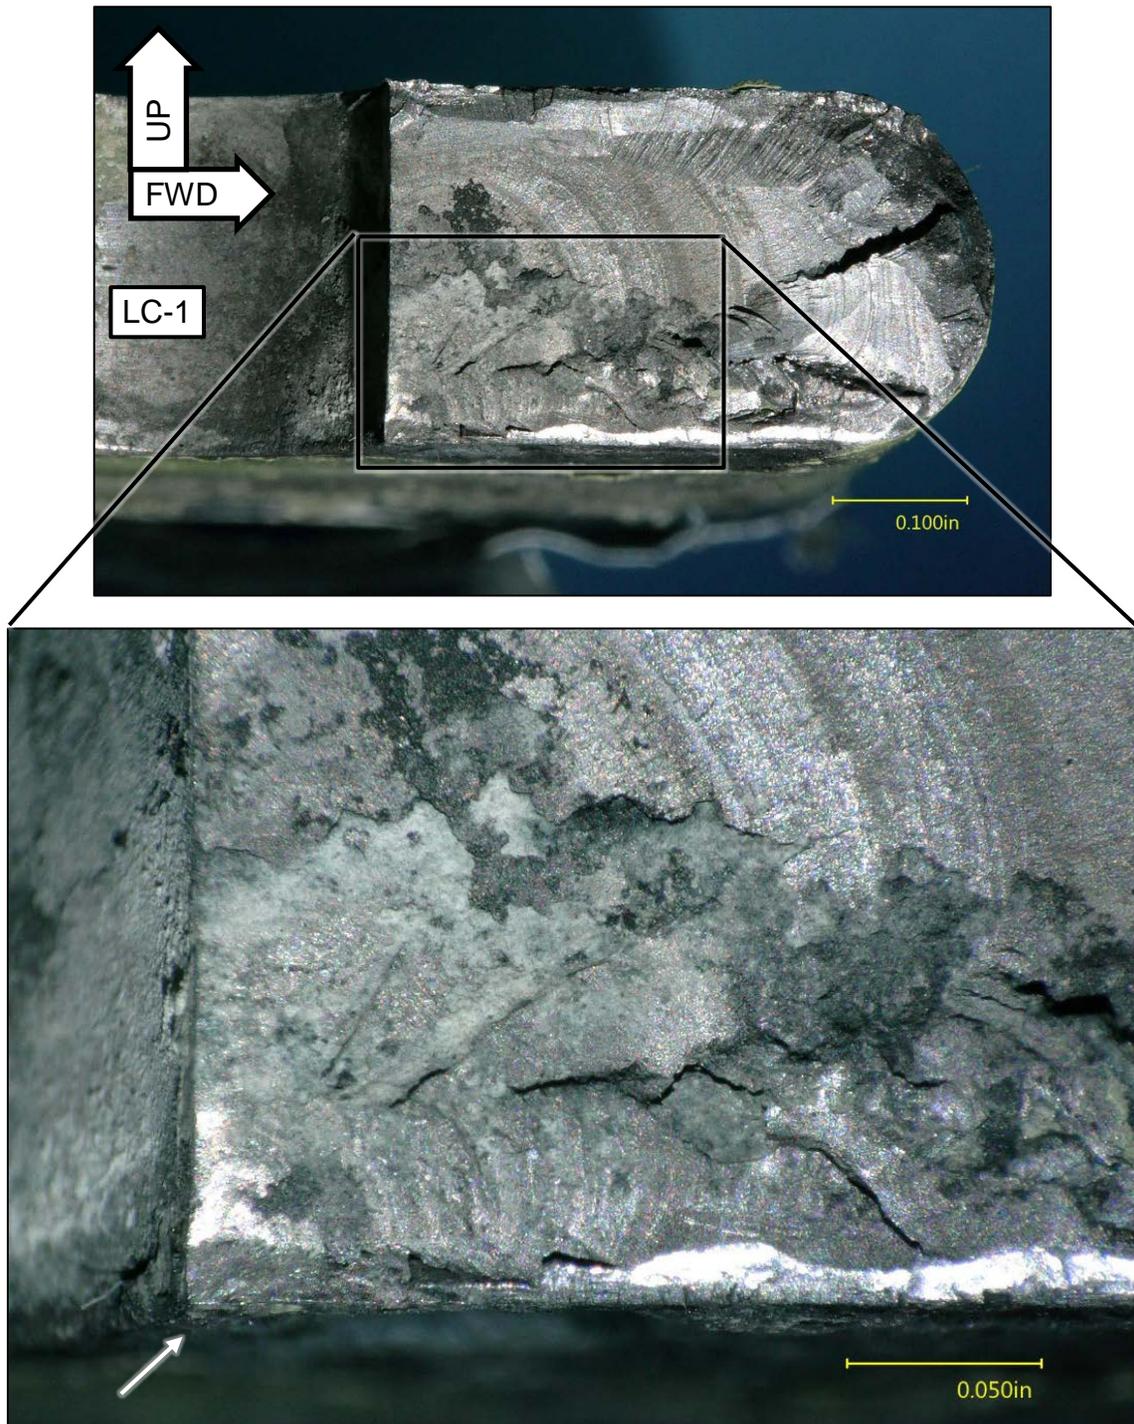
Next, the lower spar cap was examined using a scanning electron microscope (SEM). Parts of the fracture surface remained obscured by light green deposits on the surface visible in the optical image in figure 6. The deposits generally appeared brighter in the SEM due to charging effects associated with SEM imaging of nonconductive materials.

Figure 6. Optical images of the fatigue region forward of hole LC-1 (upper image) with a closer view of the fatigue origin area. An unlabeled arrow indicates the fatigue origin area.

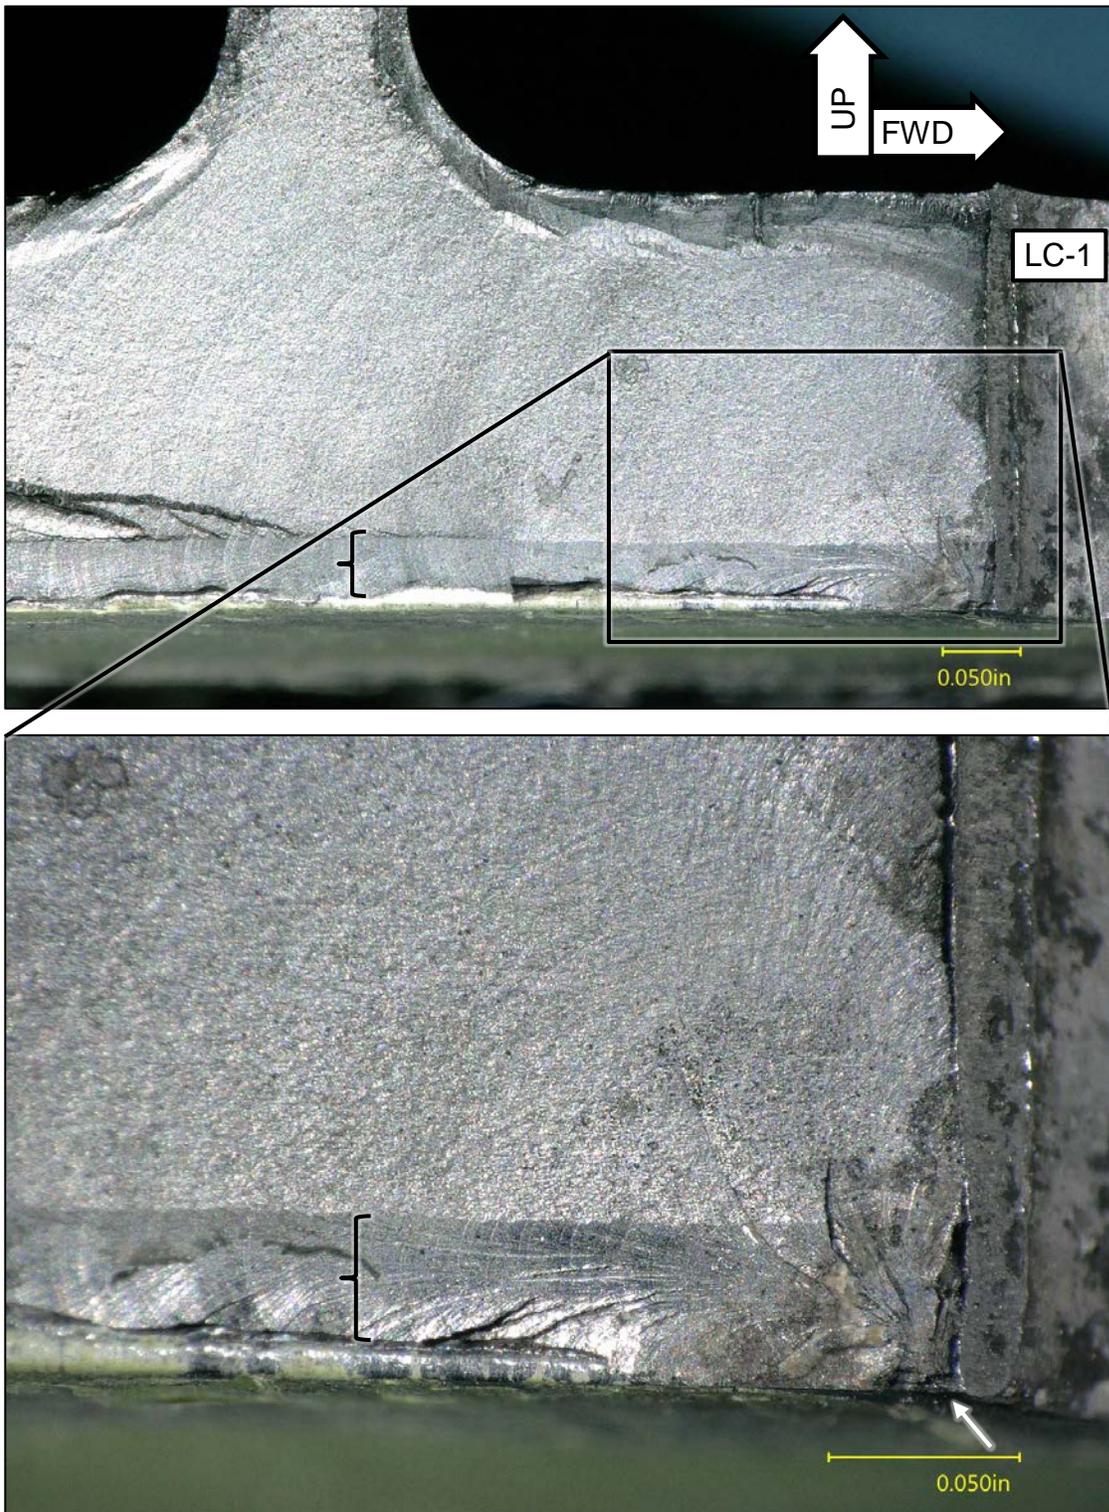
Closer views of the fatigue region aft of hole LC-1 are shown in figure 7. Near the surfaces of the spar cap, fatigue features had a different texture, appearing smoother than features near the middle of the thickness with a distinct boundary between the different-textured regions. Brackets in figure 7 indicate smoother areas at the lower surface of the spar cap.

Figure 7. Optical images of fatigue features aft of hole LC-1 including a view of the origin area at higher magnification (lower image). Unlabeled brackets indicate areas near the surface with relatively smoother fatigue features, and an unlabeled arrow indicates the fatigue origin area.

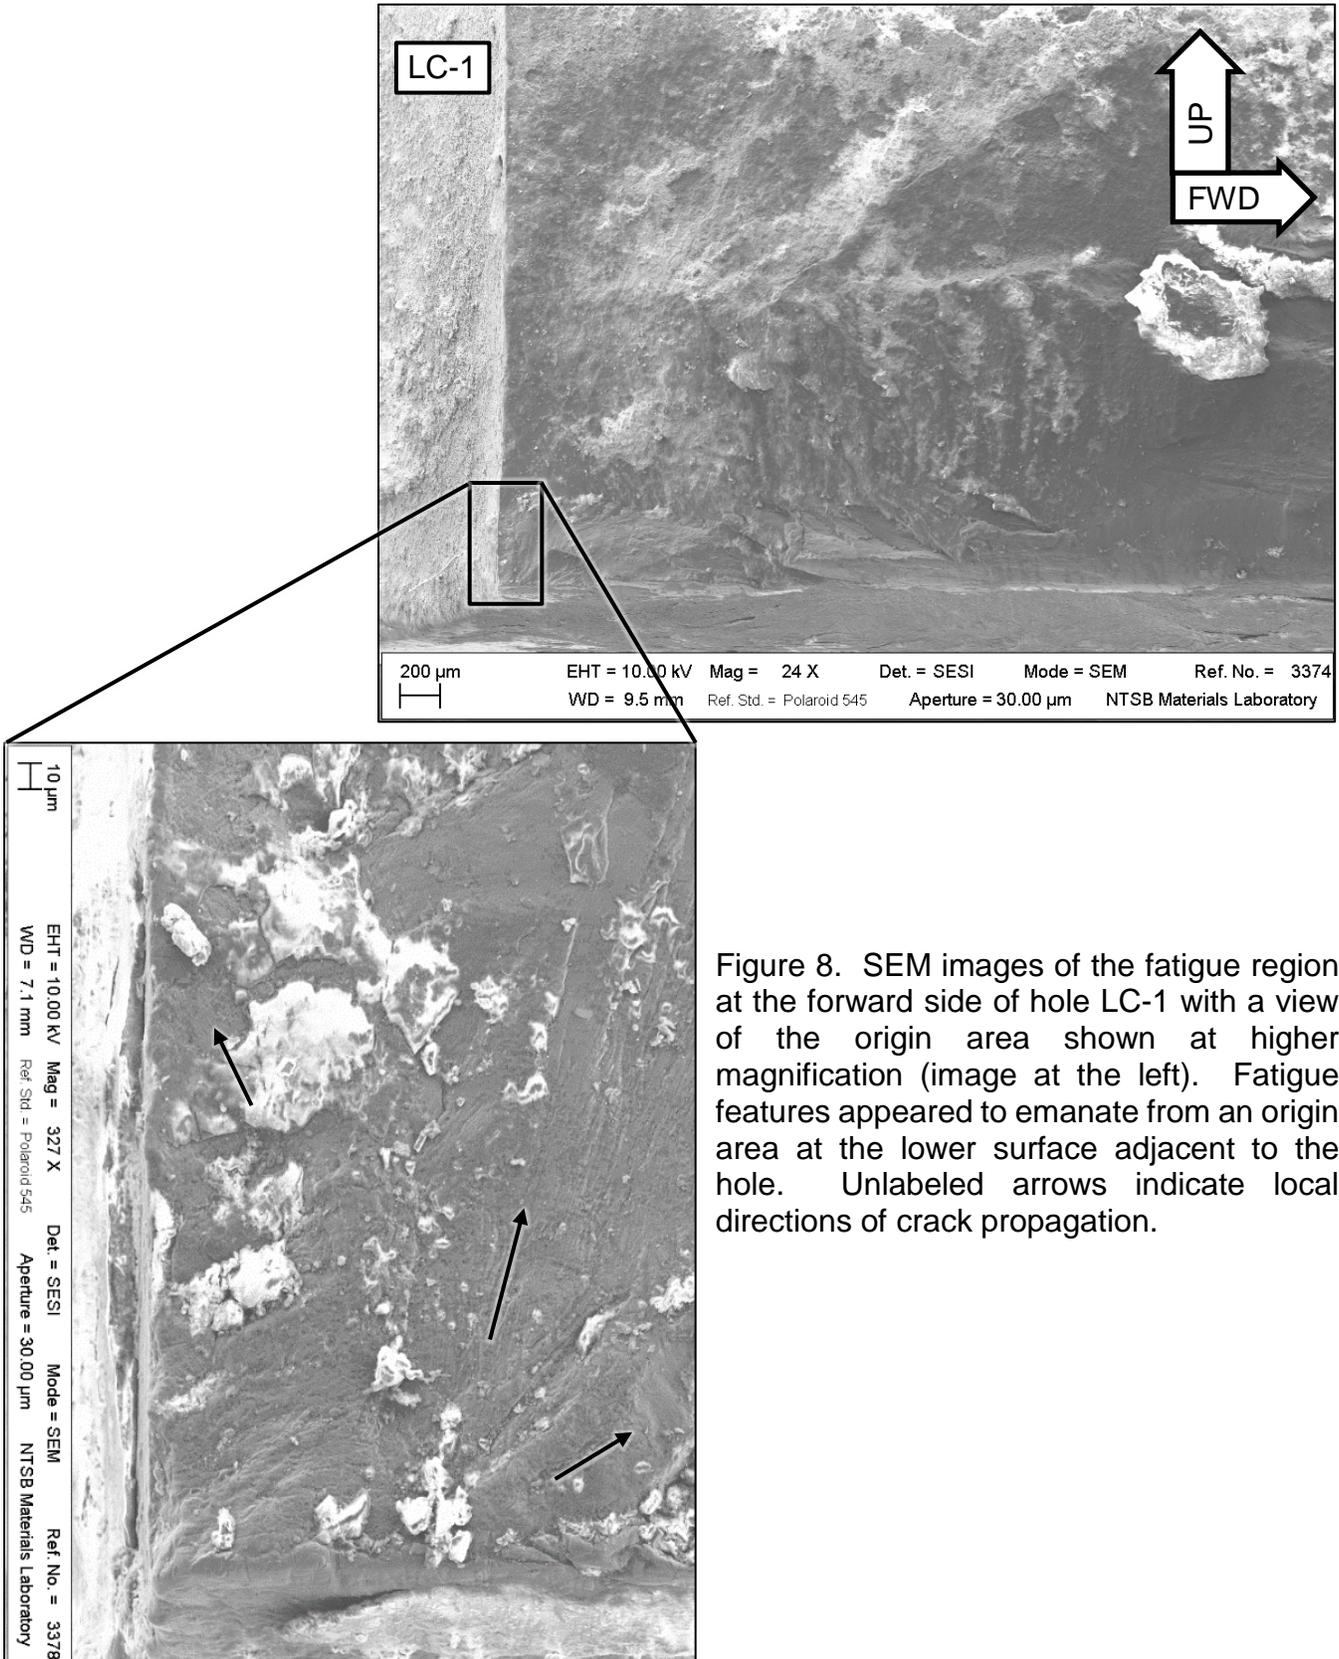
SEM views of the origin areas at the forward and aft sides of hole LC-1 are shown in figures 8 and 9. Unlabeled arrows in figures 8 and 9 indicate local directions of fatigue crack propagation based on available fracture features in the images. The origin areas in each location appeared partly obscured or damaged by post-fracture rubbing or deposits on the surface. However, fracture features appeared to emanate from origins at the lower surface of the spar cap adjacent to attachment hole LC-1.

Figure 8. SEM images of the fatigue region at the forward side of hole LC-1 with a view of the origin area shown at higher magnification (image at the left). Fatigue features appeared to emanate from an origin area at the lower surface adjacent to the hole. Unlabeled arrows indicate local directions of crack propagation.

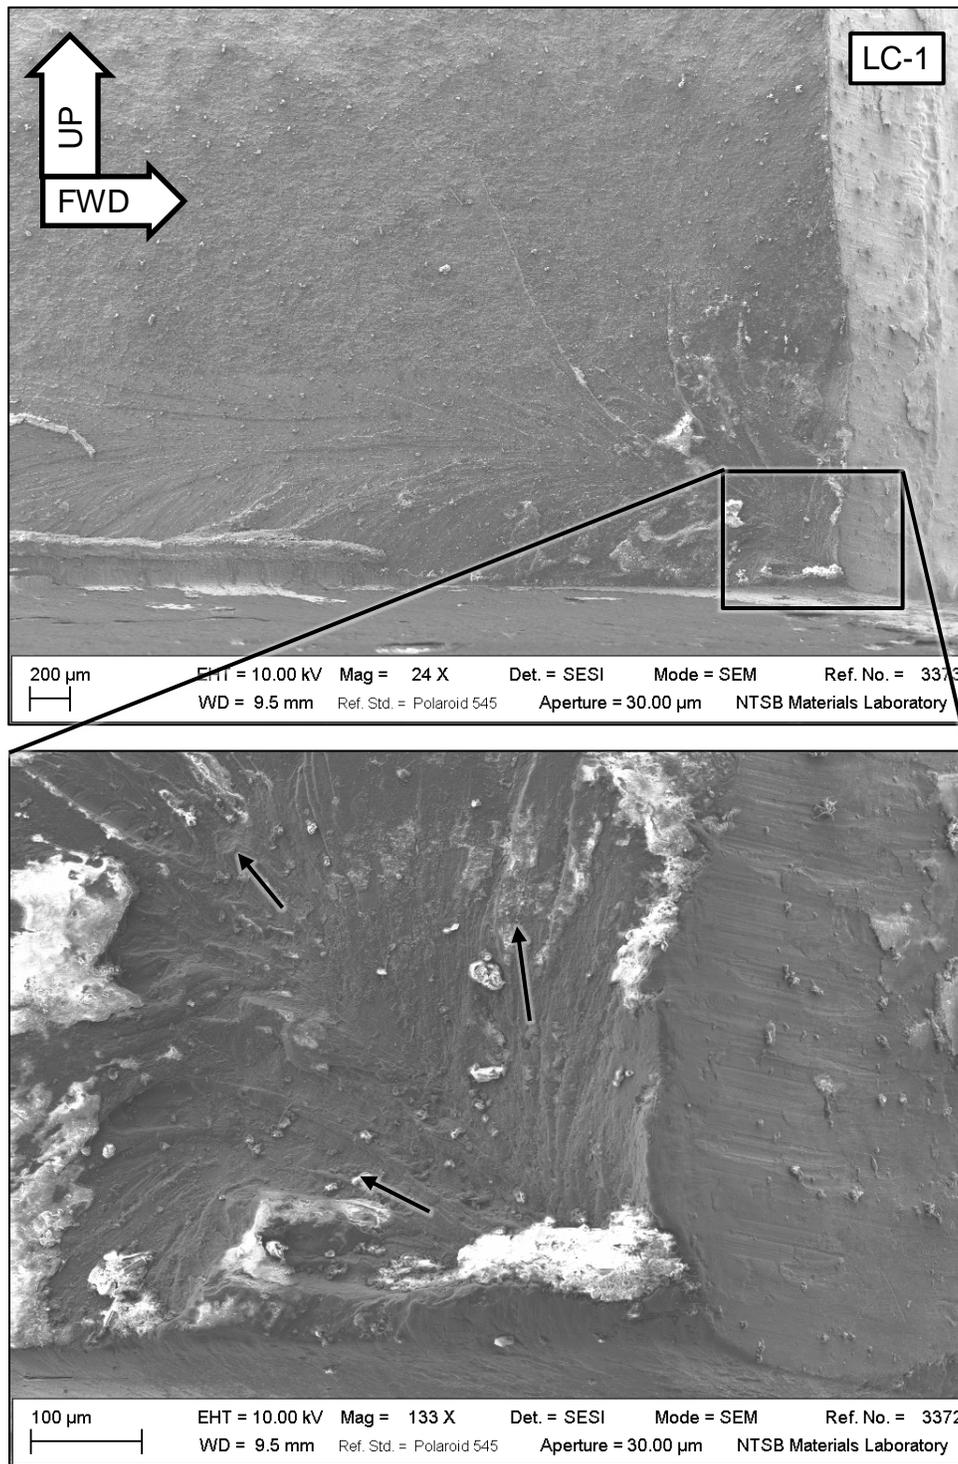
Figure 9. SEM images of fracture features at the aft side of hole LC-1 with a view of the origin area shown at higher magnification (lower image). Unlabeled arrows indicate local directions of crack propagation.

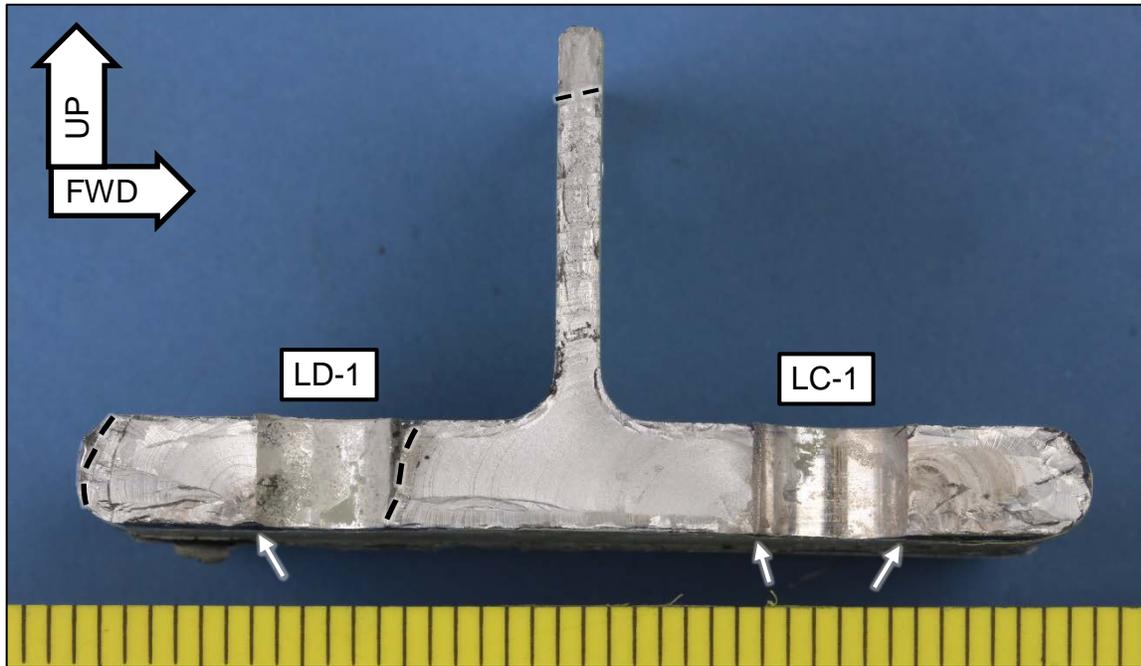
To further characterize the origin areas at the forward and aft sides of hole LC-1 on the lower spar cap, the fracture surface was cleaned by briefly submerging the piece with the fracture surface in a heated aqueous solution containing phosphoric acid and chromium trioxide. A photograph of the fracture surface after completion of the chemical cleaning process is shown in figure 10.

Figure 10. View of the lower spar cap fracture surface after chemical cleaning. Unlabeled arrows indicate fatigue origin areas, and dashed lines indicate fatigue boundaries.

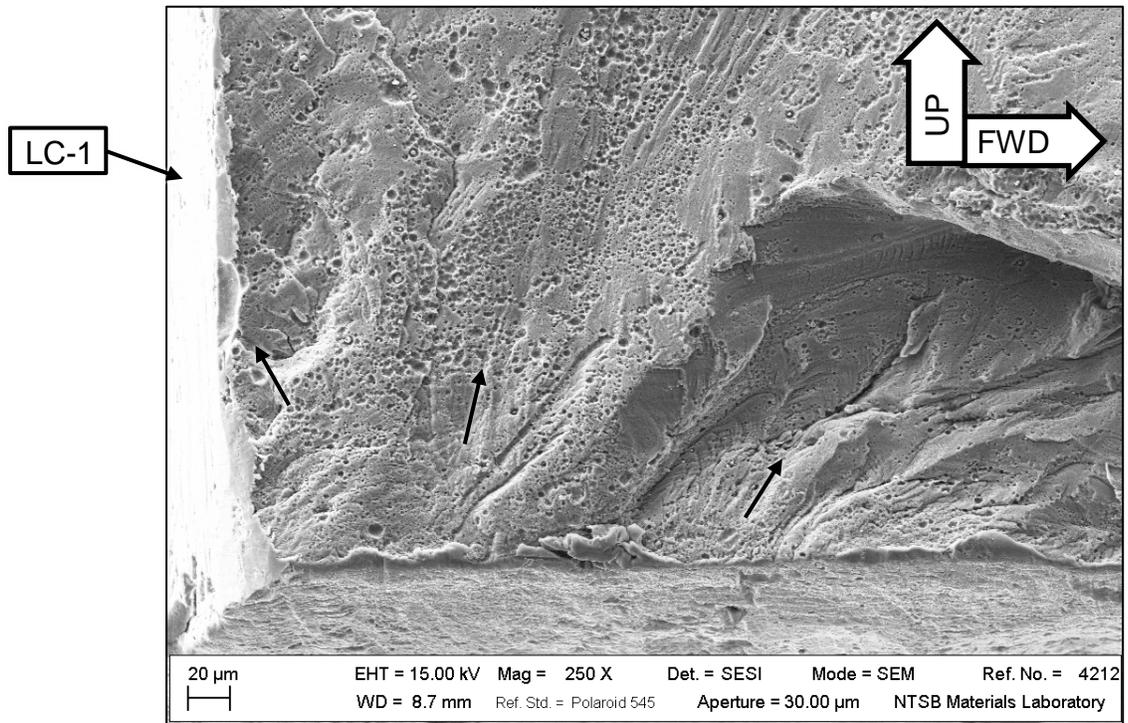
SEM images of the chemically cleaned origin areas at the forward and aft sides of hole LC-1 are shown in figures 11 and 12, respectively. After cleaning, deposits that partly obscured the origin areas were removed, revealing additional fracture features. At the forward side of hole LC-1, fracture features at the corner between hole LC-1 and the lower surface appeared rubbed. However, the direction of local crack propagation in adjacent areas of the fracture surface (see unlabeled arrows in figure 11) appeared to be consistent with a crack origin at the lower surface adjacent to hole LC-1. At the aft side of the hole shown in the upper image in figure 12, a deformed lip was present on the lower side of the fracture which obscured fracture features at the lower edge, and the fracture surface appeared deformed along the edge of hole LC-1 near the lower surface.

Figure 11. SEM image of the fatigue origin area at the forward side of hole LC-1 after chemical cleaning. Fatigue features appeared to emanate from an origin area at the lower surface adjacent to the hole, but a precise origin was not identified due to damage to the fracture surface. Unlabeled arrows indicate local directions of crack propagation.

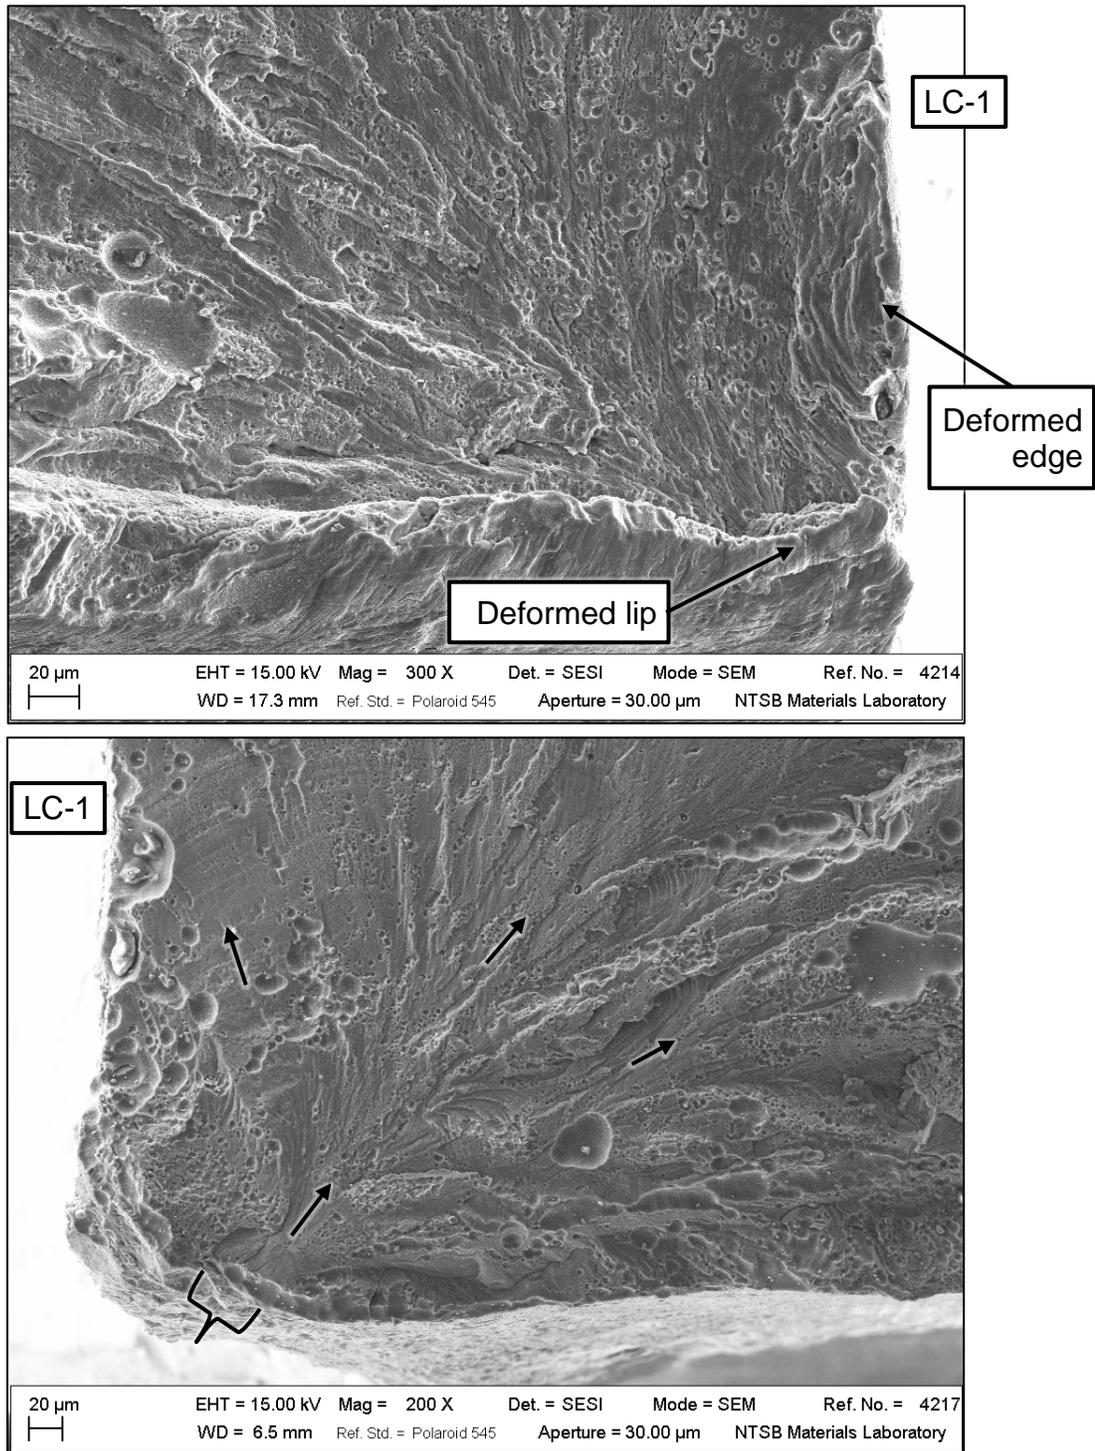
Figure 12. SEM images of mating fracture surfaces at the aft side of hole LC-1 showing the outboard side (upper image) and the inboard side (lower image) of the fracture after each surface had been chemically cleaned. An unlabeled bracket indicates the location of the origin area (identified with an unlabeled bracket) on the inboard side of the fracture which was damaged on the mating outboard side. Unlabeled arrows indicate local directions of crack propagation.

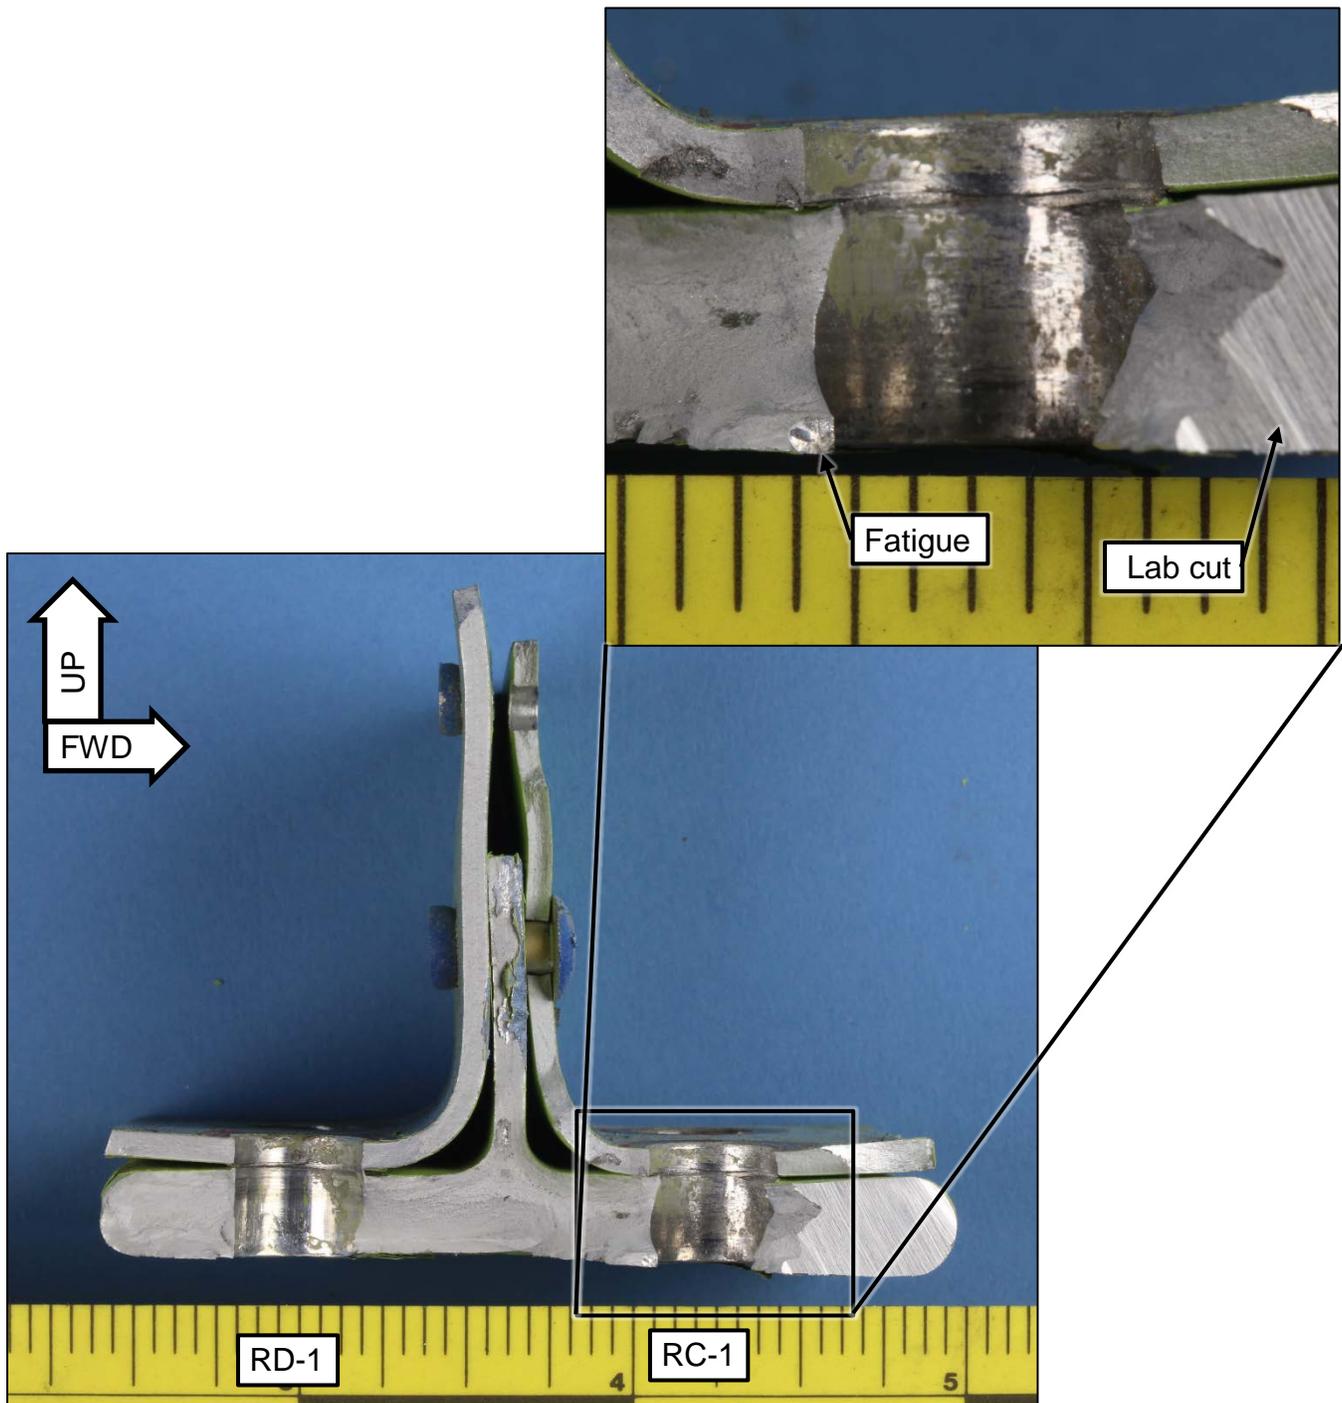
After torque measurements were completed, the right main spar piece was disassembled from the center wing box assembly, and cuts were made to facilitate separating the mating fracture surfaces. Views of the inboard side of the fracture after completing the break with a lab fracture is shown in figure 15. The fracture surface had mostly rough matte-gray features consistent with ductile overstress fracture. River patterns associated with the fracture emanated from hole RD-1 located aft of the spar web consistent with fracture initiation near hole RD-1. The overstress fracture in the right main spar lower spar cap emanated forward, intersecting hole RC-1. As shown in figure 15, a reflective area was observed on the fracture surface at the lower aft side of hole RC-1.

Figure 15. View of the right main spar lower spar cap and doublers from the accident airplane after the crack was opened by lab fracture. The fatigue region at the aft side of hole RC-1 is indicated.

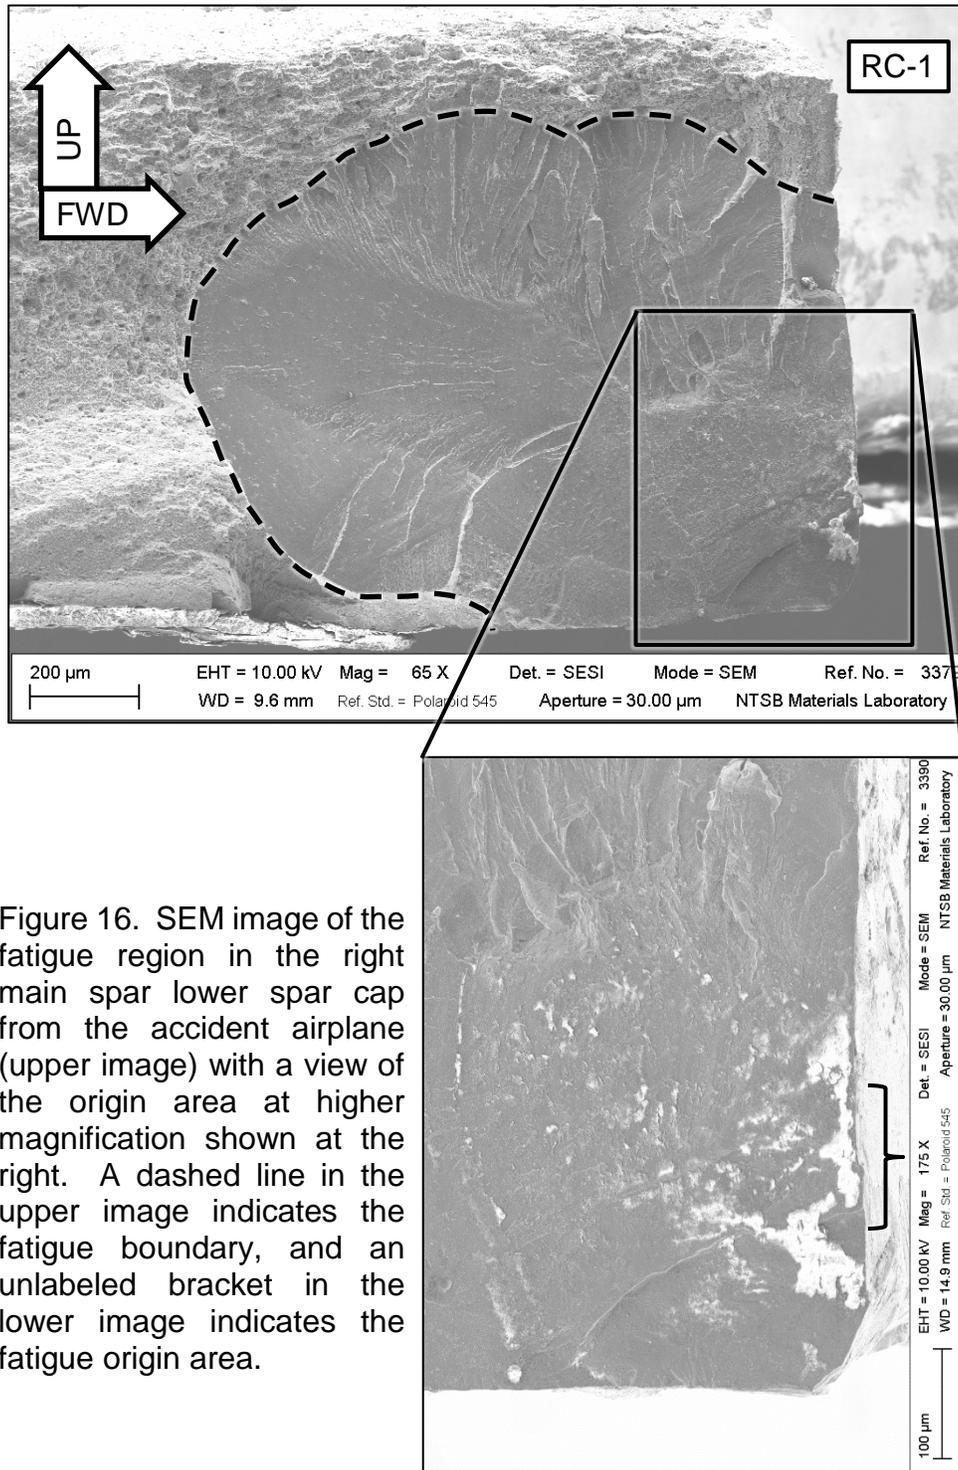
The right wing main spar lower spar cap piece shown in figure 15 was further examined using an SEM, and resulting images of the reflective area at the forward side of hole RC-1 are shown in figure 16. At higher magnification, striations were observed consistent with fatigue. Fatigue features emanated from an origin area located at the hole surface as indicated with a bracket in the lower image in figure 16. A dashed line in the upper image in figure 16 indicates the fatigue boundary, extending up to 0.047 inch aft of the hole and 0.038 inch upward from the lower surface. Where the fatigue region intersected the lower surface, the fatigue crack length was 0.026 inch. No evidence of a preexisting crack was observed at hole RD-1 (where the overstress fracture of the spar cap initiated).

Figure 16. SEM image of the fatigue region in the right main spar lower spar cap from the accident airplane (upper image) with a view of the origin area at higher magnification shown at the right. A dashed line in the upper image indicates the fatigue boundary, and an unlabeled bracket in the lower image indicates the fatigue origin area.
