NATIONAL TRANSPORTATION SAFETY BOARD

MATERIALS LABORATORY FACTUAL REPORT

Report No. 18-061

Place : Daytona Beach, Florida
Date : April 4, 2018
Vehicle : Piper PA-28R-201, N106ER
NTSB No. : ERA18FA120
Investigator : Aaron McCarter, AS-ERA / Clinton R. Crookshanks, AS-40

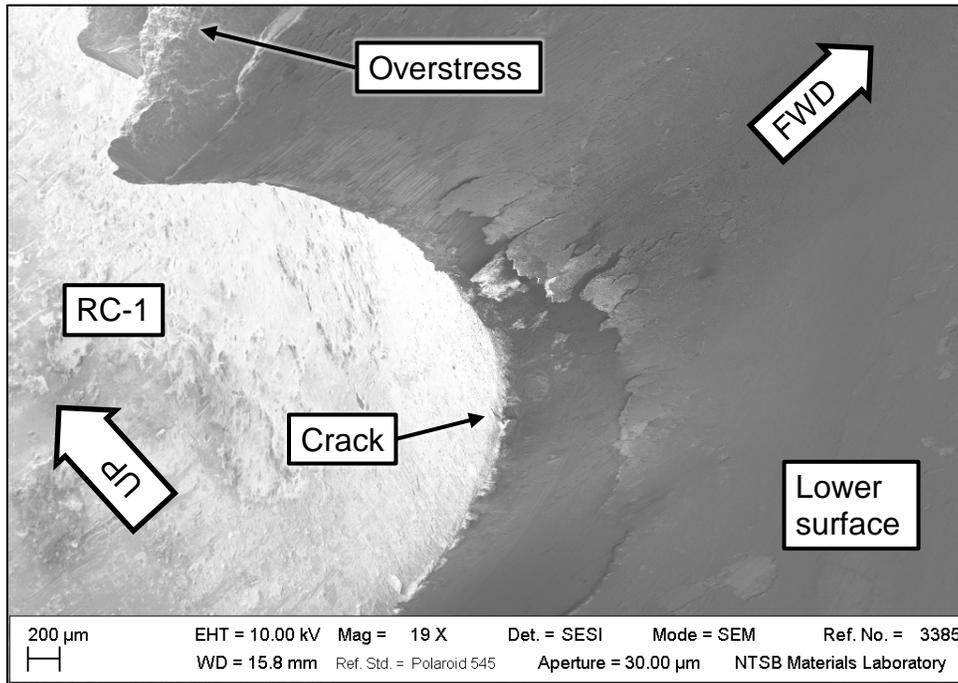
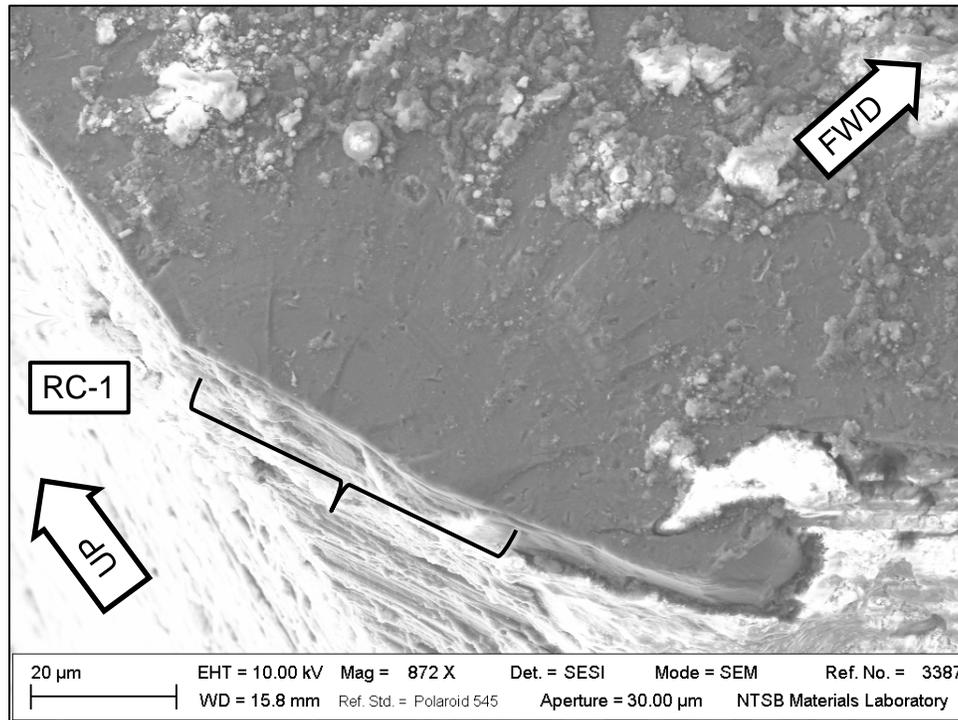
The overstress fracture at the forward side of the hole was located outboard of the transverse plane intersecting the hole center. A tilted view of the forward edge of the hole inboard of the overstress fracture is shown in the upper image in figure 17. As indicated, a crack was observed at the forward edge of the hole where it intersected the lower surface. A closer view of the crack fracture surface is shown in the lower image in figure 17. Smooth fracture features with curving crack arrest lines were observed consistent with fatigue fracture. Ratchet marks² were also observed, consistent with multiple fatigue origins. A bracket in the lower image in figure 17 indicates the fatigue origin area located in the chamfer between the hole bore and the lower surface of the main spar.

Figure 17. SEM images of a fatigue crack at the lower forward side of the forward hole in the right wing main spar lower spar cap from the accident airplane after lab fracture. The location of the crack is indicated in the upper image, and the fracture surface of the crack is shown in the lower image. An unlabeled bracket indicates the fatigue origin area.

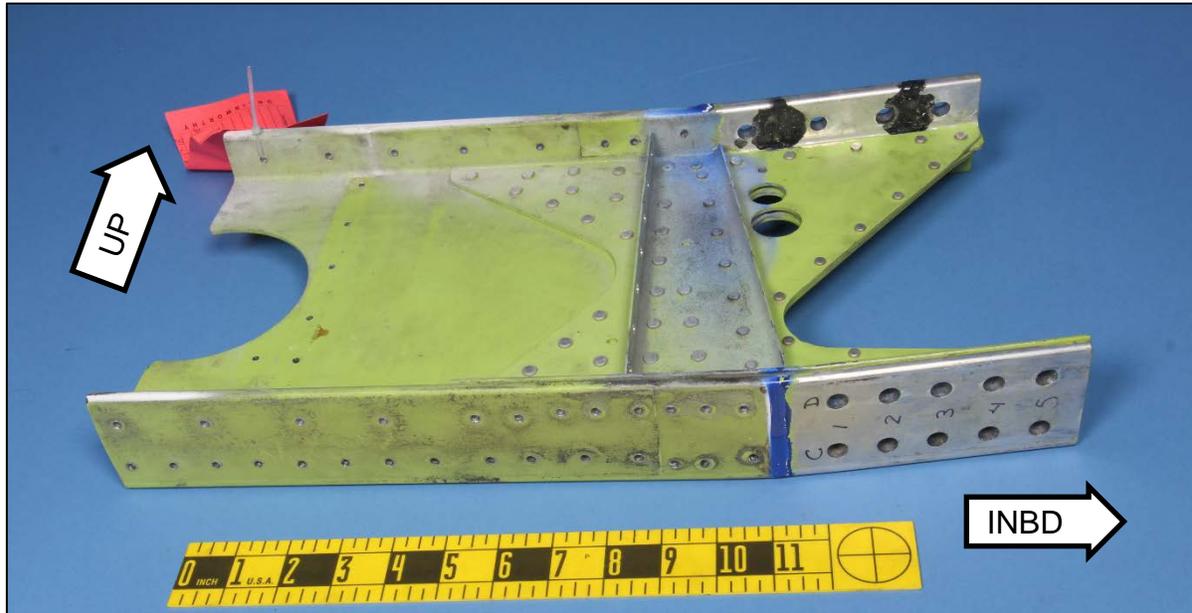
The inboard end of the wing spar was separated from the rest of the wing and sent to the NTSB Materials Laboratory for examination, and a view of the submitted piece is shown in figure 18. A crack feature was visible under optical magnification as shown in figure 19, where a bracket indicates the location of a crack feature extending from the forward side of hole LC-1. No crack features were detected under optical magnification at the aft side of hole LC-1.

Figure 18. Overall view of the left wing main spar from airplane N104ER.

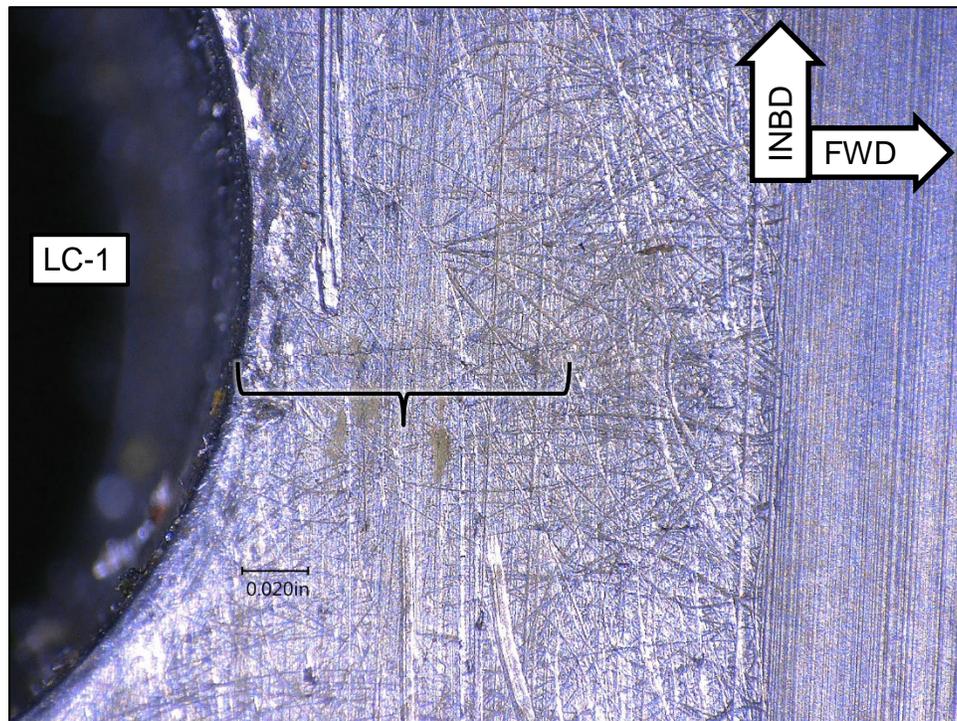
Next, the wing spar was cut to facilitate opening the crack by lab fracture. A transverse cut was made inboard of the attachment holes followed by a longitudinal horizontal cut through the web above the lower spar cap to separate the lower spar cap from the rest of the piece. Then a vertical cut was made through the row C attachment holes followed by a transverse cut through the forward edge of the lower spar cap toward the crack tip. The sectioned piece was then bent by hand to open the crack shown in figure 19.

Figure 19. Lower surface of the left wing main spar from airplane N104ER. A bracket indicates a crack extending from the forward side of hole LC-1.

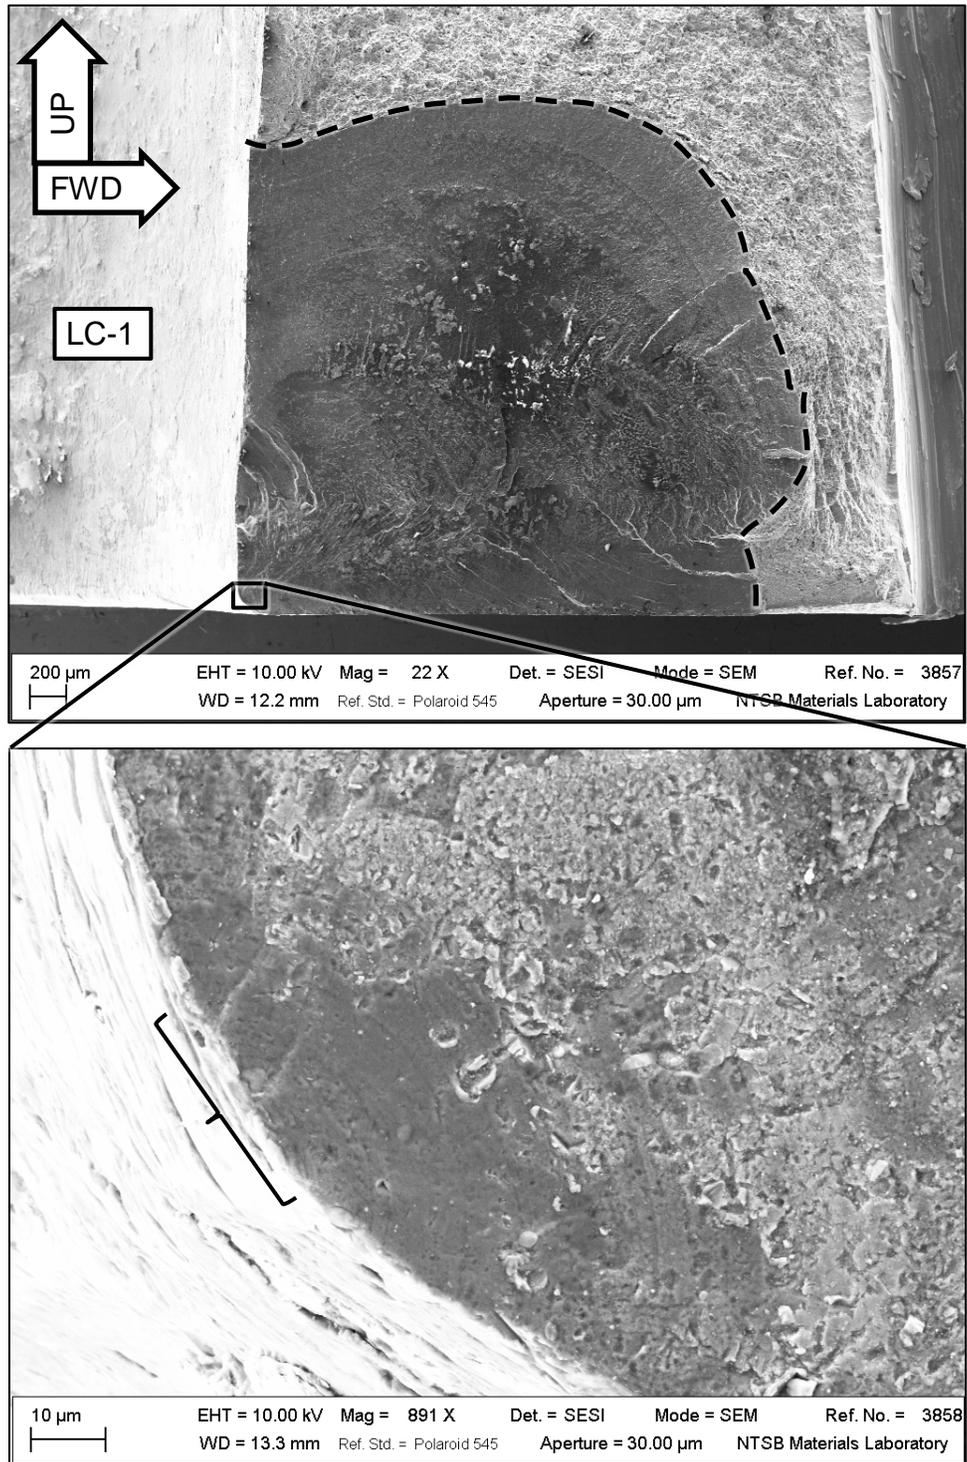
After an initial examination under an optical stereomicroscope, the lab fracture was placed in the SEM for further examination. The crack fracture surface exposed by the lab fracture had relatively smooth features with curving crack arrest lines, features consistent with fatigue. A dashed line in figure 20 indicates the extent of the fatigue region extending up to 0.126 inch forward from the hole surface and up to 0.115 inch upward from the lower surface. Where the fatigue region intersected the lower surface, the length from the hole surface to the fatigue boundary was 0.119 inch.

A closer view of the fatigue origin area is shown in the lower image in figure 20. Ratchet marks were observed indicating multiple fatigue origins within the area indicated by the unlabeled bracket. The origins were located within the corner radius between the hole LC-1 bore and main spar lower surface.

Figure 20. SEM images of the fatigue region in the left wing main spar lower spar cap from airplane N104ER. A dashed line in the upper image indicates the fatigue boundary, and an unlabeled bracket in the lower image indicates the fatigue origin area.
