Piper Aircraft, Inc.
2926 Piper Drive
Vero Beach, FL, U.S.A. 32960

SERVICE NO. 1357 BULLETIN

Date: October 27, 2020

**WING RIB INSPECTIONS AT WS 106.19 AND
WS 123.15**

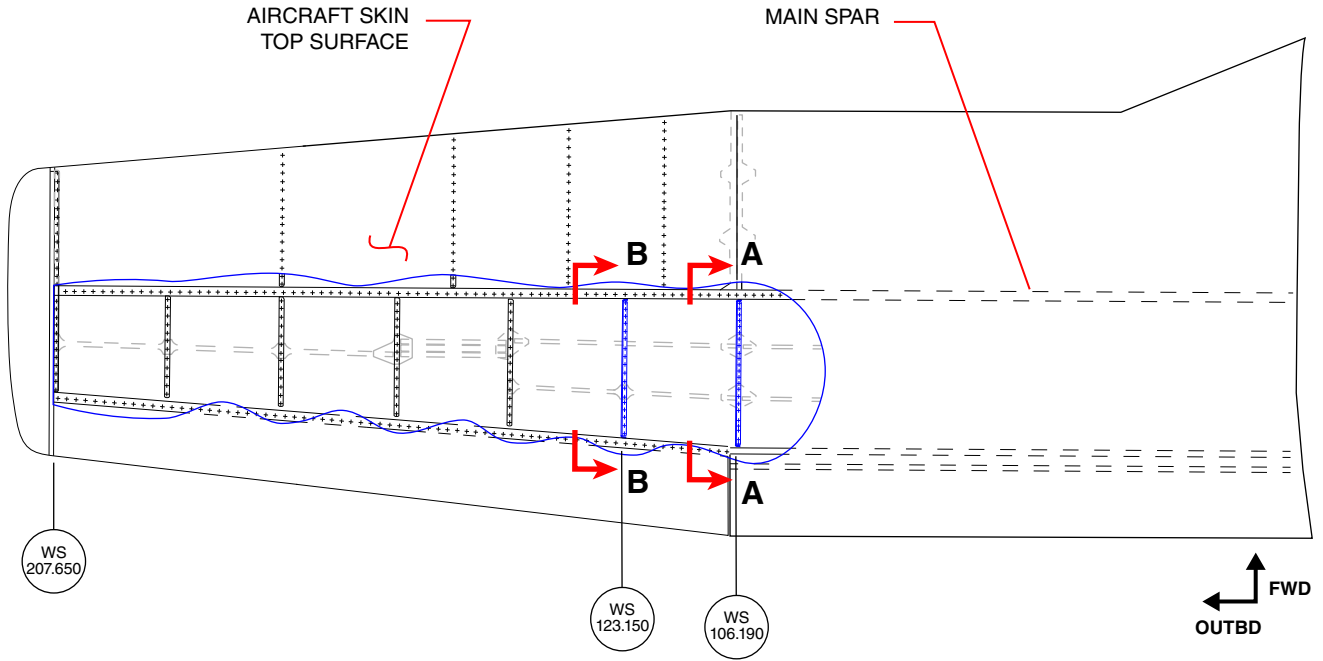
Figure 1 – Sheet 1 of 2
Wing Rib Inspection Locations

1. Gain visual access to the outboard face of the wing ribs at WS 106.19 and WS 123.15, which are located aft of the main wing spar. Refer to Figure 1.
2. Locate the area of inspection, identified in Figure 1, Views A–A and B–B and perform an initial inspection, to determine the rib configuration.
 - If the web of the rib is flat (that is, it's a planar surface), then no further inspection of the specific rib is required. Continue with the initial inspections of the remaining ribs.
 - If the web of the rib includes one or more fluting features, such as those shown in Figure 2, then a detailed inspection is required. Inspect for cracks, with emphasis on the bend radii of the fluting features.
 - If no cracks are discovered, continue with the initial inspections of the remaining ribs.
 - If any crack is discovered, repair or replace the damaged parts prior to next flight.

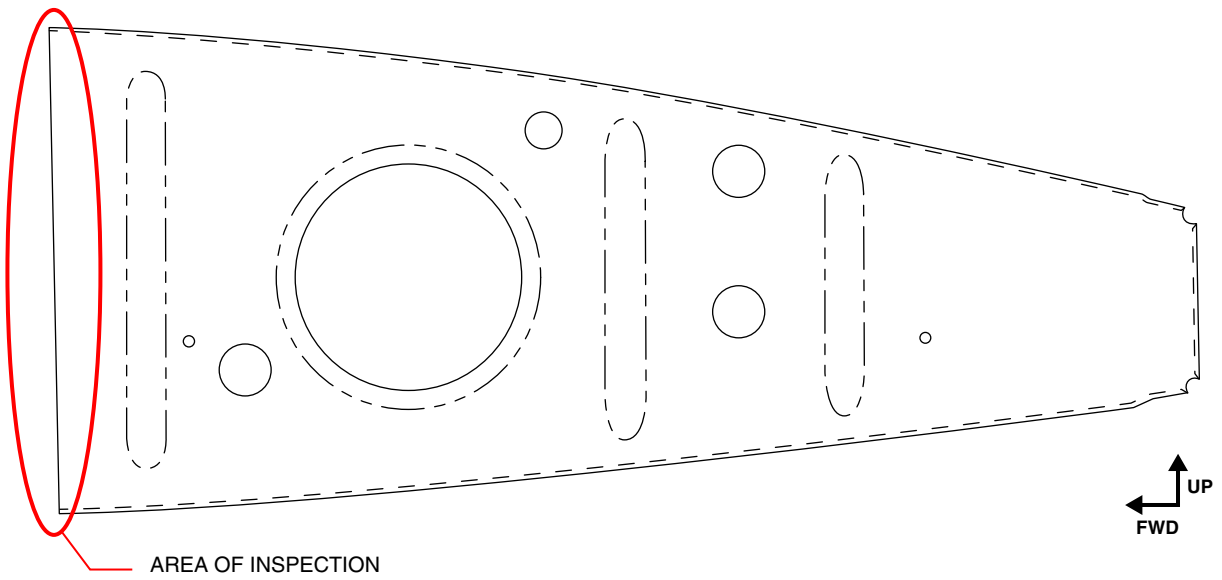
VIEW A-A

LOOKING INBOARD
RIB AT W.S. 106.190

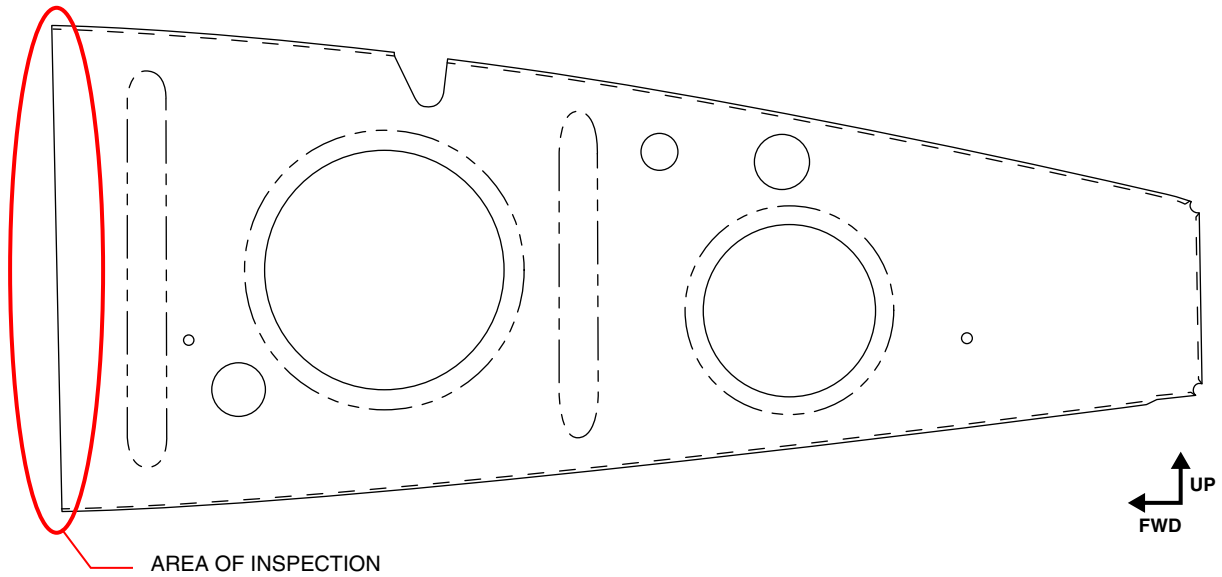
VIEW B-B

LOOKING INBOARD
RIB AT W.S. 123.150

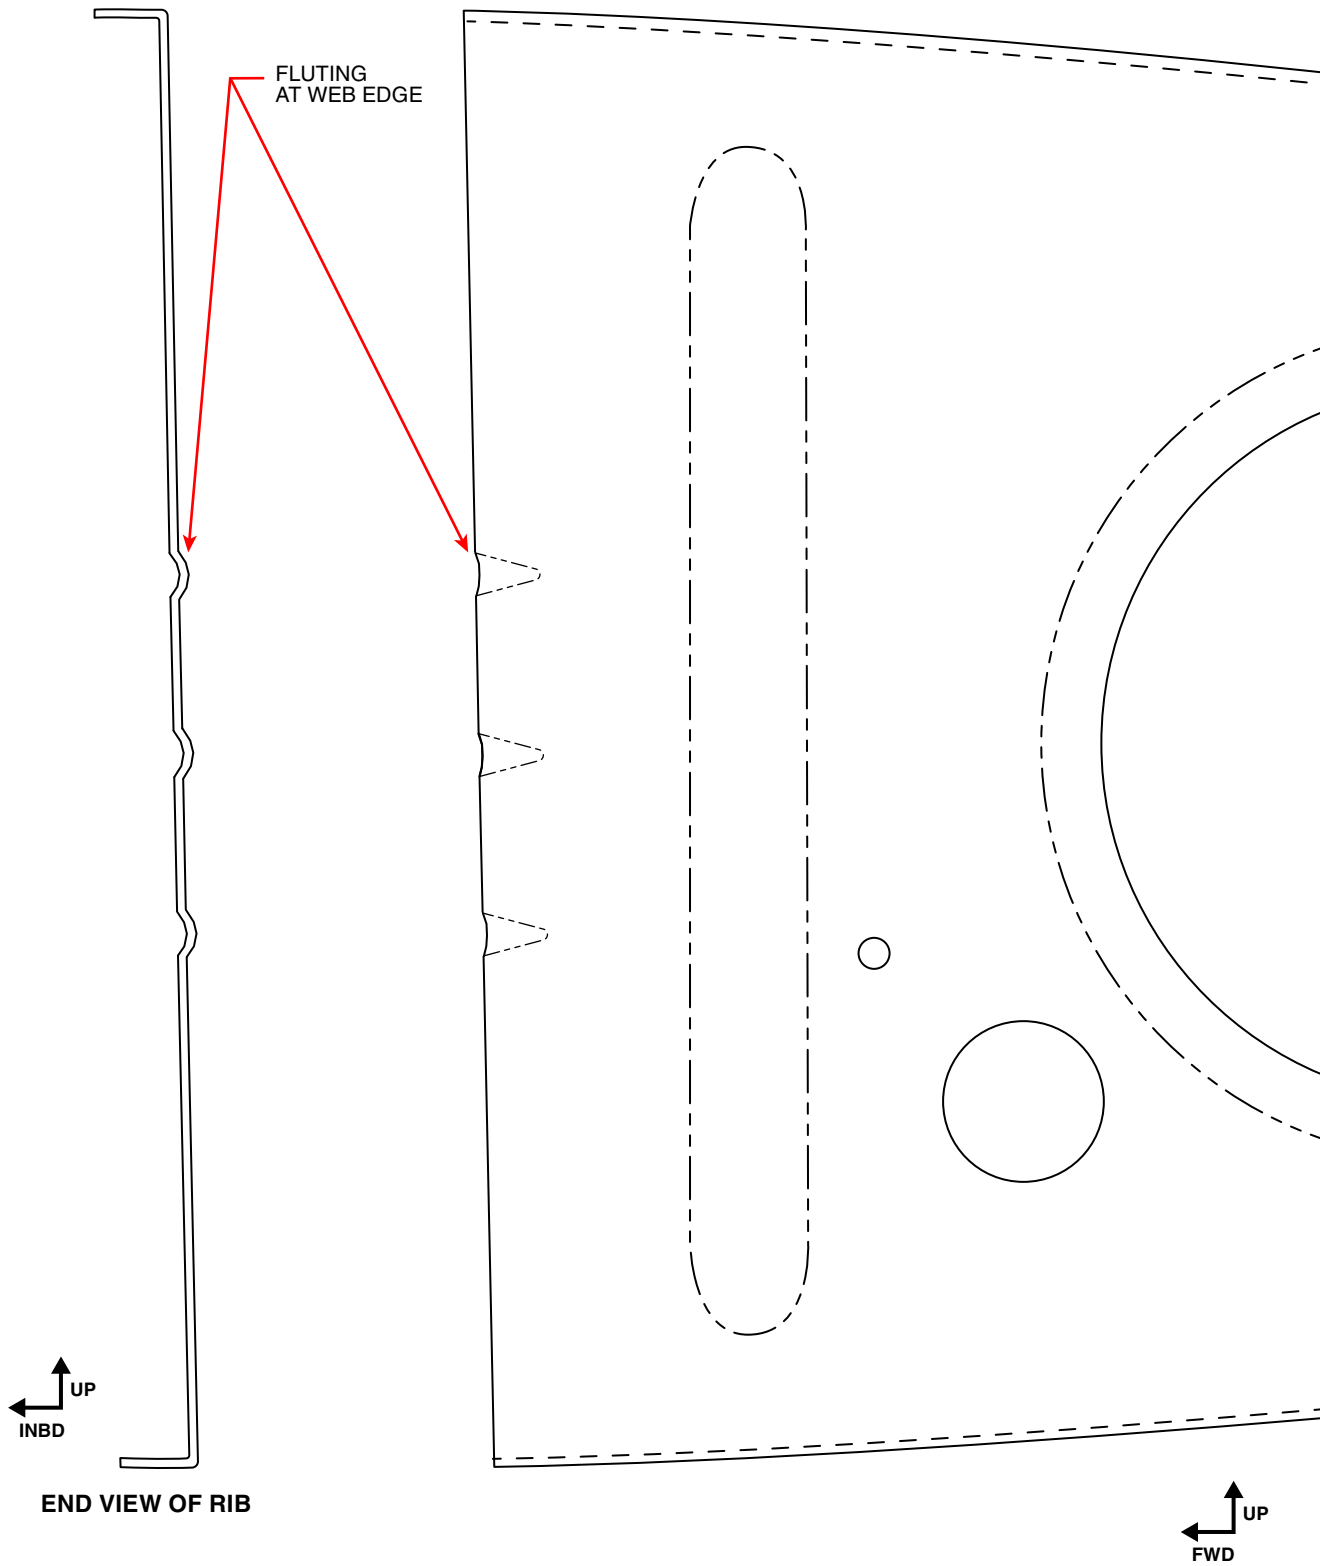
Figure 2
Wing Rib Assembly with Fluting

Some of the affected airplanes may have wing ribs that were fabricated in such a manner that they may develop cracks in the forward edge of the web. This service bulletin provides instructions for a one-time inspection of wing ribs at wing station (WS) 106.19 and WS 123.15 for cracks. Left undetected, a crack in a wing rib could propagate to a critical length, potentially resulting in the structural failure of the wing and loss of control of the aircraft.

TYPICAL VIEW OF AREA OF INSPECTION
CONFIGURATION SHOWN REQUIRES A DETAILED INSPECTION
