SERVICE NO. 1304A BULLETIN

Date: August 14, 2018

MAIN WING SPAR INSPECTION

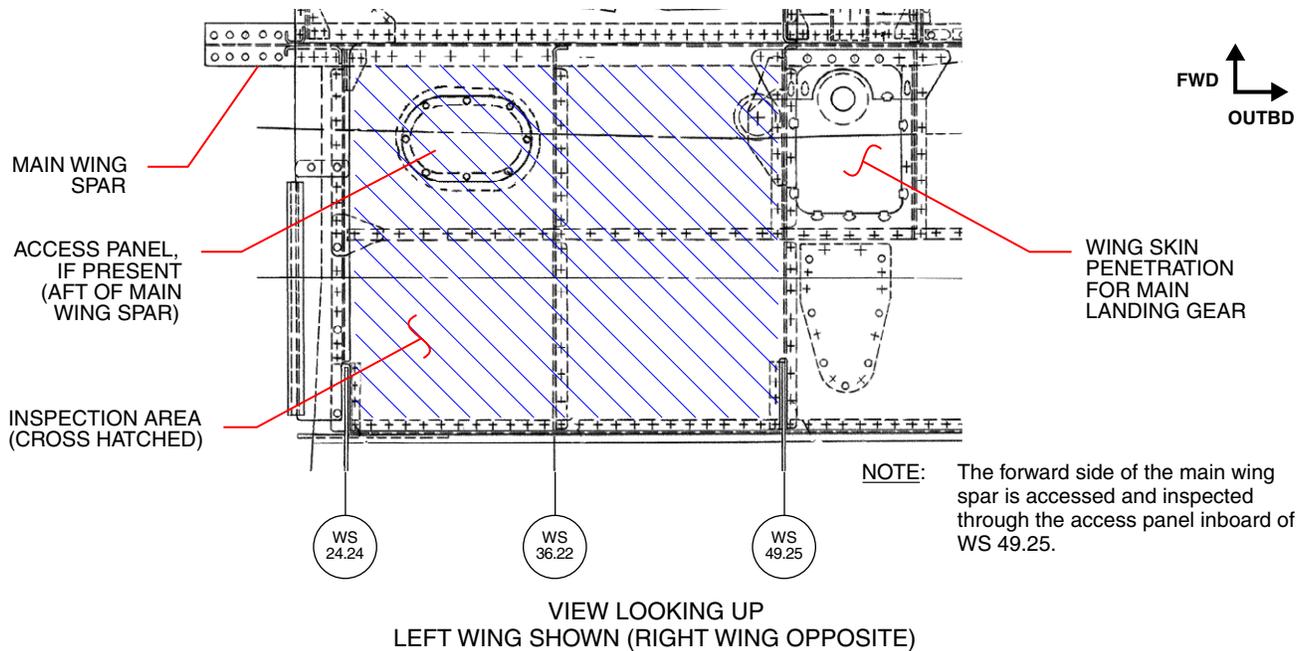
Figure 1
Access Panel Location

1. Examine the lower wing skin in the area shown in Figure 1 for the presence of an access panel, which is in the area aft of the main wing spar and inboard of the main landing gear. This access panel, if present, will be oval shaped, roughly eight (8) inches long and 5.50 inches wide.
 - If an access panel already exists in the area identified in Figure 1, proceed to Step 2.
 - If no access panel exists in the area identified in Figure 1, order and install Inspection Access Hole Kit, Piper Part Number (P/N) 765-106V. Each kit provides parts to install one access panel on the lower surface of both the left and right wings, at a location that provides direct visual access to the inspection area. Proceed to Step 2.
2. RC – Remove wing inspection panels and fairings, as required, to gain visual access to the main wing spar.

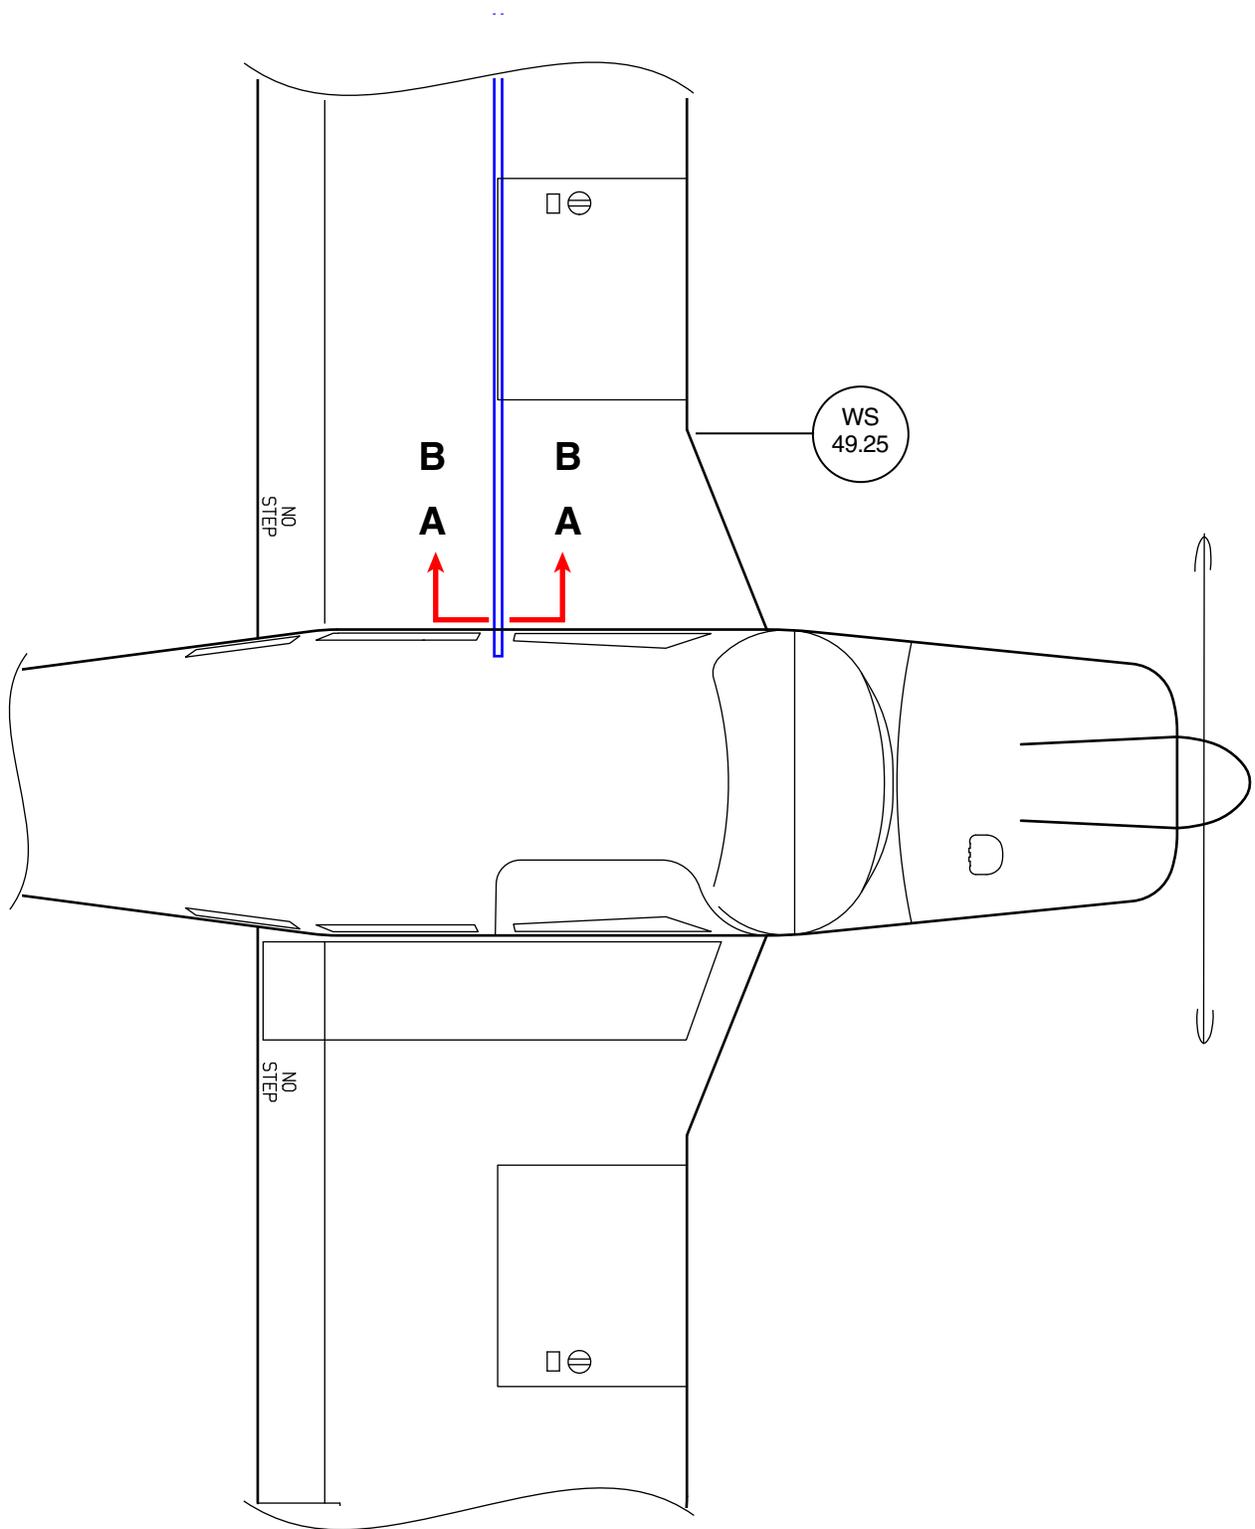
Figure 2, Sheet 1 of 2
Wing Spar Configurations

4. RC – Compare the aircraft model and serial number against Tables 1 and 2 and Figure 2, to identify the applicable main wing spar configuration before proceeding.

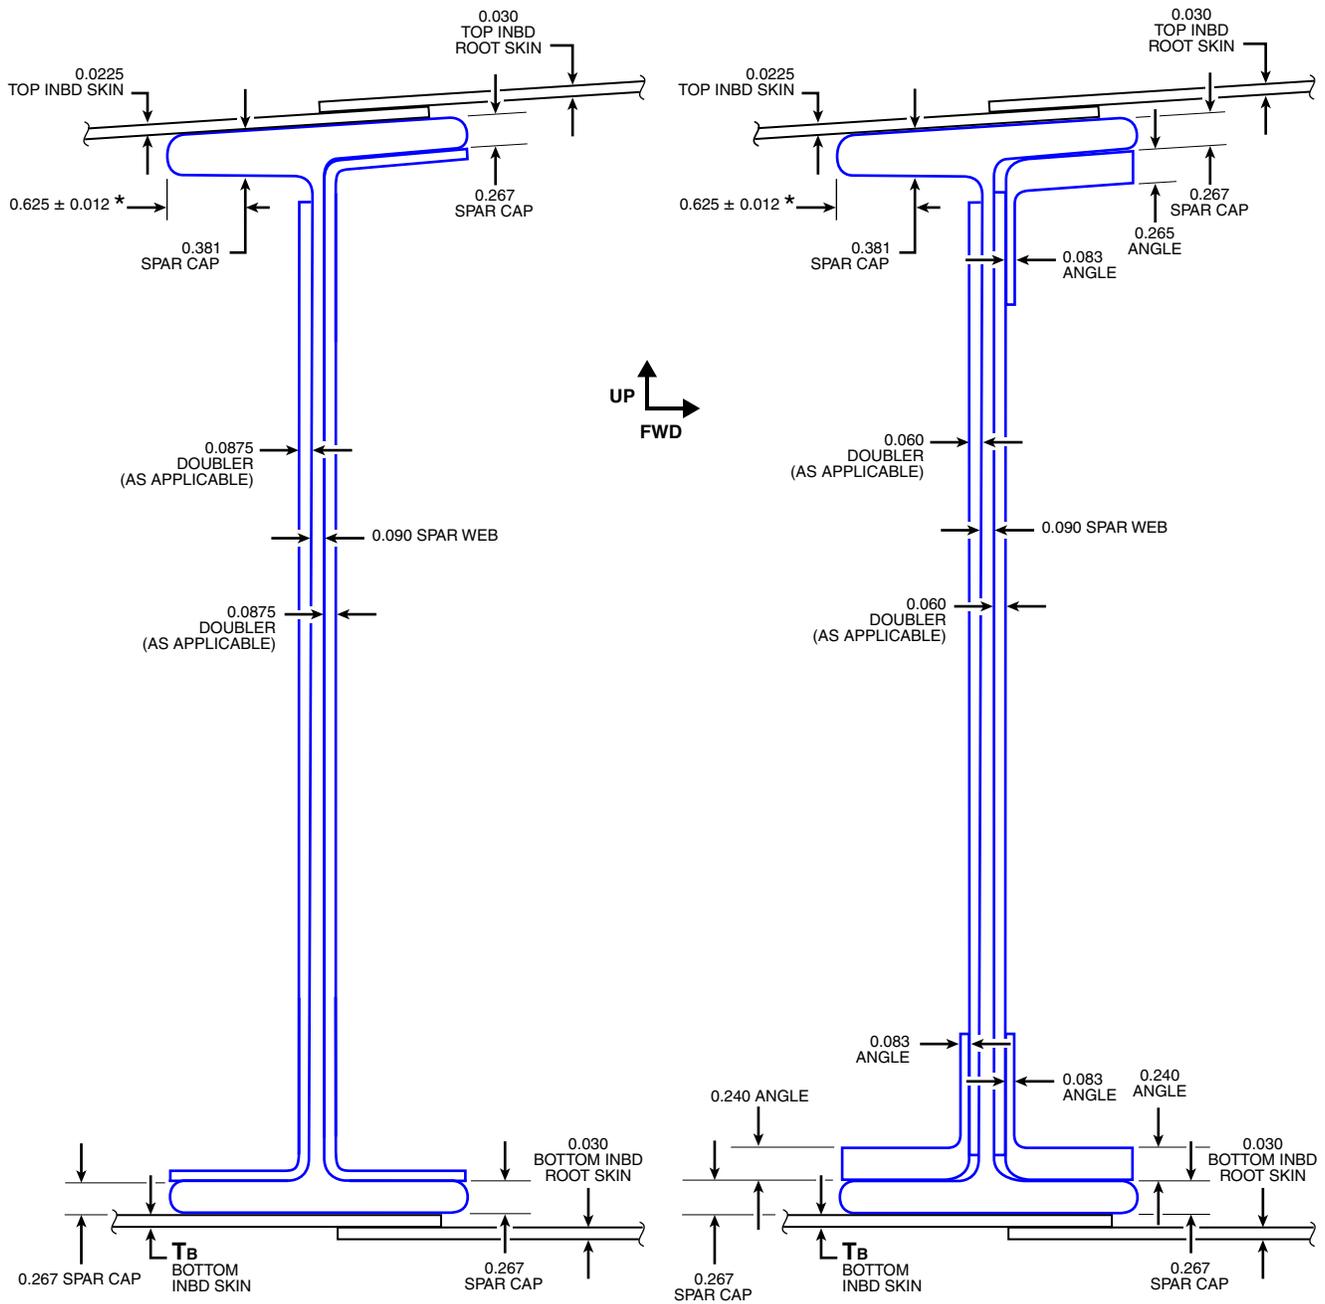
Figure 2, Sheet 2 of 2
Wing Spar Configurations

NOTE: If SB 1304 (original version) was complied with, and, in accordance with Part I, Step 4, corrosion was removed, then: to comply with SB 1304A, measure (1) the **top inboard skin** and (2) the **bottom inboard root skin**. Their thicknesses must meet or exceed the corresponding minimum thicknesses provided in Table 2 and Figure 2, Sheet 2, below.

* The dimension 0.625 +/- 0.012 is not a measure of material thickness. Rather, this dimension defines the location to measure for the minimum allowable thickness of 0.381 in the spar cap.

5. RC – After removal of the corrosion, verify that all affected areas meet or exceed the minimum thicknesses stated within this service bulletin. At locations where direct measurement is not possible, thickness measurements shall be accomplished using a nondestructive inspection method such as ultrasound, eddy current, or equivalent, provided that such method achieves a measurement accuracy of +/- 0.005 inches or better.
