COMPLIANCE NECESSARY TO MAINTAIN SAFETY

- SUBJECT:** Potential Improperly Lubricated Roller Bearing in S-1200 Series Magnetos
- PURPOSE:** Notify customers of inspection requirement for affected S-1200 Series Magnetos.
- COMPLIANCE:** Within 25 hours after the affected magneto(s) are placed in service. If either magneto has accumulated more than 25 operating hours, inspect prior to next flight.

**DOC NO** **REVISION**  
CSB673 C

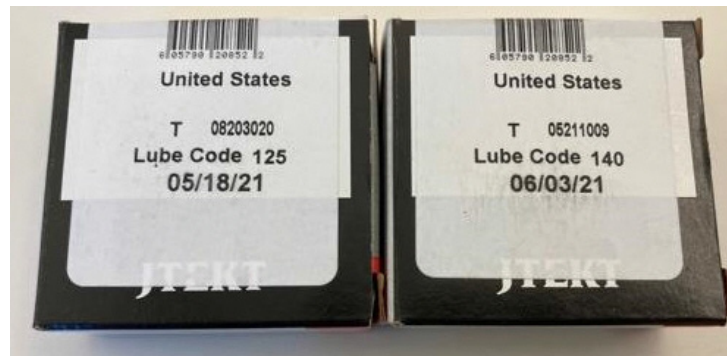
Figure 1. Bearing Package Markings

Return affected Part No. 10-400561, Roller Bearings purchased for inventory to Continental for warranty replacement. If the roller bearings are in the original packaging, refer to the package labels in Figure 1. Parts identified with **Lube Code: 140** are treated with the proper lubricant. If the label indicates *Lube Code: 125*, return the bearing(s) to Continental for replacement. If the bearings were removed from the original packaging, inspect the bearings using the criteria in Section III. B. 8 for disposition.

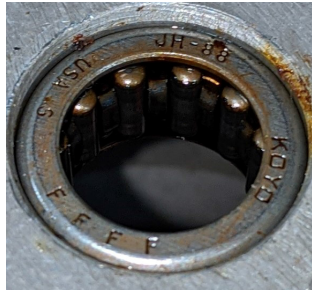
**Bearing - No Grease**

- b. If no white grease is detected in these areas:
    - 1) Inspect rotating magnet shaft (61) at the bearing area for signs of bearing distress, including but not limited to overheating (bluing, discoloration) and/or displaced metal. If rotating magnet shaft (61) shows signs of bearing distress, it must be replaced along with bearing (63), cam (33) and all contact assemblies (30). Remove rotating magnet shaft (61) according to the “Disassembly”

**Figure 2. Bearing Condition Inspection**

- 2) Place the magneto housing (72) on the base plate of an arbor press with the drive end down. Using the “R” (for “Remove”) end of the 11-9815 drift, press out the roller bearing (63) and discard. (See X42001, figure 4-4).

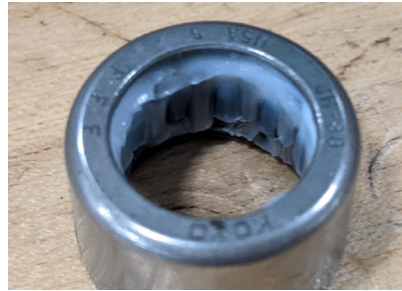
**Greased Bearing Before Installation**

- a. Translucent white grease (Figure 2) residue in this area is an indicator of a properly lubricated bearing. If grease is detected here, go to “Assembly” procedures in Section C.

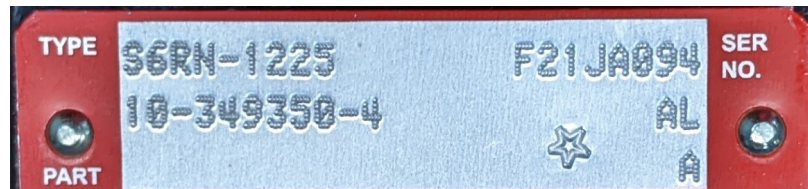
**Figure 3. Magneto Dataplate After Compliance**

Affected magnetos that have been reworked and inspected are being identified with a **five-point star stamped** on the **data plate** (see Figure 3) after corrective action is accomplished. If the S-

1200 Magneto is within the affected serial number range and the magneto data plate is marked with a five-point star, corrective action is complied with - no further action is required.

1. Reassemble magneto according to “Assembly” instructions in the latest revision of S-1200 Service Support Manual, Document Number X42001, using paragraphs 9-2.1, 9-2.2, 9-2.3, 9-2.4, 9-2.5, 9-2.6, 9-2.7, 9-2.8, 9-2.9, 9-2.13, 9-2.16, 9-2.17, 9-2.18, 9-2.19, 9-2.20 as necessary.
2. Install magneto on engine according to “Assembly” instructions in S-1200 Service Support Manual, Document Number X42001, paragraph 9-3 and the engine manufacturer’s instructions.
3. When corrective action is complete, mark the dataplate in the lower right corner with a commercially available ImpressArt (or equivalent) 2.50mm five-point star stamp and ball-peen hammer to indicate compliance with this bulletin.
