SUBJ: Wing Spar

This Special Airworthiness Information Bulletin (SAIB) alerts all owners, operators, maintenance technicians, and inspectors of **Piper Aircraft, Inc. (Piper) PA-28 and PA-32** airplanes of information gathered as result of a fatal accident of a Piper Model PA-28R-201 airplane in 2018 and the inspection findings that followed. The accident, determined to be caused by fatigue cracks in the lower spar cap, resulted in the Federal Aviation Administration (FAA) issuing Airworthiness Directive (AD) 2020-26-16, which requires several actions including a one-time inspection of certain lower spar cap bolt holes. AD 2020-26-16 was issued as an interim action and requires reporting certain inspection information to the FAA to help determine the number of cracks present in the fleet. The inspection reports received by the FAA thus far indicate the presence of numerous cracks and hole-quality issues in a significant number of airplanes.

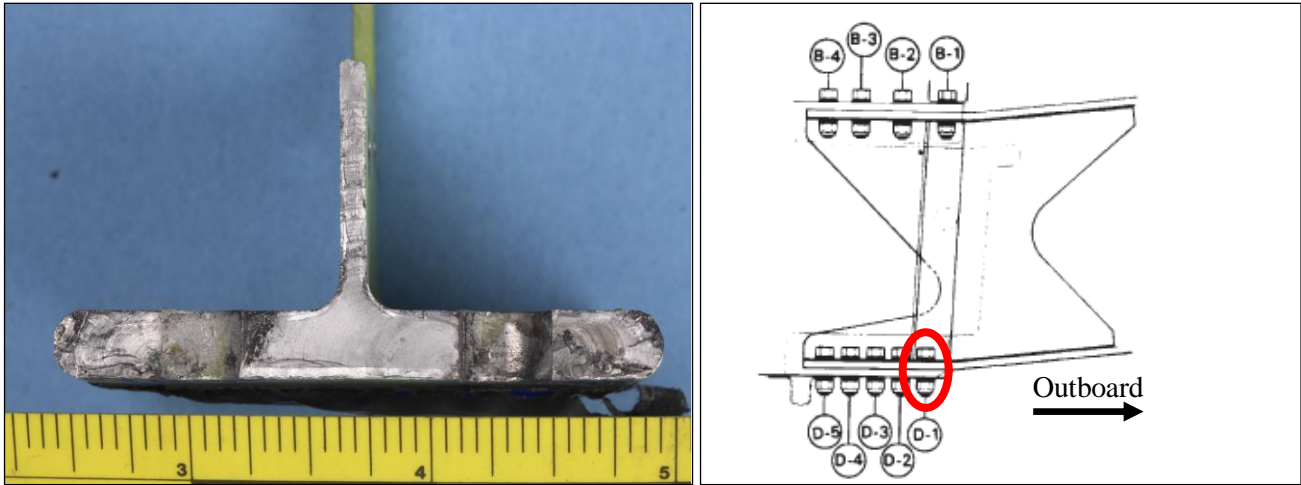
As stated above, the FAA issued AD 2020-26-16 due to a 2018 in-flight wing separation on a Piper Model PA-28R-201 airplane caused by fatigue cracks located in a visually inaccessible area of the lower main wing spar cap. Inspection of another airplane in the same fleet of the accident airplane (manufactured at a similar time and operated in a similar training mission) was also found to have cracking in the wing spar. The National Transportation Safety Board (NTSB) found fatigue cracking across an extensive cross-section of the lower spar cap. The crack and failure occurred across the T-section at the two most outboard bolt holes attaching the lower spar to the wing box (see Figure 1).

Figure 1. Spar Cap Failure at Outboard Bolt Holes (left), Spar and Center Wing Attachment Configuration, Failure Location Shown (right)

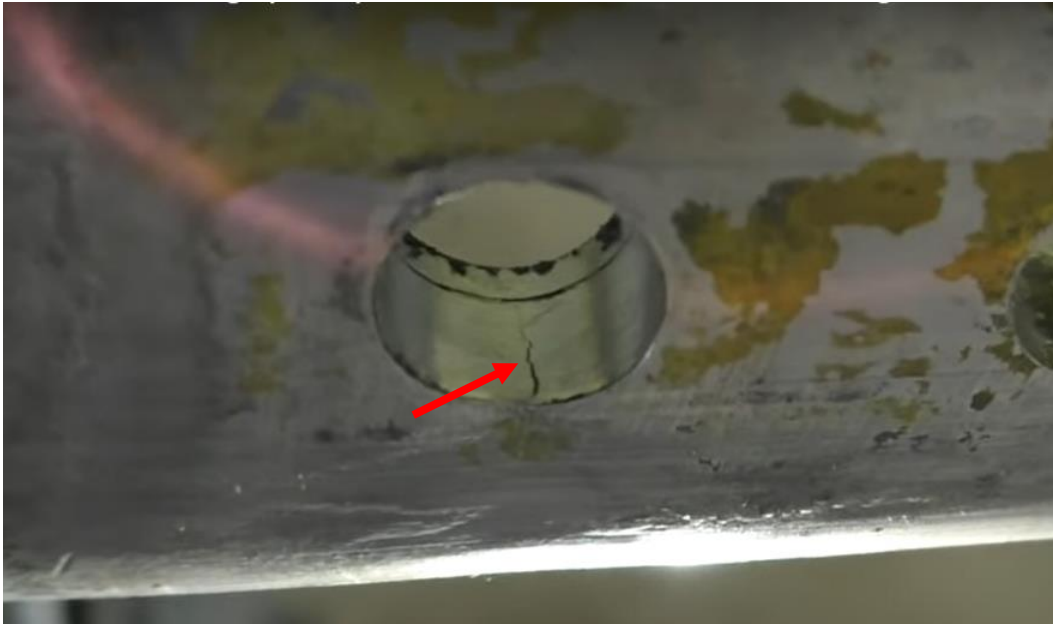
**Figure 6. Example of Cracks Intersecting Bolt Hole
PA-32-300, 5,319 hours TIS**

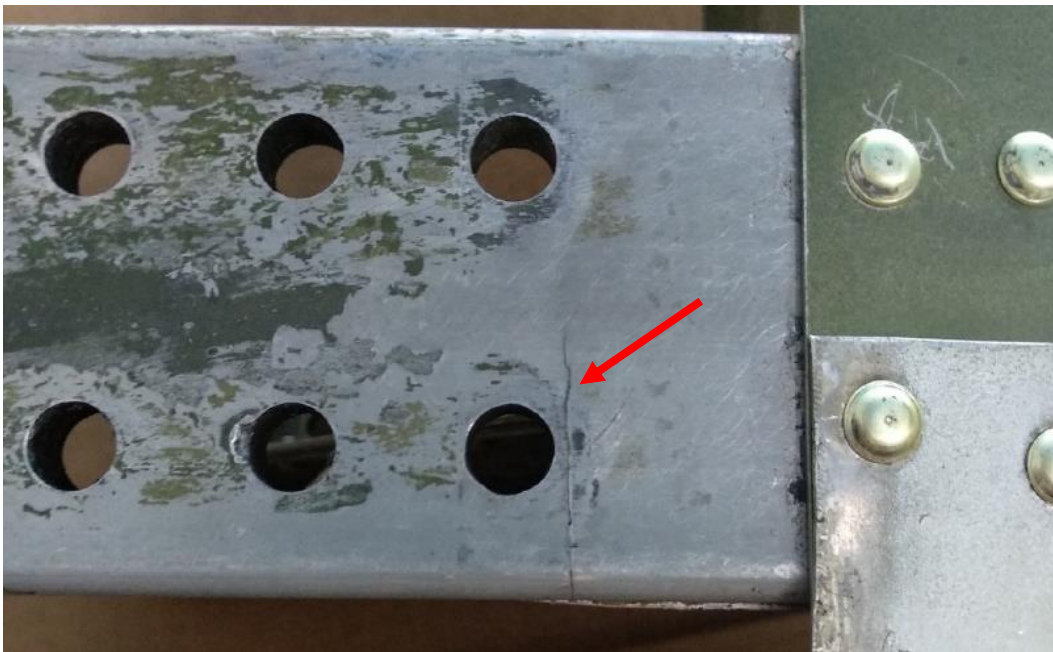
**Figure 7. Example of Cracks Not Intersecting Outboard Bolt Hole
PA-28-181, 12,824 hours TIS**

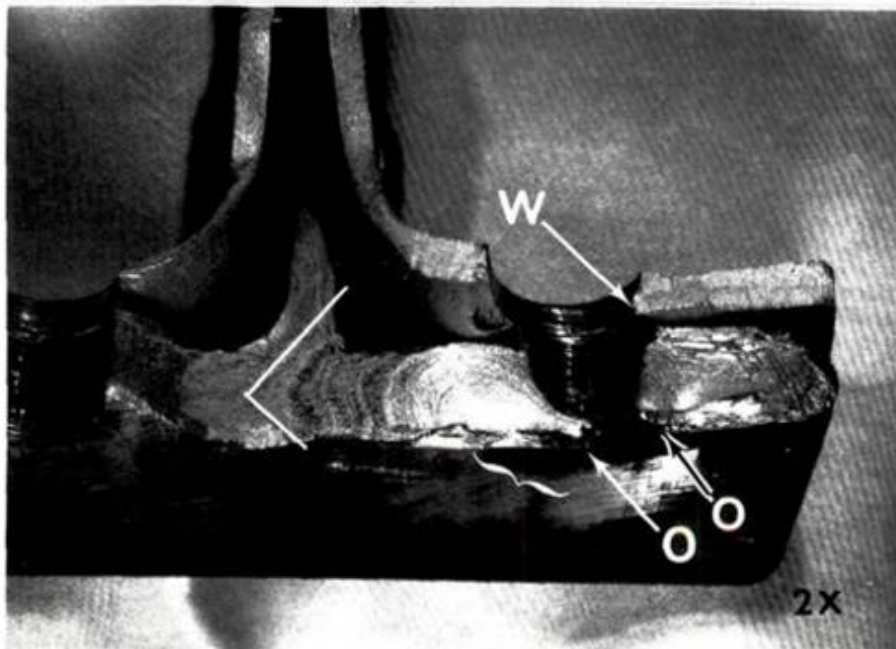
The first related accident occurred in 1987 in Marlin, TX. The accident airplane was a Piper Model PA-28-181 airplane with 7,490 hours TIS. Nearly all of this airplane's flight time was known to be spent in a "Pipeline Patrol" mission. This type of mission is characterized by very low altitude and terrain following flight profiles. These flying characteristics degrade an aircraft's structure faster than most other missions. See Figure 10 for a view of the accident airplane's failed spar, where "O" indicates fatigue crack origins and "W" indicates a web fatigue crack.

**Figure 10. 1987 Accident, Failed Wing Spar
PA-28-181, 7,490 hours TIS; O indicates crack origin**

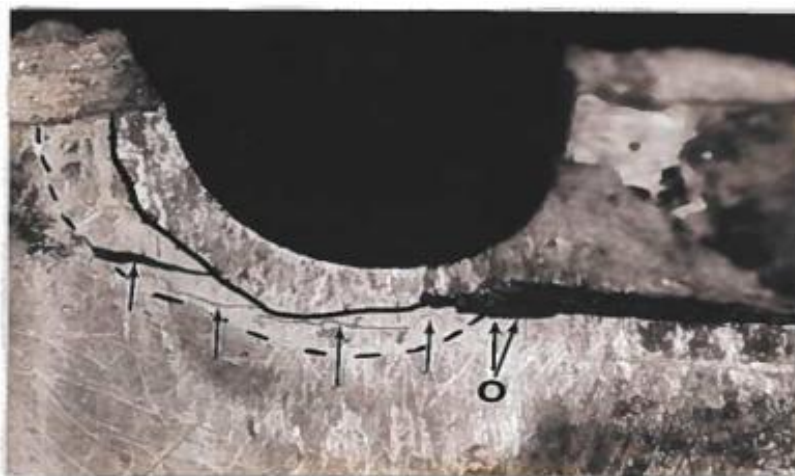
The second of these accidents occurred in 1993 in Provincetown, MA. The accident airplane was a Piper Model PA-28-181 airplane with 11,683 hours TIS. This accident was attributed to weather with signs of structural overloading, but a fatigue crack was also found in the failed spar. The crack is beyond the critical crack size later calculated for that spar. While the NTSB did not identify the fatigue crack as the probable cause of the accident, its presence may have contributed to the effect of the structural overload. At the time of the accident, the airplane was being flown for personal use; however, the airplane was operated by a company providing a mix of training and charter flights. The training mission type of flying is characterized by low altitudes and many takeoff and landing cycles. While less severe than a “Pipeline Patrol” mission, the training mission would contribute more towards fatigue than personal use. See Figure 11 for a view of the accident airplane’s failed spar near a bolt hole, where “O” indicates fatigue crack origins. The origin in this case was adjacent to the hole, not in the hole, as in the 2018 accident.

**Figure 11. 1993 Accident, Failed Wing Spar
PA-28-181, 11,683 hours TIS; O indicates crack origin adjacent to the bolt hole**

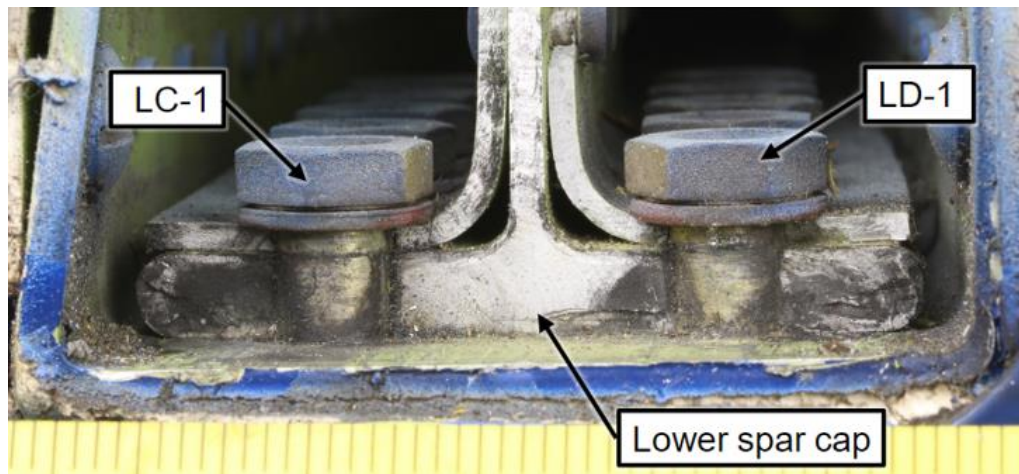
The third and most recent of these accidents occurred in 2018 in Daytona Beach, FL. The accident airplane was a Piper Model PA-28R-201 airplane with 7,691 hours TIS. This airplane was used almost exclusively for flight training throughout its lifetime. This type of usage is expected to reduce the fatigue life of the airplane more than an airplane used as a mixture of personal and training, while still less damaging than use exclusively in the “Pipeline Patrol” mission. See Figure 12 for a view of the accident airplane’s failed spar.

**Figure 12. 2018 Accident, Failed Wing Spar
PA-28R-201, 7,691 hours TIS**
