Piper Aircraft, Inc.
 2926 Piper Drive
 Vero Beach, FL, U.S.A. 32960

SERVICE NO. 1327A LETTER

WING WALK MODIFICATION AND INSPECTION

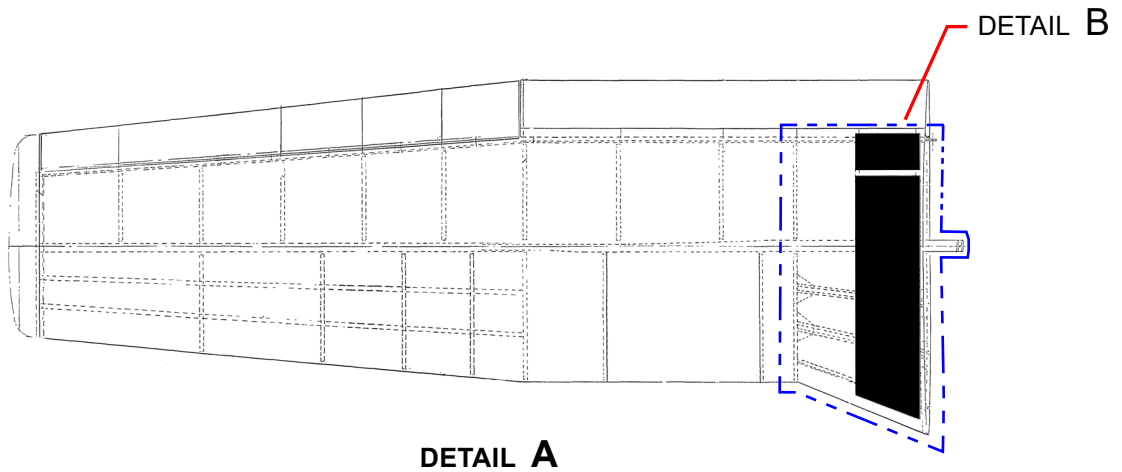
Figure 1 (Sheet 1 of 2)
Wingwalk Inspection Areas

Cracks may be discovered in the doublers (aka wing skin pan) that reinforce the wing skin, localized around the wing walkway. Aircraft with this condition are considered airworthy and may continue to operate, provided that a recurring inspection is performed on the affected wing skin. However, cracks may appear in areas normally obscured by the wing walkway material. This service letter provides a modification to the wing walkway by removing and replacing part of the wing walkway material to facilitate the required recurring inspection.

1. Locate the wing skin pan, as shown in Figure 1.
2. Inspect the pan from below for cracks.
 - If cracks are found in the pan, proceed to Part III.
 - If no cracks are found, no modification is required at this time.
 - Make a logbook entry documenting compliance with Part I of this service letter.

1. If the modification described in Part III of this service letter has not been performed, locate and inspect the pan from below for cracks, as shown in Figure 1. Otherwise, proceed to step 2.
 - If cracks are found in the wing skin pan, proceed to Part III.
 - If no cracks are found, no modification is required at this time. Proceed to step 3.
2. If the modification described in Part III has been performed on this aircraft, inspect the wing skin where the clear tape has been applied.
 - Verify there is no cracking/damage in the wing skin local to the walkway.
 - Verify there is no permanent contour deformation in the wing skin.

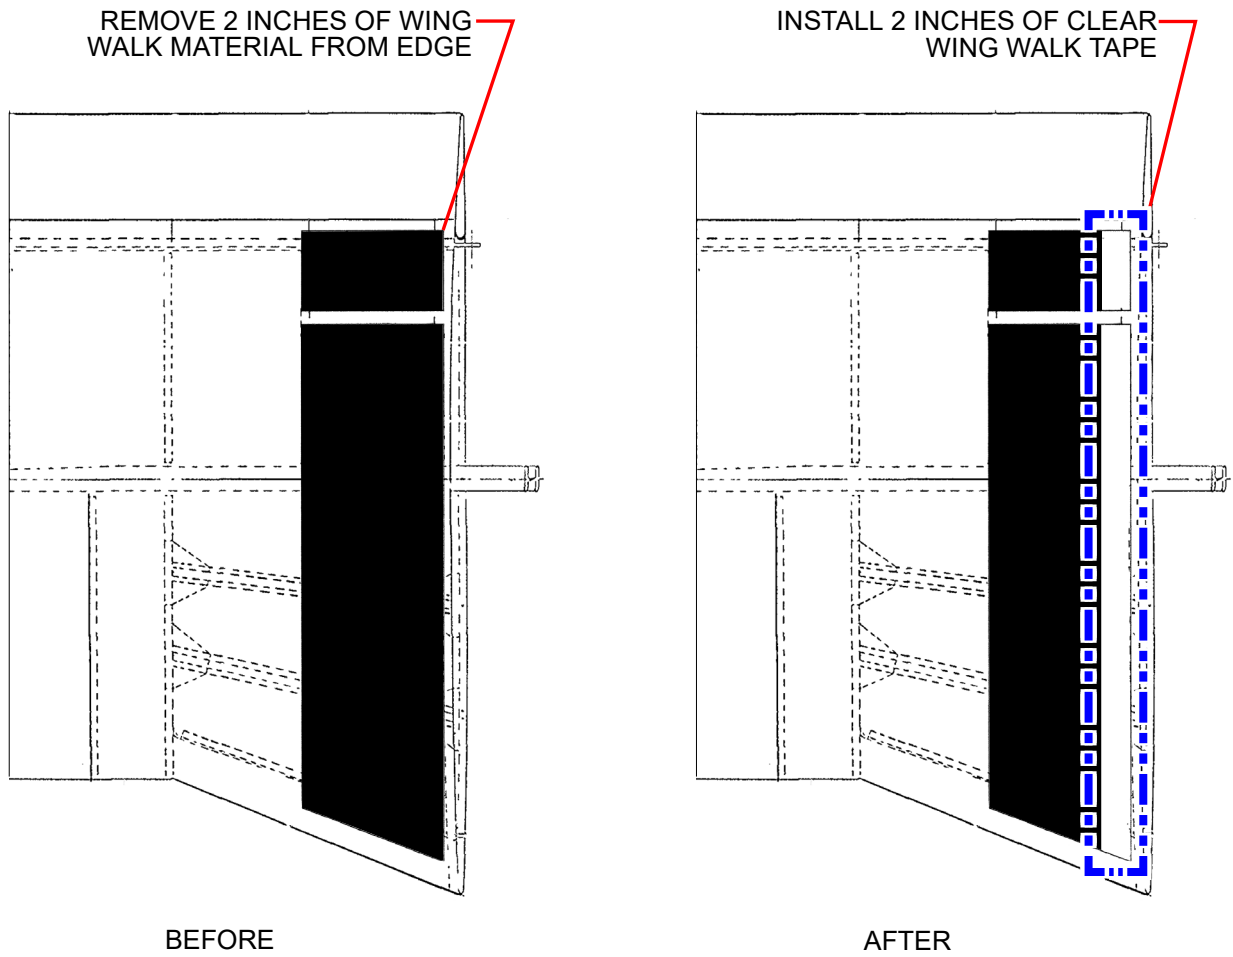
Figure 2
Wingwalk Modification

If cracks or other damage are discovered in the wing skin, replacement of the wing skin and doublers is required.

1. Locate the wing walk, as shown in Figure 2.
2. Remove two (2) inches of wing walk material at the location indicated in Figure 2. While the wing walk material is removed, inspect the wing skin for cracks. If cracks are found, replacement of the wing skin and pan is required. Otherwise proceed to step 3.
3. Install a two (2) inch wide strip of 3M Safety-Walk clear wingwalk tape, 3M ID 70070548980, or equivalent transparent slip-resistant wing walk tape, where the original wing walk material was removed. Refer to the manufacturer for installation instructions.
4. Make a logbook entry documenting compliance with Part III of this service letter.
