Piper Aircraft, Inc.
 2926 Piper Drive
 Vero Beach, FL, U.S.A. 32960

SERVICE NO. 1405A BULLETIN

Date: October 24, 2023

SUBJECT: FUSELAGE SKIN RIVET INSPECTION, FS 156

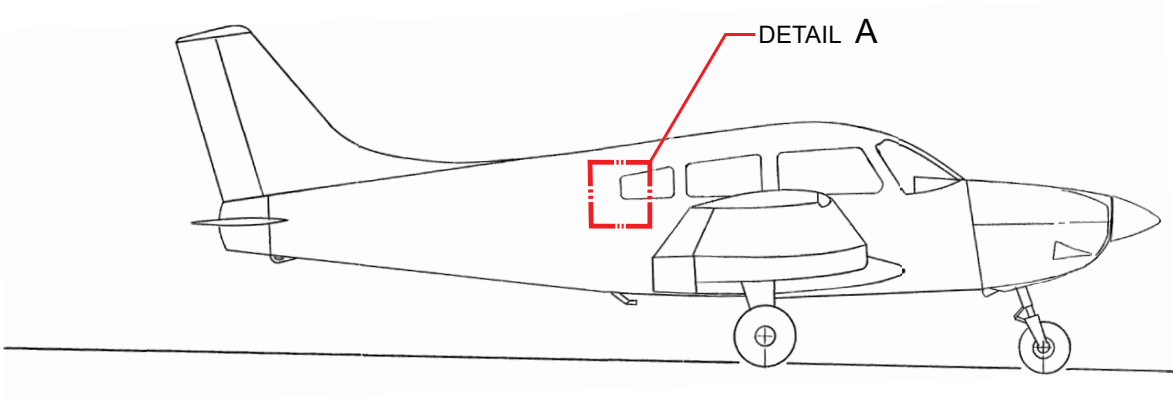
Figure 1 (Sheet 1 of 2)
Inspection Area for Missing Rivets

PURPOSE: On some of the affected aircraft, one or more rivets common to the aircraft skin and the outboard flange of the Fuselage Station (F.S.) 156.00 frame may be missing. This service bulletin provides instructions to inspect, and on condition, install the missing rivets.

PA-28 SHOWN, PA-44 SIMILAR

1. Locate the portion of the aircraft skin in the vicinity of F.S. 156.00, as shown in Detail A of Figure 1. Inspect for the presence of the 6 rivets.
 - If all 6 rivets are installed as shown, then the rivet count conforms to type design at this location. No rework is required. Proceed to step 4.
 - If one or more rivets are missing, then rework is required. Proceed to step 2.
2. Install MS20470AD4 series rivets as required to conform to type design as shown in Detail A of Figure 1. Dimensions shown are nominal, with a tolerance of +/- 0.03 inches. Adjust rivet locations from dimensions shown as needed to achieve the following constraints:
 - Maintain minimum edge distance of at least 0.22 inches from the edge of all parts in the stack up.

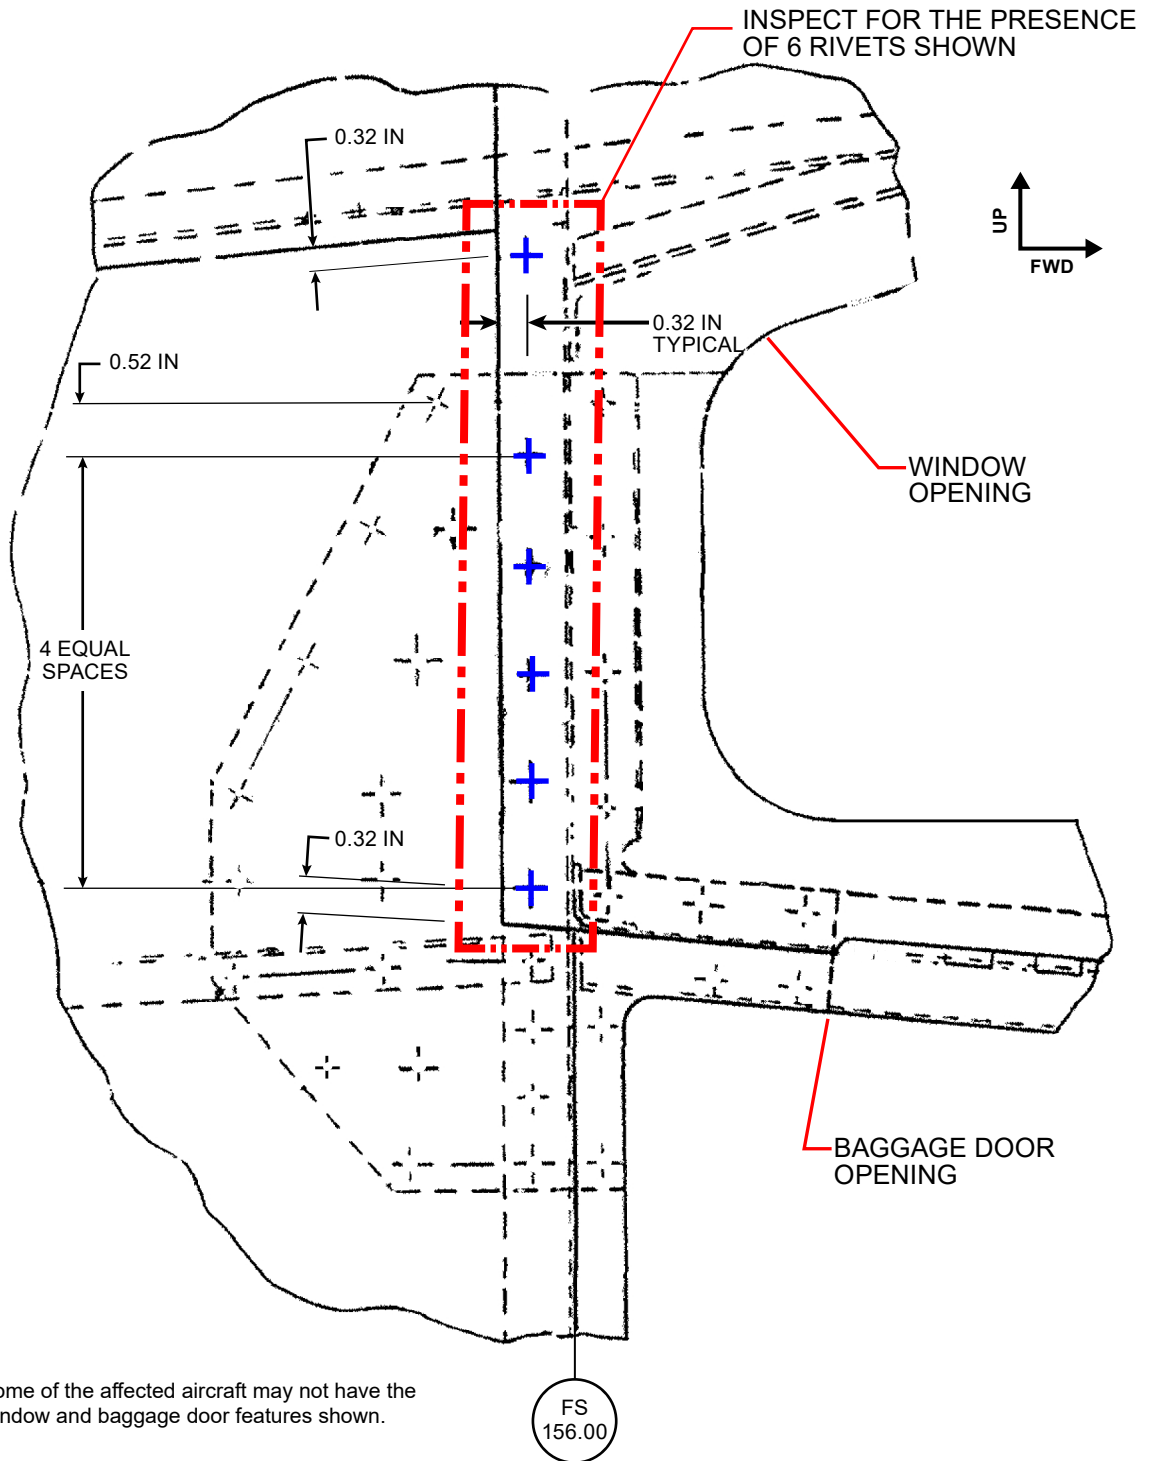
Figure 1 (Sheet 2 of 2)
Inspection Area for Missing Rivets

DETAIL A
RIGHT SIDE VIEW OF AIRCRAFT SKIN

- Maintain a minimum rivet spacing of at least 0.38 inches from all adjacent rivets.
3. Finish all bare metal surfaces by applying a primer that conforms to MIL-PRF-85582 Type 1 Class C2, or any of the primers listed in Table 1. For exterior surfaces, apply a top coat of Axalta Imron paint in a color to match adjacent surfaces.
 4. Make a logbook entry documenting compliance with this service bulletin.
