Location:	Olathe, KS	Accident Number:	CEN22FA119
Date & Time:	February 13, 2022, 10:20 Local	Registration:	N2445F
Aircraft:	PIPER AIRCRAFT INC PA46-500TP	Injuries:	1 Fatal
Flight Conducted Under:	Part 91: General aviation - Personal

CEN22FA119

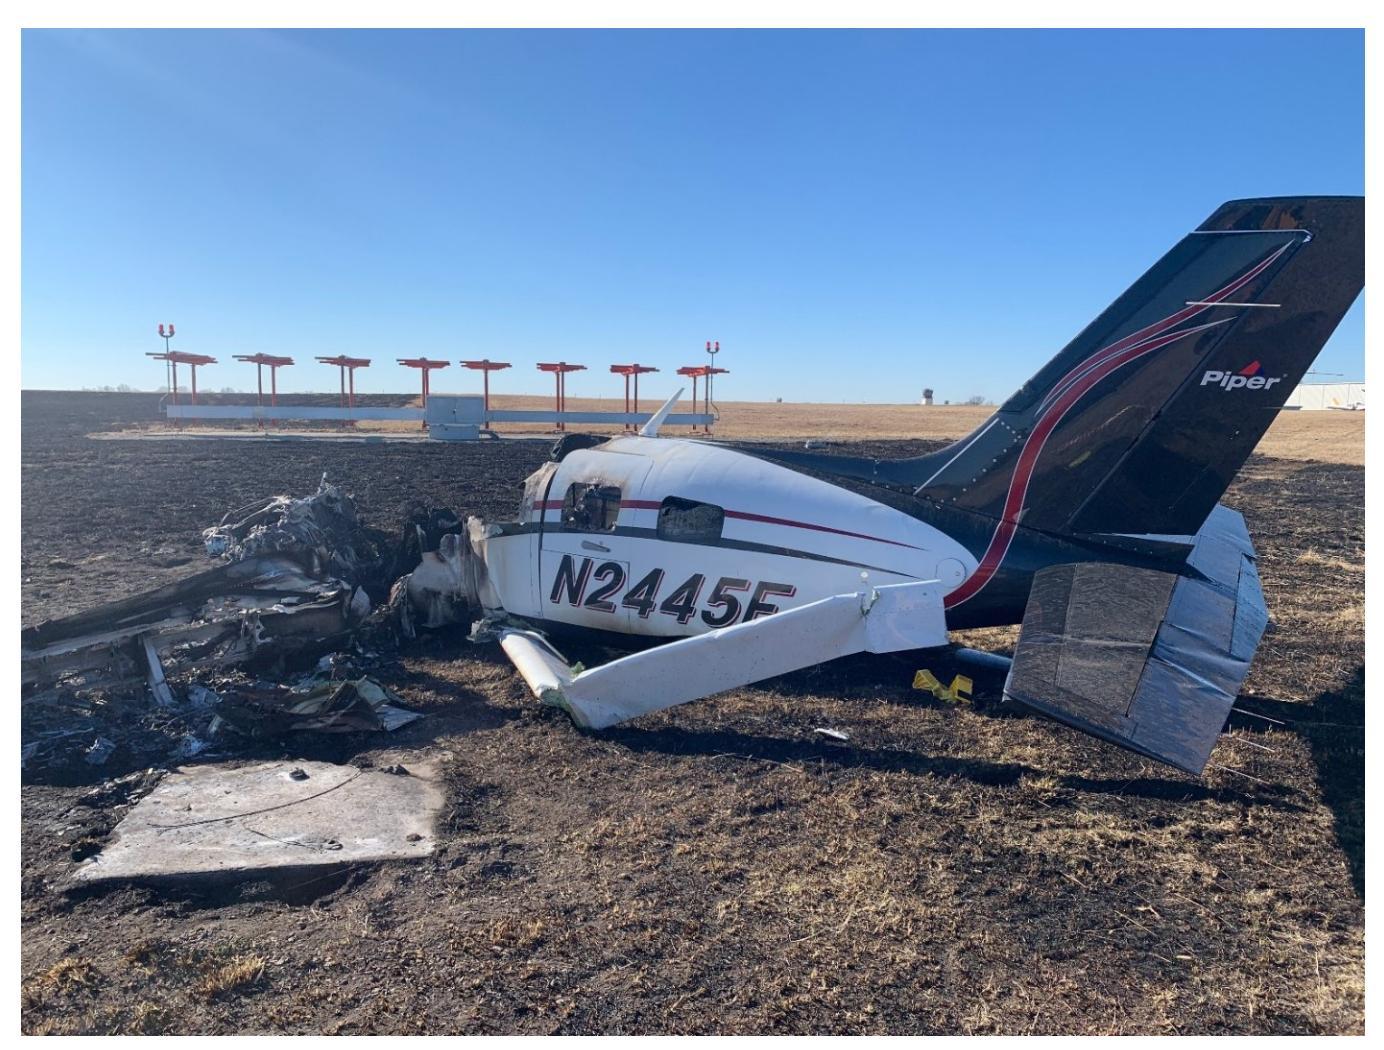
The airplane impacted the ground on the extended runway centerline about 400 ft. past the departure end of runway 36. The airplane came to rest upright with its fuselage oriented in a southeasterly direction. There was a postimpact fire that burned the wings and forward fuselage aft to the rear spar carry-through structure. The fuselage aft of the cabin, including the empennage, was intact. There was a fan shaped burn area on the ground that extended from the aircraft wreckage in a southerly direction.

Figure 3. The aircraft wreckage at the accident site looking south

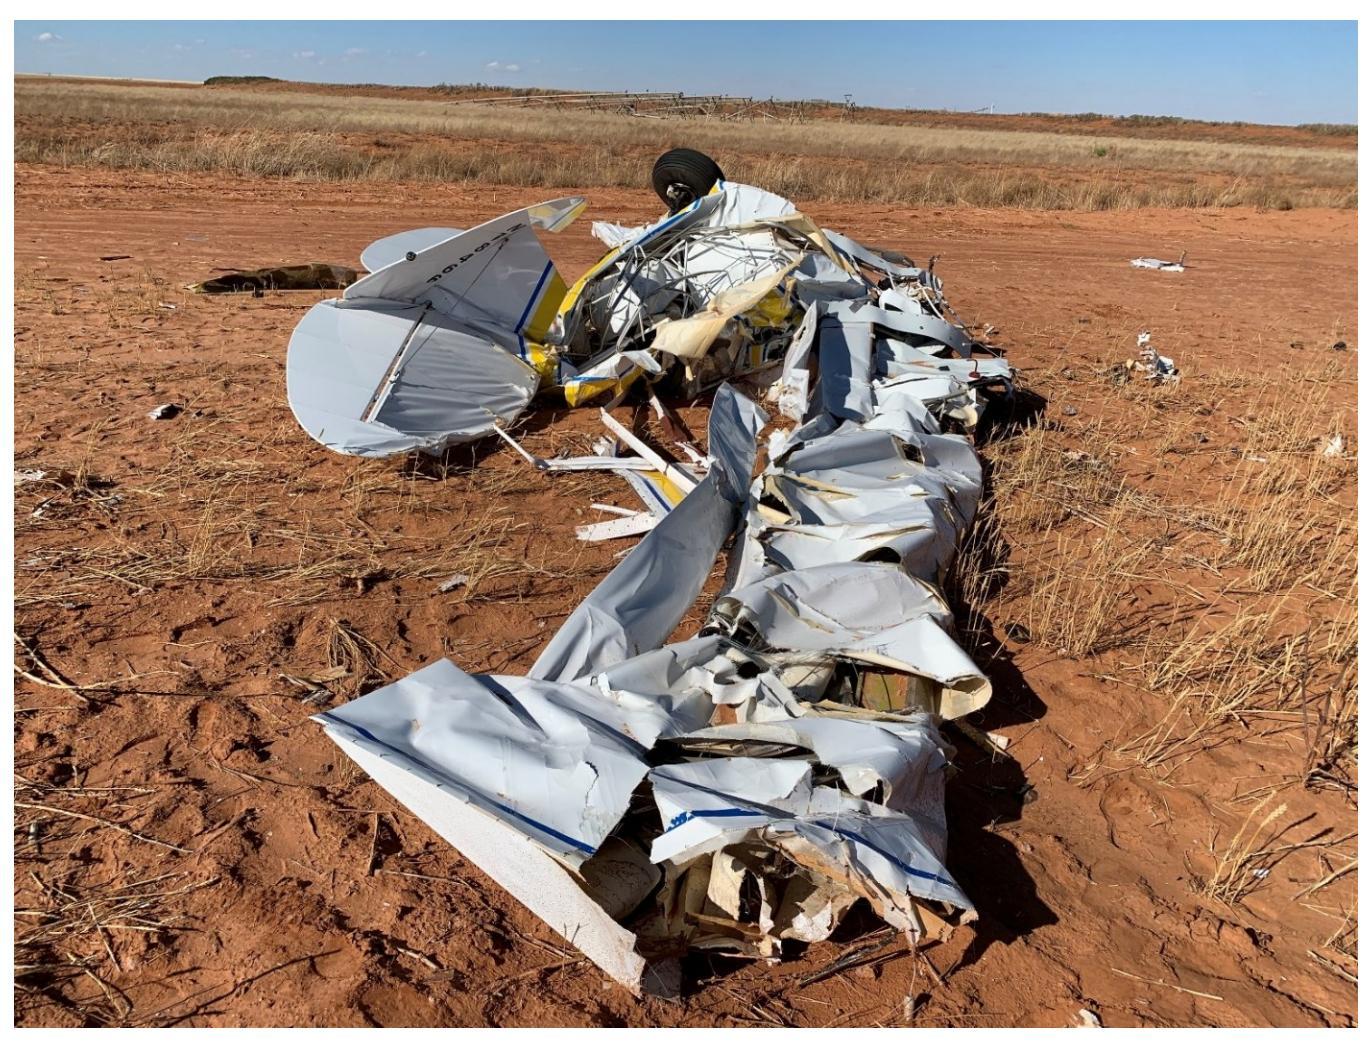
Postaccident examination of the accident site revealed the airplane impacted the terrain in a nose and right-wing low attitude. The initial ground scar was consistent with the propeller, engine, forward fuselage, left and right wings. The airplane sustained substantial damage to the fuselage, wings, and empennage (see Figure 1.).

Figure 1. Accident airplane.

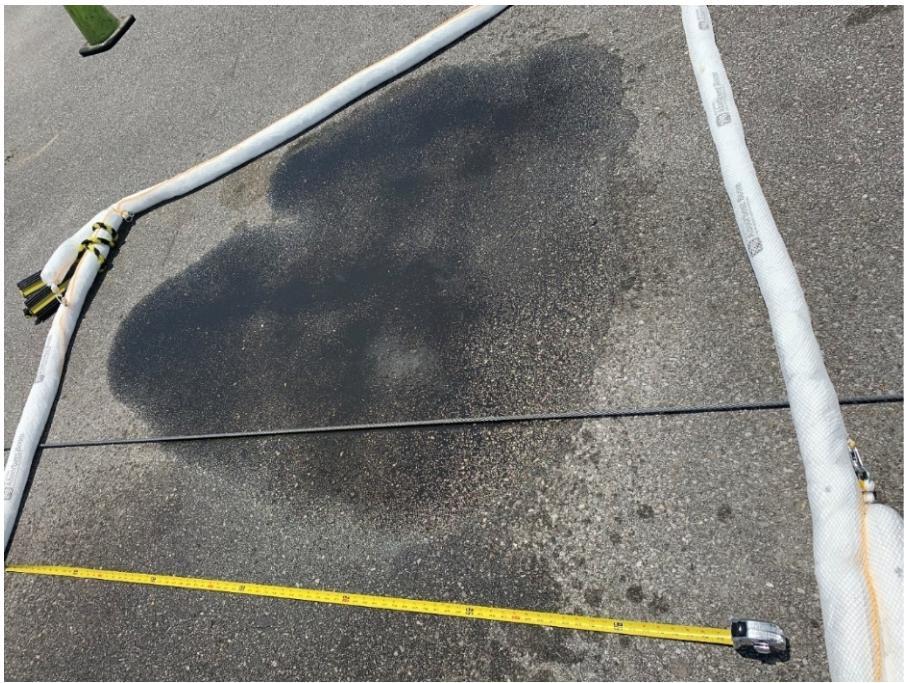
Examination of the pavement in the parking area of the FBO revealed a trail of oil drops that led to a small puddle of oil where the airplane was initially parked. A second larger area of oil staining that measured about 6 ft by 6 ft, was found at the 2nd parking location (where the

Figure 2. View of large pool of oil where airplane was sitting at engine start. Measuring tape indicated the pool was about 6 ft long.

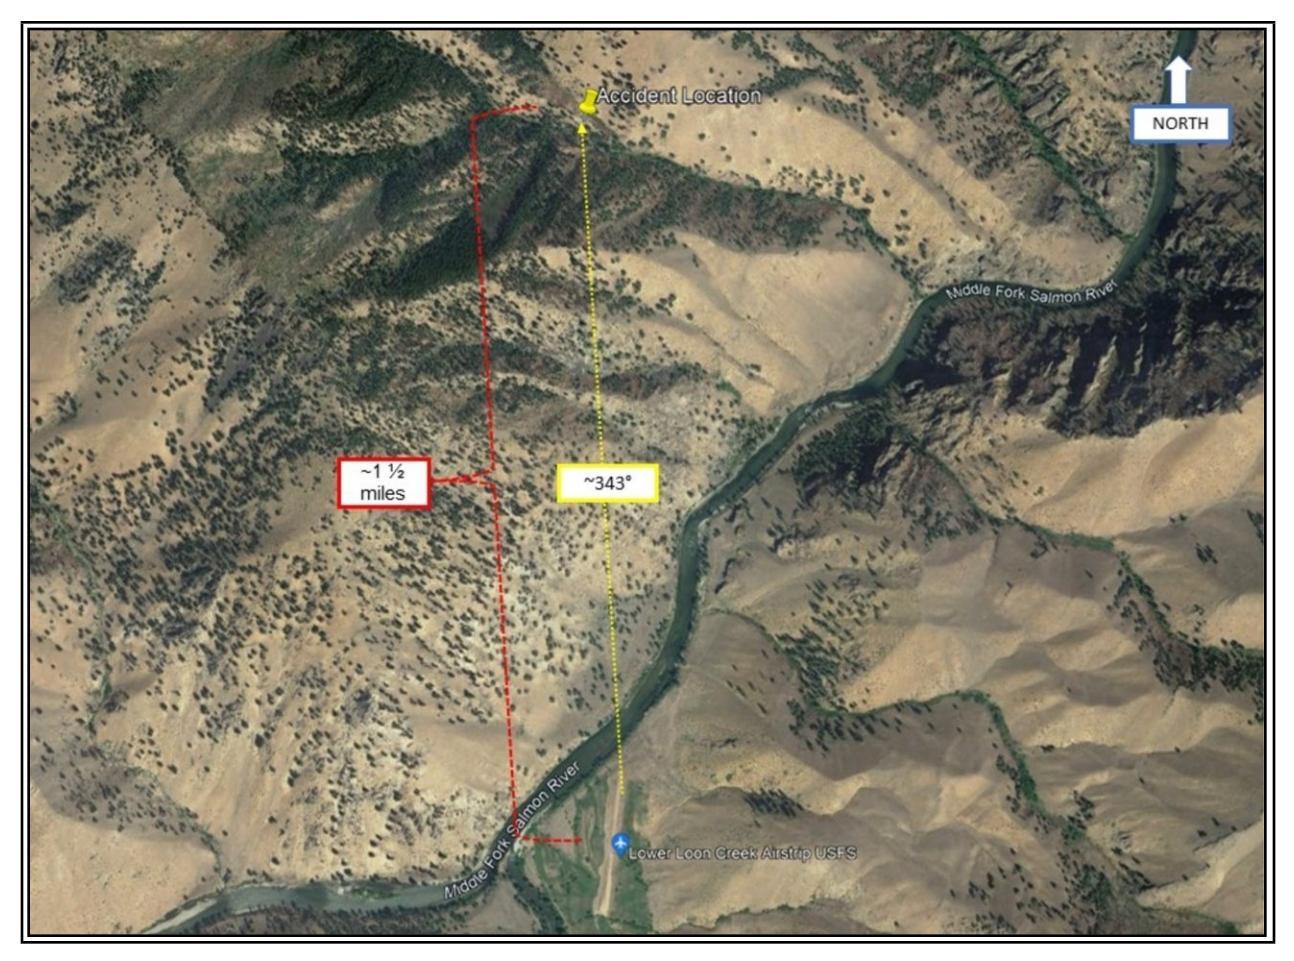
First responders located the airplane wreckage by air the following day about 1 ½ miles north of C53. On June 28, they accessed the accident site and reported that the airplane had impacted steep rising mountainous terrain at an elevation of about 4,200 ft mean sea level (msl) on an approximate southerly heading. The main wreckage came to rest upright about 30 ft below the first identified point of impact and was mostly consumed by fire. All major structural components of the airplane were observed at the accident site.

Figure 1: Overview of the accident site location.

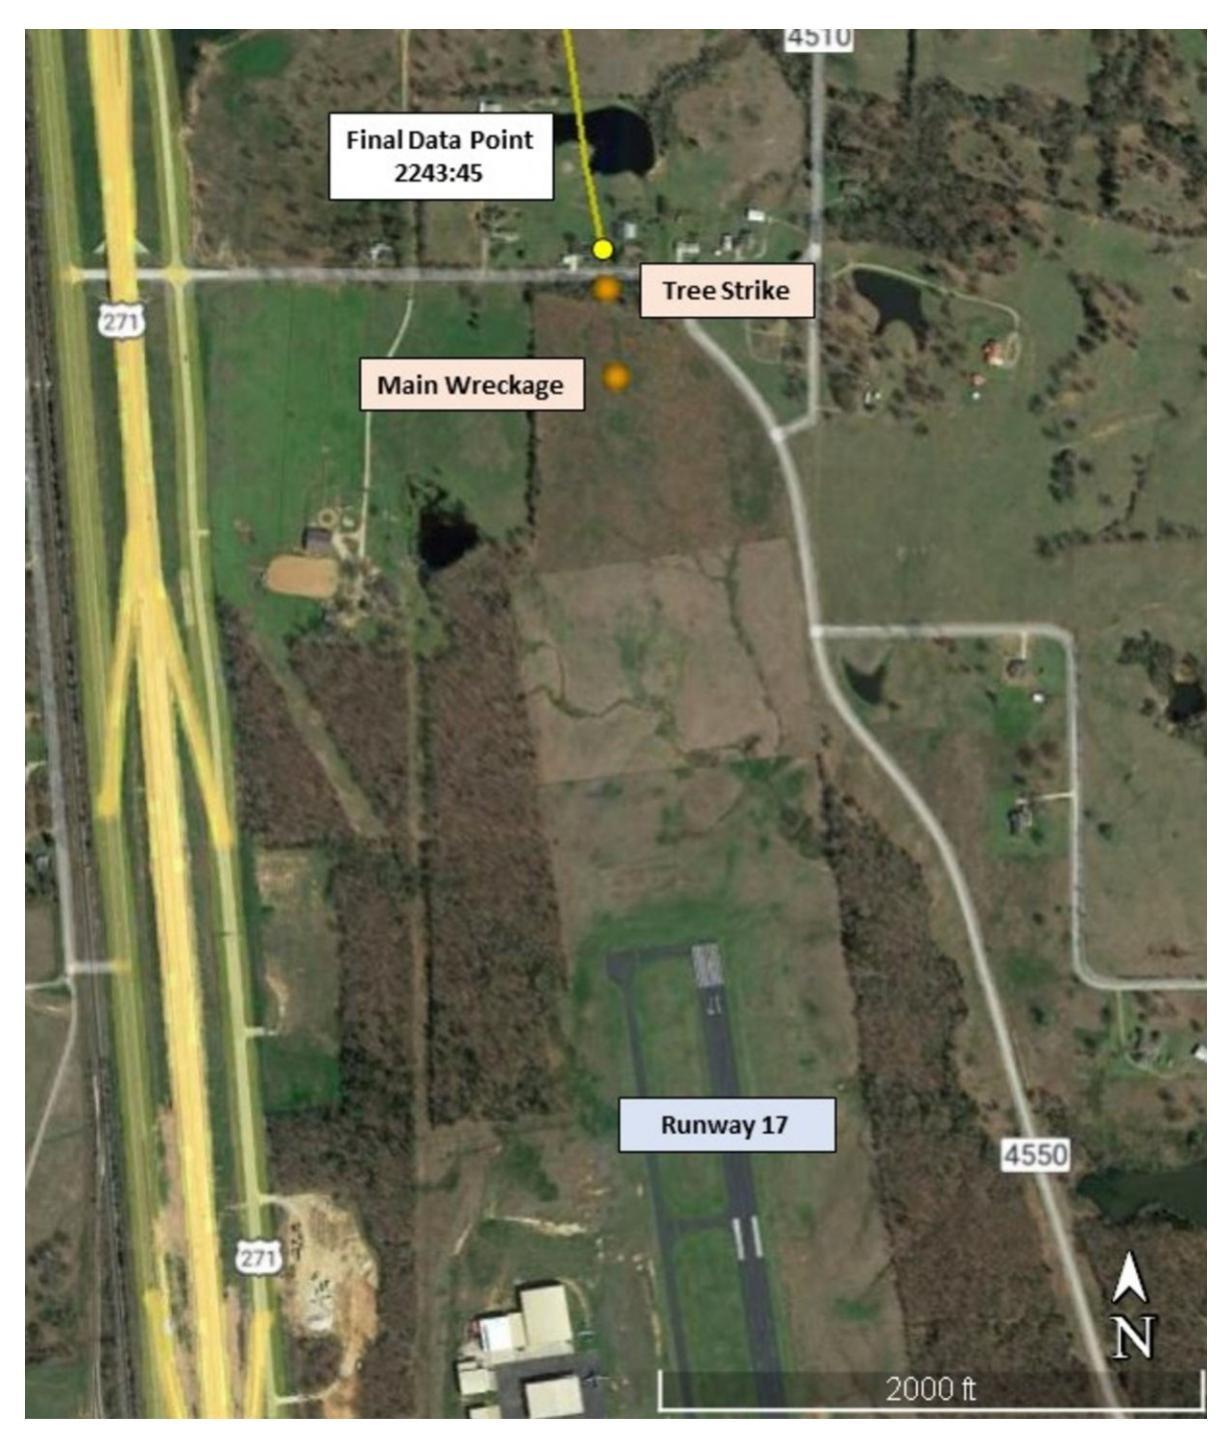
The airplane impacted trees and terrain about 0.40 miles from the runway 17 arrival threshold. The right wing separated, and the outboard 4-foot section of the right wing was suspended in a tree about 50 ft above ground level. The right-wing tip was resting on the ground near the tree. Tree branches exhibiting fresh breaks were also near the initial tree strike. The remaining inboard section of the right wing was separated at the root and located along the debris path.

A ground impact path began about 160 ft from the initial tree strike and extended to the main wreckage. The main wreckage was located about 320 ft from the initial tree strike. The main wreckage consisted of the fuselage, empennage, left wing, engine, and propeller. The fuselage was inverted and resting on the left wing which was separated at the root.

Figure 1 – Flight Path / Accident Site

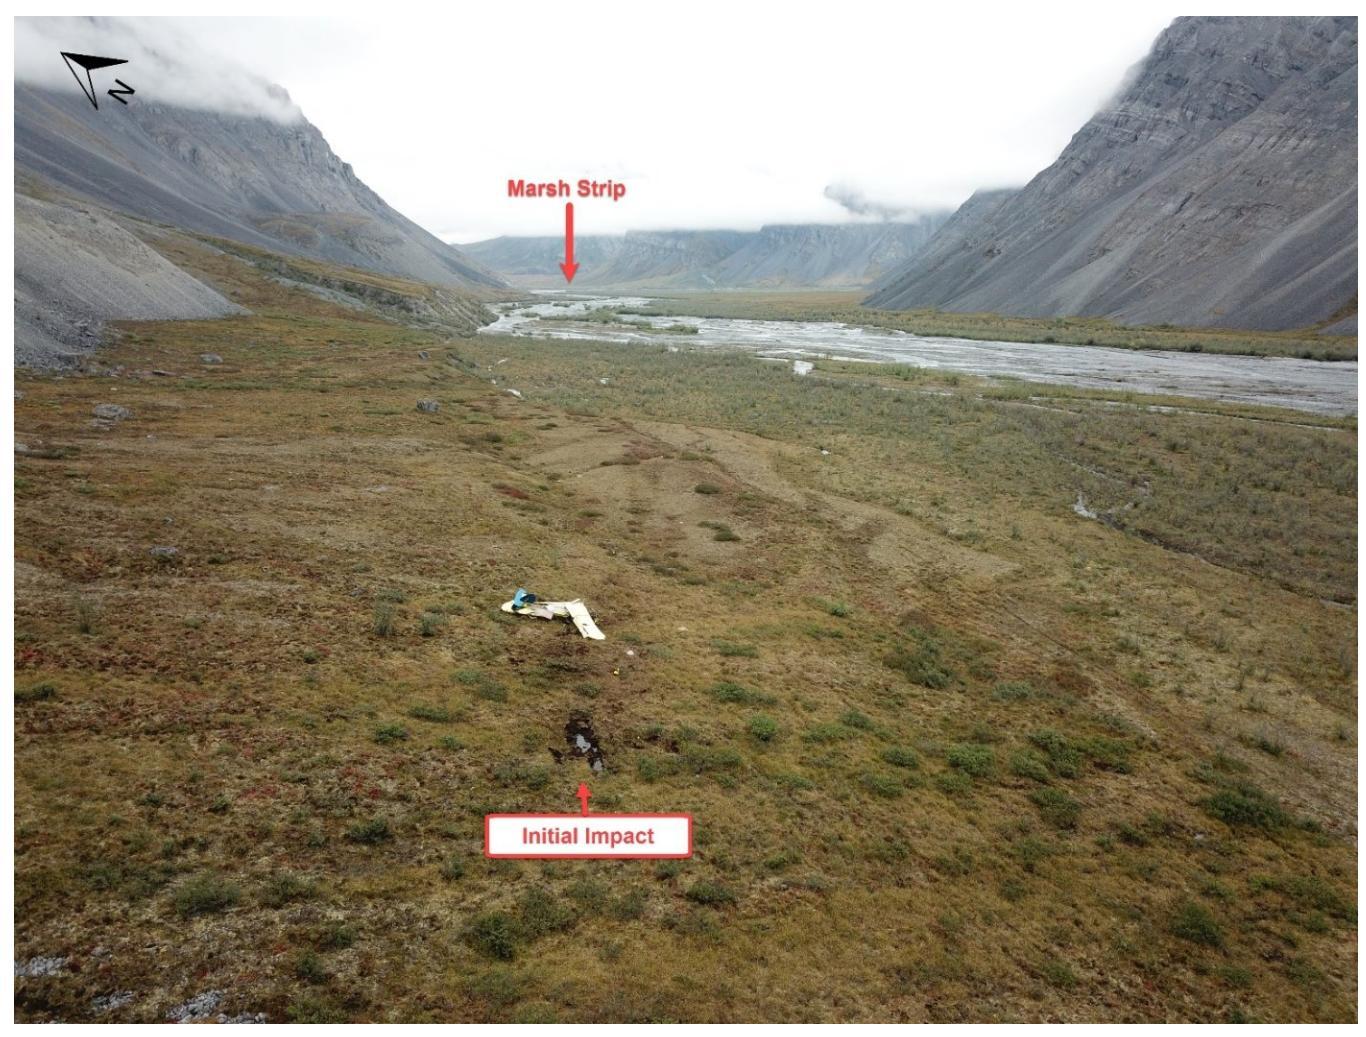
The accident site featured an initial impact crater about 20 yards west of the airplane and the wreckage path was on a heading of 064°. On the right side of the impact crater was a disturbance in the ground that contained an inspection panel from the right wing. The main wreckage came to rest facing southeast and remained mostly intact (Figure 2).

Figure 2. Aerial view of accident site
