Best Practices Guide

Maintaining Exhaust System Turbocharger to Tailpipe V-band Couplings / Clamps

JASC 8100 Exhaust Turbine System (reciprocating) JASC 8120; Exhaust Turbocharger

April 2018

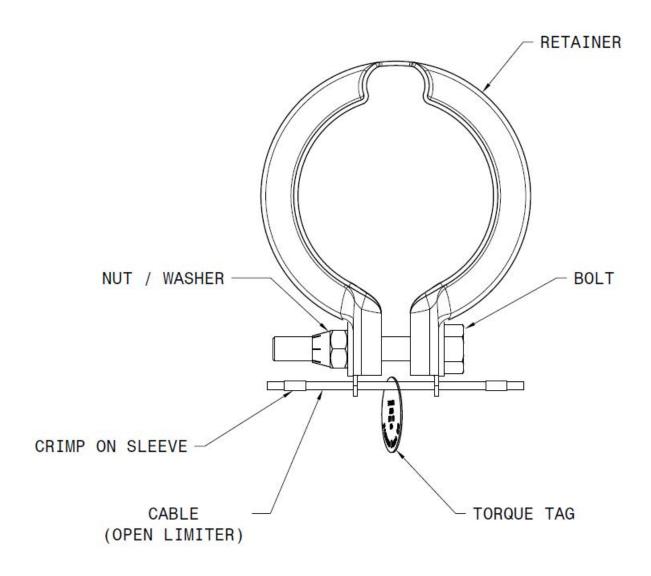
Figure 7
Single-Piece, V-band Clamp

Single-Piece, V-band *Clamps* are stamped and roll formed from one single-piece of base material. Materials used throughout are various stainless steel alloys or Inconel's. The single-piece straight (only) bolt is a stainless steel alloy. The self-locking nut is typically a high temperature steel alloy that is often silver coated. The self-locking nut is all-metal and the locking feature is a mechanical interference type with no polymer inserts. There is typically one washer under the bolt head and one washer under the nut on these clamps. They also typically come with a cable across the open end which acts as an open limiter. Installed on that cable there can be a tag with torque and/or part number and a pair of crimped on sleeves to limit opening. Lack of the cable, torque tag and/or crimp(s) (if applicable to the p/n) that appear replaced should make the clamp suspect. Refer to Figure 7 and 8.

- f. Crack in the clamp V-band exterior or interior surface along the V-apex, around the perimeter. Refer to Figures 16, 26 & 27.
- g. Clamp open limiter cable (if applicable to the specific part number of clamp) missing or detached. Refer to Figures 7, 8 & 16.

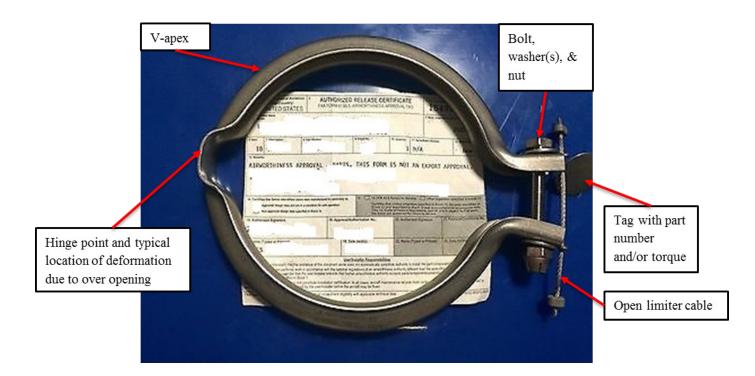
Figure 8
Single-Piece, V-band Clamp

- h. Clamp part number and/or torque tag (if applicable to the specific part number of clamp) missing or detached. Refer to Figures 7, 8 & 16.
- i. Contact of the V-retainer segments ends or clamp ends at any location (e.g. bolt area). Refer to Figures 14 & 16.

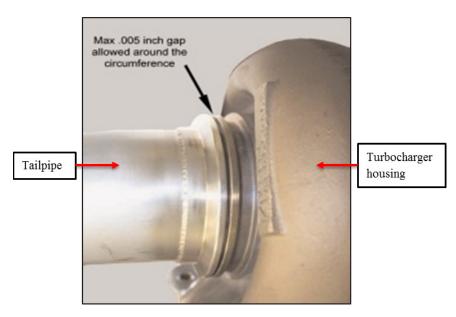
Figure 9
Typical turbocharger exhaust exit flange to tailpipe interface

Inspect the turbocharger exhaust exit flange and the exhaust tailpipe flange interfaces for any un-flat (0.005 in. or greater) or wavy condition, corrosion, pitting, scaling or deposits (not easily removed) and correct per the manufacturer's recommendations. Refer to Figure 9.

If the coupling/clamp is removed, inspect the turbocharger exit flange and the tailpipe flange interfaces for any un-flat (0.005 in. or greater) or wavy condition, corrosion or deposits (not easily removed) and correct per the manufacturer's recommendations. Refer to Figure 9.

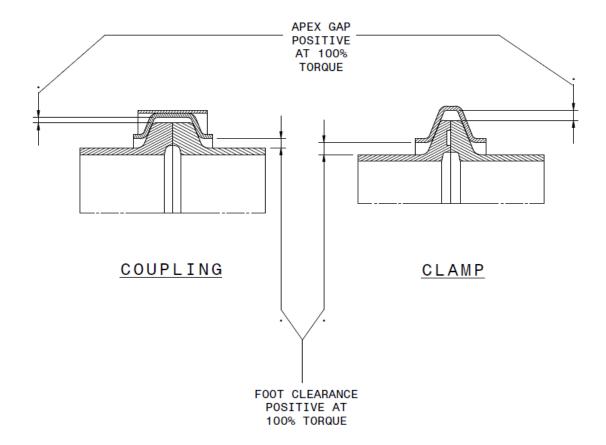
Figure 11
Coupling & Clamp Installation Clearances

- k. Check the coupling V-retainer and clamp V-band apex gap and foot clearances. At full torque, a positive clearance must be maintained throughout to prevent the coupling/clamp from bottoming out on the flanges before the required loading has been achieved. Refer to Figure 11.

- o. After a coupling/clamp is installed/reinstalled and fully torqued, check the coupling V-retainer and clamp V-band apex gap and foot clearances. A positive clearance must be maintained throughout to prevent the coupling/clamp bottoming out on the flanges. If there is no clearance in either location, a new coupling/clamp should be installed prior to further flight. Refer to Figure 11.

- j. Lack of positive clearance at either the apex gap or foot clearance locations at full torque. Refer to Figure 11.
- k. Bolt shank bent, bowed, or deformed (not at the T-bolt head end, as there are some which are manufactured with a slight angle to it.)

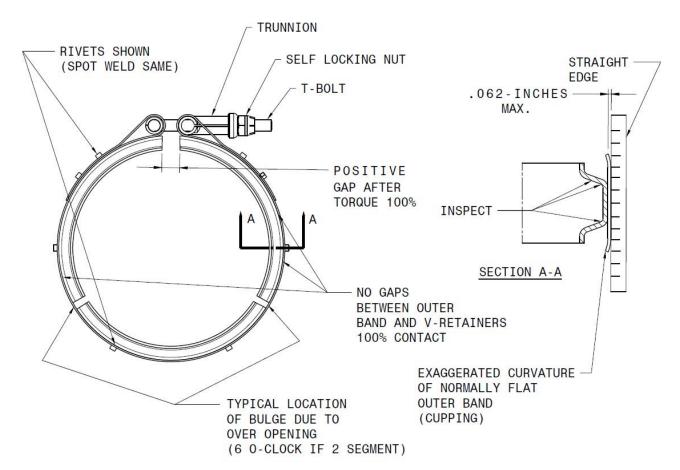
Figure 14
Multi-Segment, V-band Coupling

- c. Visually inspect the coupling outer band for flatness using a straight edge. Lay the straight edge across the width of the outer band. The gap between the straight edge and the band must be less than 0.062 inches. Refer to Figure 14.

- d. With the T-bolt in the 12 o'clock position, visually inspect the coupling for the attachment of the outer band to the V-retainer coupling segments. Inspect for gaps between the outer band and the V-retainer coupling segments at or in between any spot-weld or rivet that holds the outer band to the V-retainers. Placing the light source on the backside of the coupling may make this assessment easier. Refer to Figure 14 & 15.

- c. Crack in any coupling V-retainer segment interior or exterior surface, e.g. at corner radii. Refer to Figures 14 & 25.
- d. Looseness, separation of the outer band to V-retainer segment(s) at any spot-weld or rivet. Refer to Figures 14 & 15.

- e. Less than 100% contact (i.e. gaps) between the V-retainer segments and the outer band at or between spot-welds or rivets on a coupling. Refer to Figures 14.

- n. After a coupling/clamp is installed/reinstalled and fully torqued, verify there is space between each V-retainer coupling segment, or verify there is space between both ends of a clamp. If there is no space between the V-retainer segment ends or clamp ends, a new coupling/clamp should be installed prior to further flight. Refer to Figures 14 & 16.

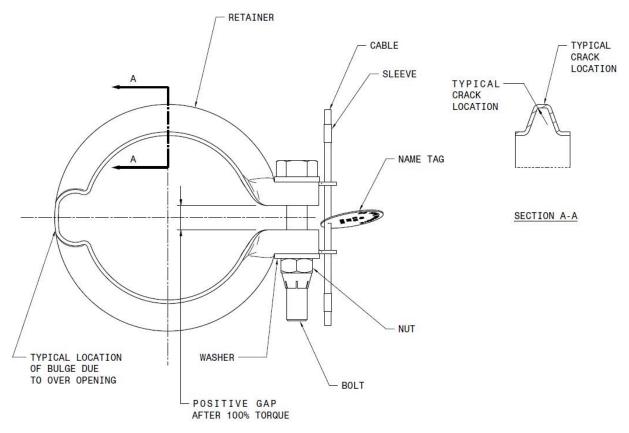
Figure 16
Single-Piece, V-band Clamp

- g. Visually inspect the outer band and the V-retainer ends of a coupling or the V-band of any clamp opposite the bolt location (6 o'clock) for physical damage (i.e. distortion, creases, bulging, or cracks). Refer to Figures 14 & 16.

- n. Peening (flattening, curling) of material on the V-retainer segment ends or clamp ends from contact with each other, at any location (e.g. bolt area). Refer to Figures 14 & 16.

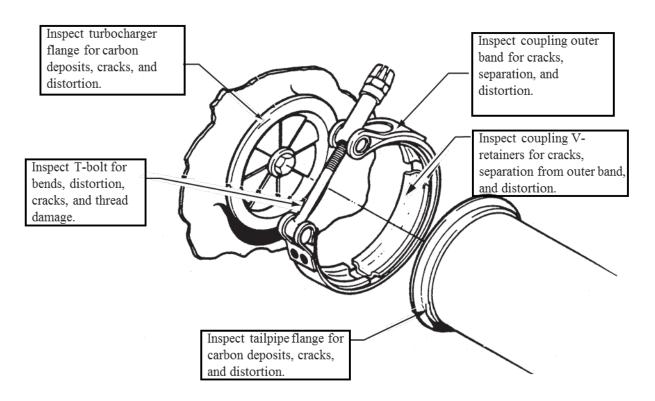
Figure 17
Typical Turbocharger to Tailpipe Interface Area

- a. Hereafter, if required, clean engine exhaust components per acceptable or approved methods using acceptable or approved materials. Pay particular attention to the outer band (flat) of a multi-segment V-band coupling, specifically at or near any spot weld or rivet, and the outer surface of the V-band on a single-piece V-band clamp. Refer to Figures 4-6, 14-16, 19, 21-23, 26 & 27.
- b. Use a 10X magnifier and bright lighting, backlighting may also be useful. Refer to Figures 14-17, 19, 21-23 & 25-27. Pay particular attention to the spot-welds or riveted areas on multi-segment couplings and the outer surface of the V-band on single-piece V-band clamps and areas that are initially hard to get to or see as installed, as these may have been neglected in prior inspections and may harbor problems.
