NATIONAL TRANSPORTATION SAFETY BOARD

MATERIALS LABORATORY FACTUAL REPORT

Report No. 18-061

Place : Daytona Beach, Florida
Date : April 4, 2018
Vehicle : Piper PA-28R-201, N106ER
NTSB No. : ERA18FA120
Investigator : Aaron McCarter, AS-ERA / Clinton R. Crookshanks, AS-40

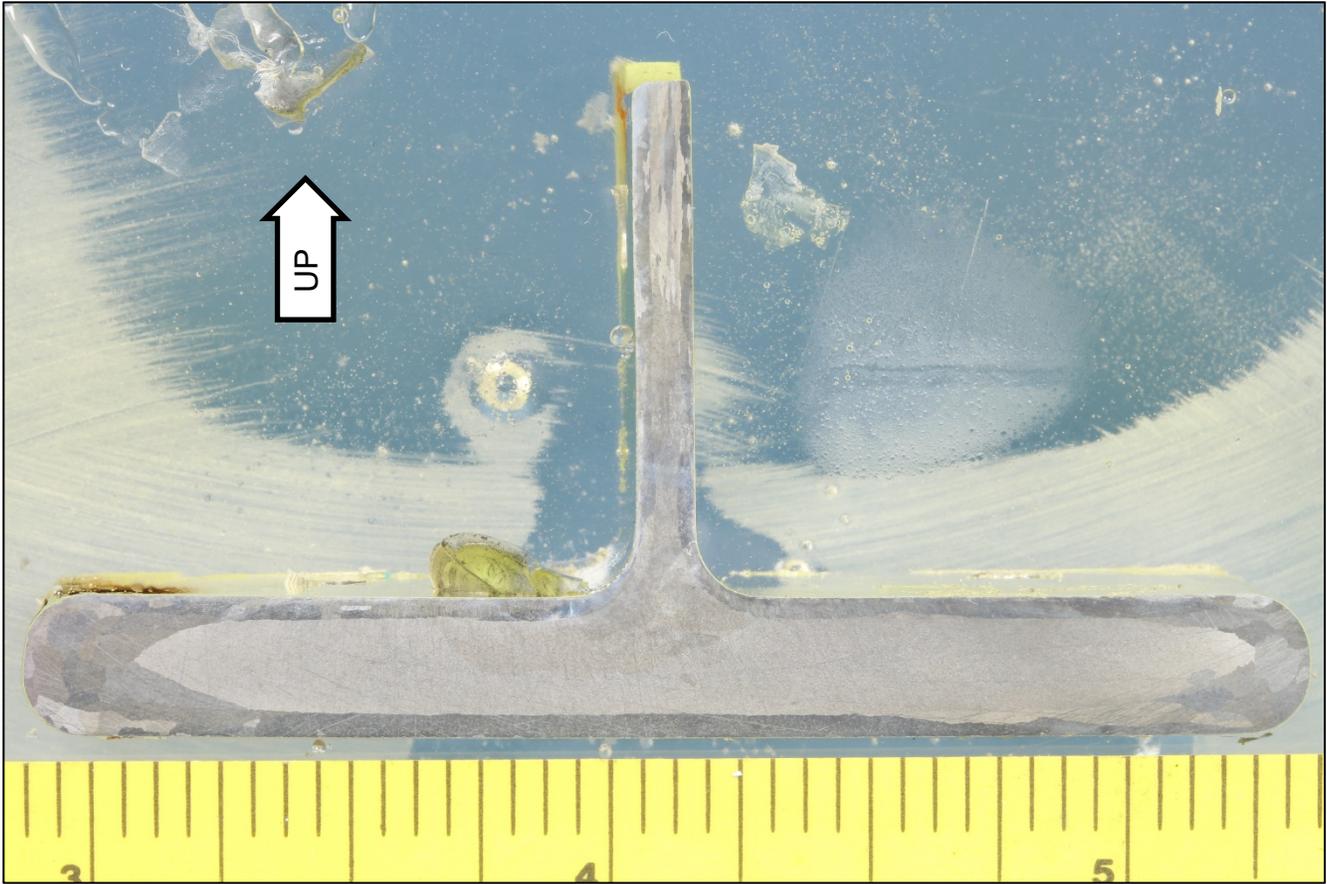
A section of the left wing main spar lower spar cap was cut from the outboard end of the piece shown in figure 4 to facilitate a metallographic examination. The spar cap piece was mounted in epoxy, polished, and etched by immersion in Keller's reagent. A macrograph of the etched cross-section is shown in figure 13. The microstructure in the spar cap consisted of large surface grains surrounding a finer-grain core. Micrographs of the cross-section at the lower surface are shown in figure 14.

Hardness and conductivity were measured on pieces of the left wing main spar lower spar cap. The average hardness measured 81.0 HRBW, an average of 5 measurements from the middle of the spar cap cross-section on the mounted sample shown in figure 13. According to the ASM Handbook,¹ the typical hardness of aluminum alloy 2024-T351 is 76 HRB (120 HB). Paint was removed from an area of the spar cap to facilitate a conductivity measurement on the surface of the spar cap. The conductivity measured 29.3% IACS. According to the ASM Handbook, the typical conductivity for aluminum alloy 2024-T351 is 30% IACS. The thickness of the left wing main spar lower spar cap measured 0.270 inch, which was within the allowable thickness range specified in the engineering drawing.

Figure 13. Optical macrograph of the polished and etched cross-section of the left wing main spar lower spar cap. Etched by immersion in Keller's reagent.

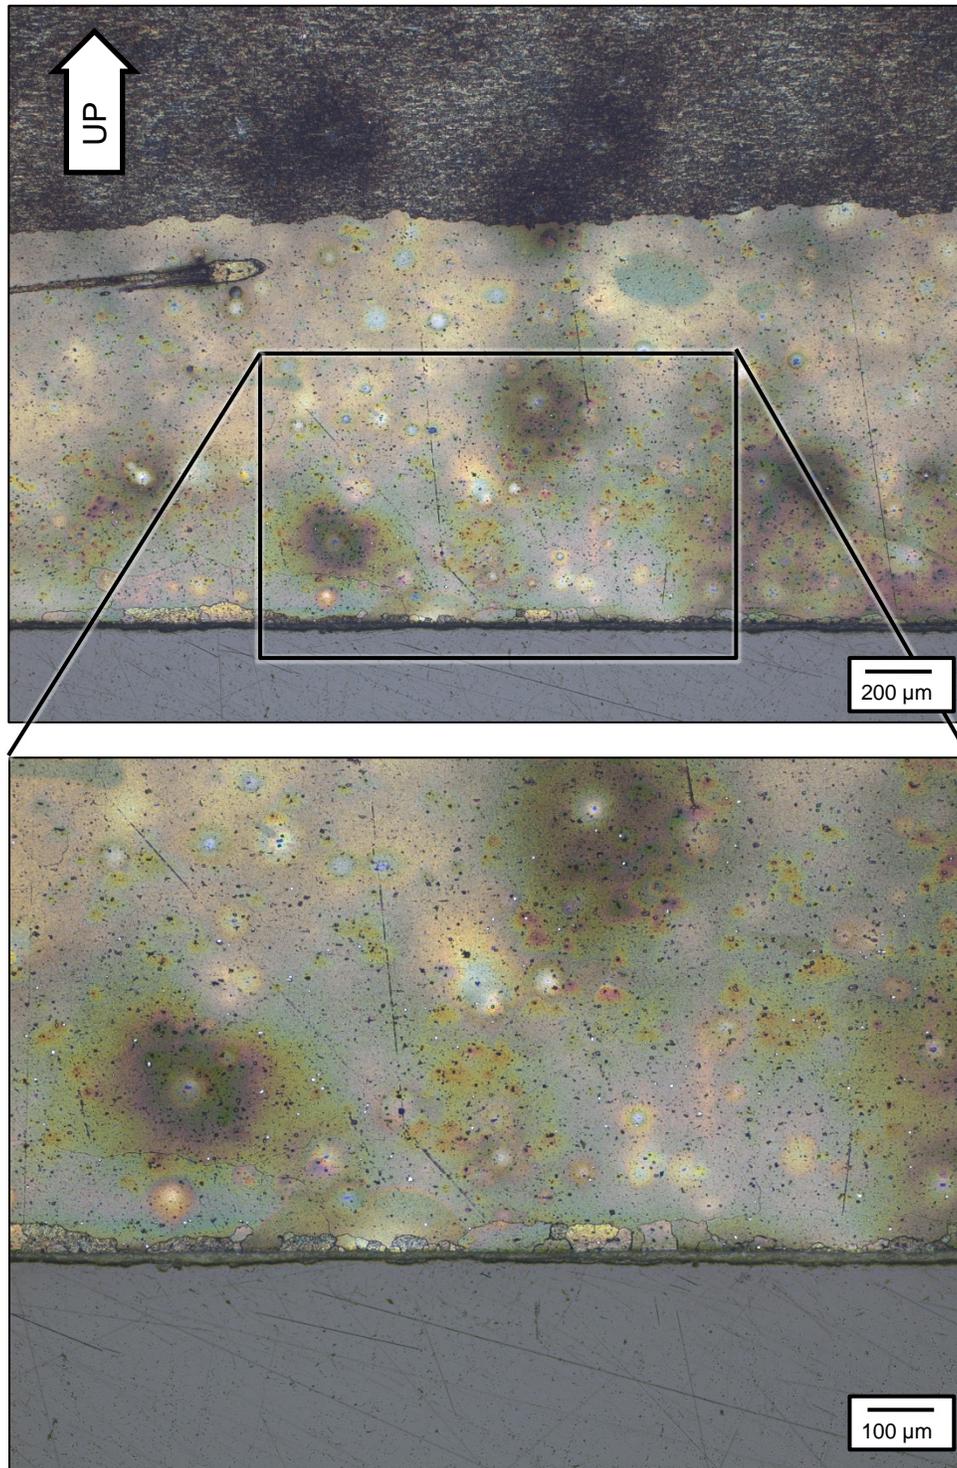
Figure 14. Optical micrographs of the polished and etched microstructure at the lower surface of the left wing main spar. Etched by immersion in Keller's reagent.

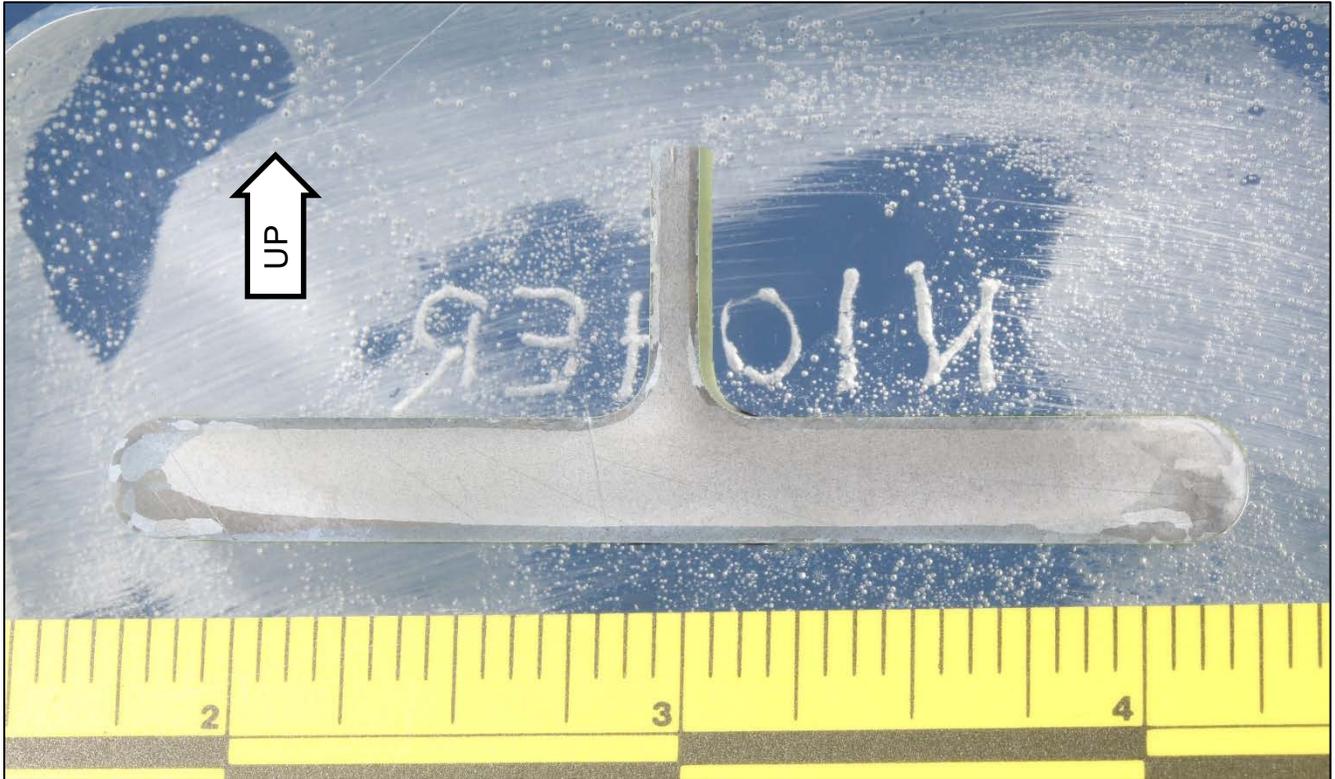
A transverse cut was made to separate a piece of the lower spar cap from the outboard end of the main spar piece shown in figure 18 for metallographic examination. The spar cap piece was mounted in epoxy, polished, and etched by immersion in Keller's reagent. A macrograph of the etched cross-section is shown in figure 21. The microstructure in the spar cap consisted of large surface grains surrounding a finer-grain core. Micrographs of the cross-section at the lower surface are shown in figure 22.

Hardness and conductivity measurements were made on the lower spar cap of the left main wing spar. The average hardness measured 80.8 HRBW, averaged from 5 measurements at the middle of the spar cap cross-section shown in figure 21. Conductivity measured on the lower surface of the spar was 29.8% IACS.

Figure 21. Optical macrograph of the polished and etched cross-section of the left wing main spar lower spar cap from airplane N104ER. Etched by immersion in Keller's reagent.

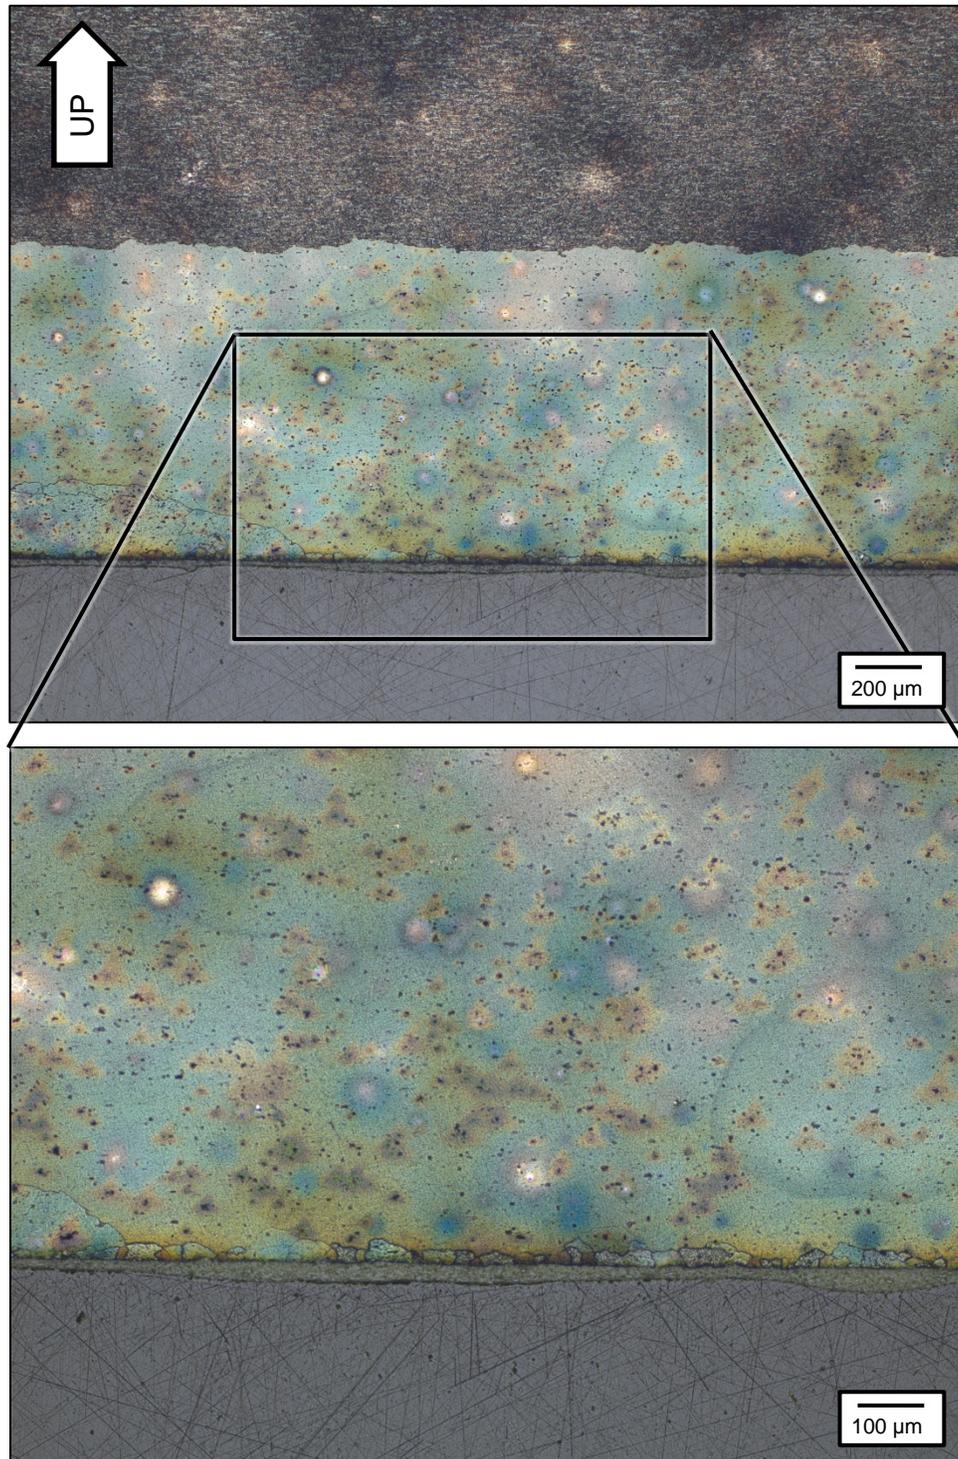
Figure 22. Optical micrographs of the polished and etched microstructure at the lower surface of the left wing main spar. Etched by immersion in Keller's reagent.

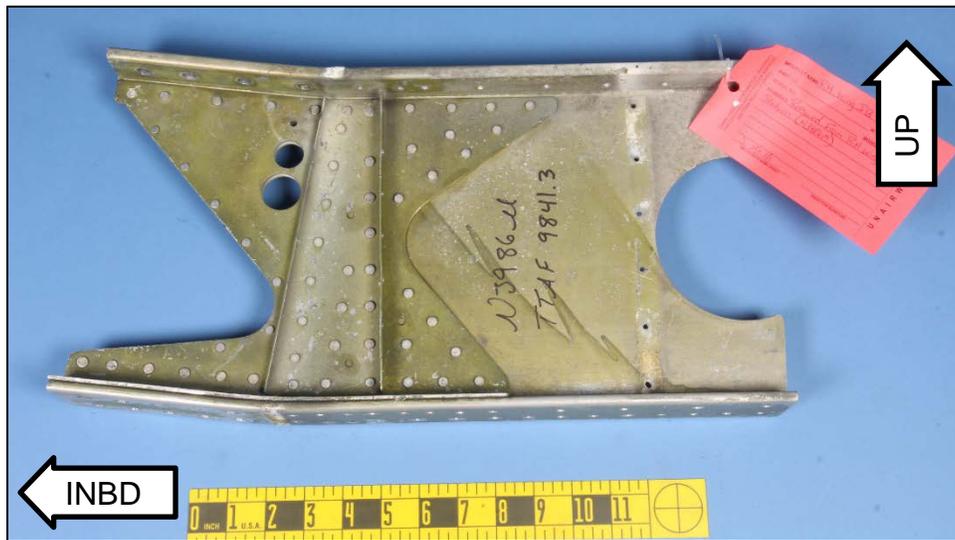
A transverse cut was made to separate a piece of the lower spar cap from the outboard end of the submitted main spar piece (see figure 23) for metallographic examination. The spar cap piece was mounted in epoxy, polished, and etched by immersion in Keller's reagent. A macrograph of the etched cross-section is shown in figure 24. The microstructure in the spar cap consisted of large surface grains surrounding a finer-grain core. Micrographs of the cross-section at the lower surface are shown in figure 25.

Figure 23. Inboard end of the right wing main spar from retired airplane N3986M.

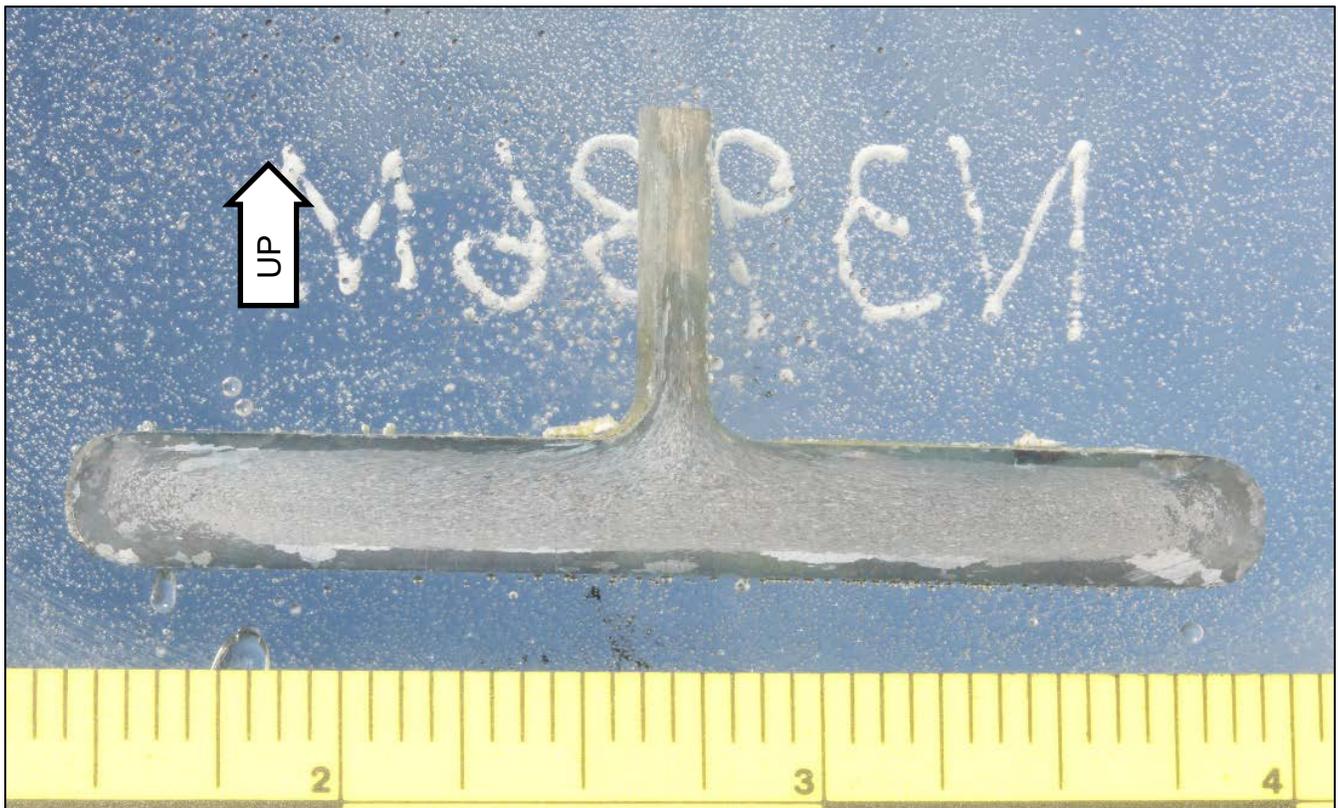
Hardness and conductivity measurements were made on the lower spar cap of the left main wing spar. The average hardness measured 79.9 HRBW, averaged from 5 measurements at the middle of the spar cap cross-section shown in figure 21. Conductivity measured on the lower surface of the spar was 29.7% IACS.

Figure 24. Optical macrograph of the polished and etched cross-section of the right wing main spar lower spar cap from airplane N3986M. Etched by immersion in Keller's reagent.

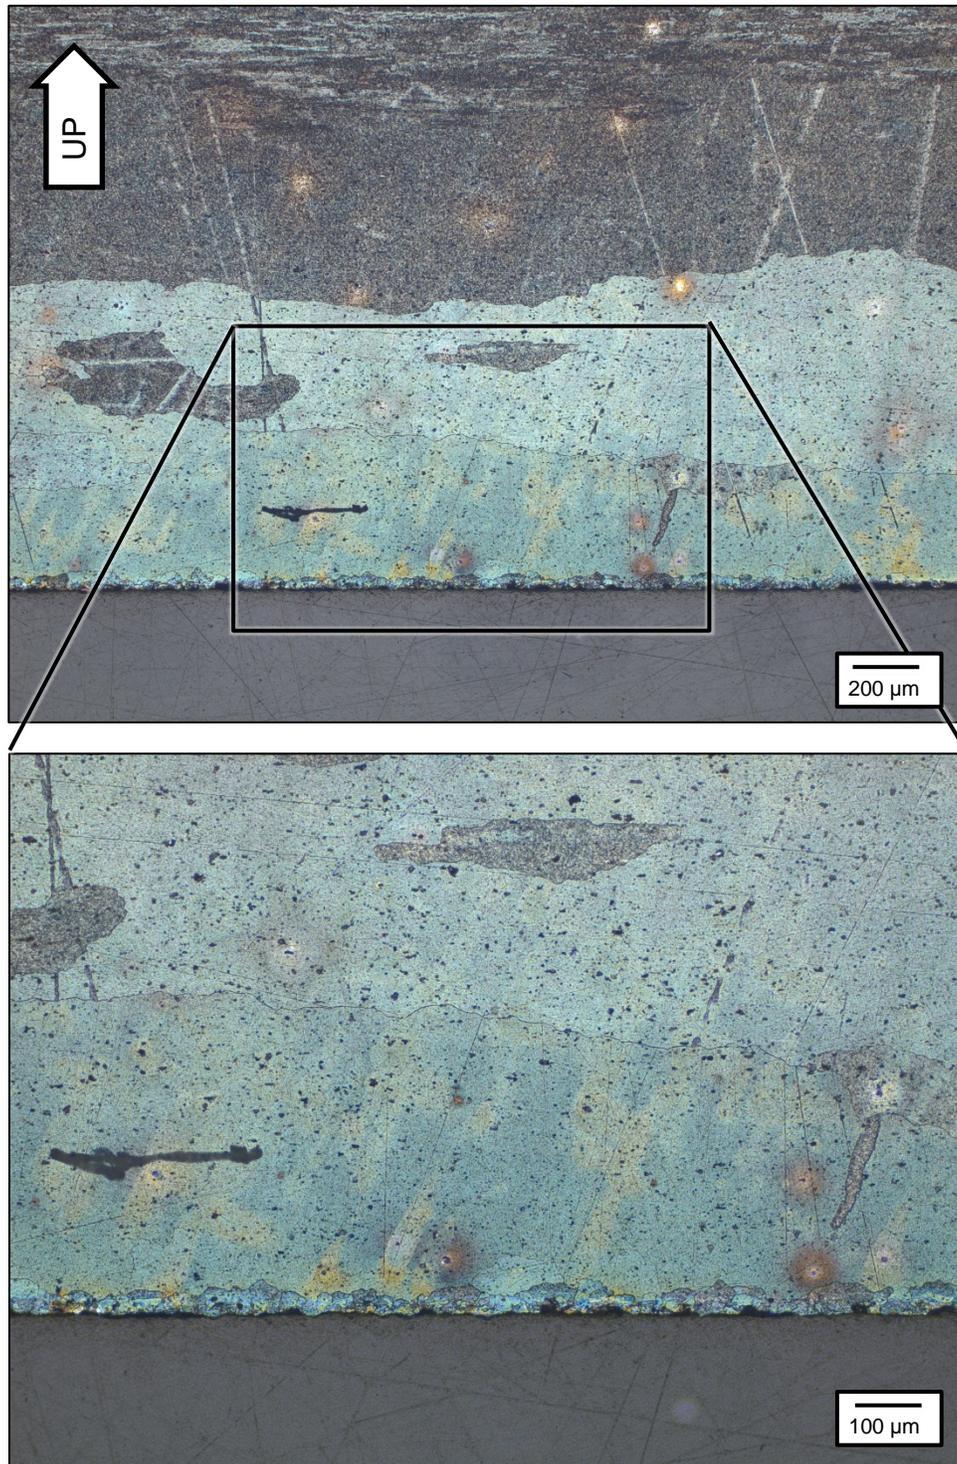
Figure 25. Optical micrographs of the polished and etched microstructure at the lower surface of the right wing main spar from airplane N3986M. Etched by immersion in Keller's reagent.

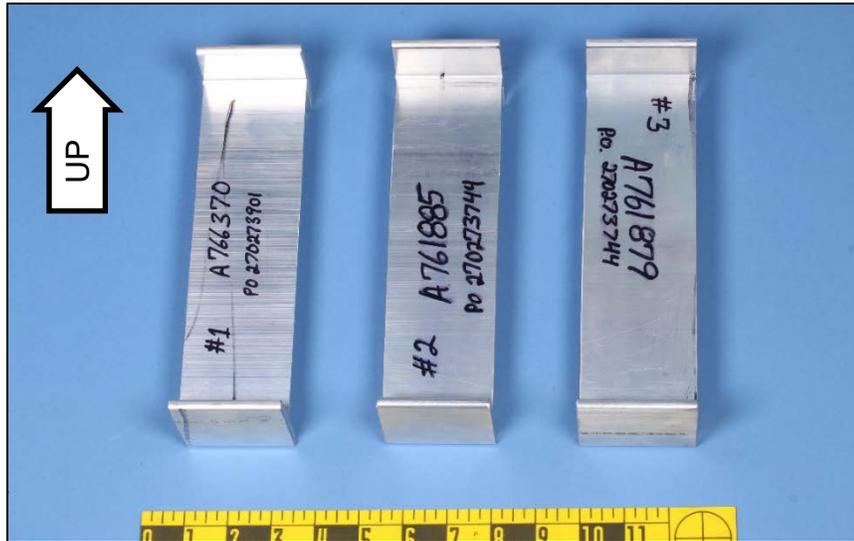
An overall view of the submitted new main spar extrusion pieces are shown in figure 26. For reference the pieces were received numbered 1 through 3 as shown in figure 26. A piece of the lower spar cap was cut from each sample for metallographic

Figure 26. New wing main spar extrusion pieces submitted as exemplar samples.

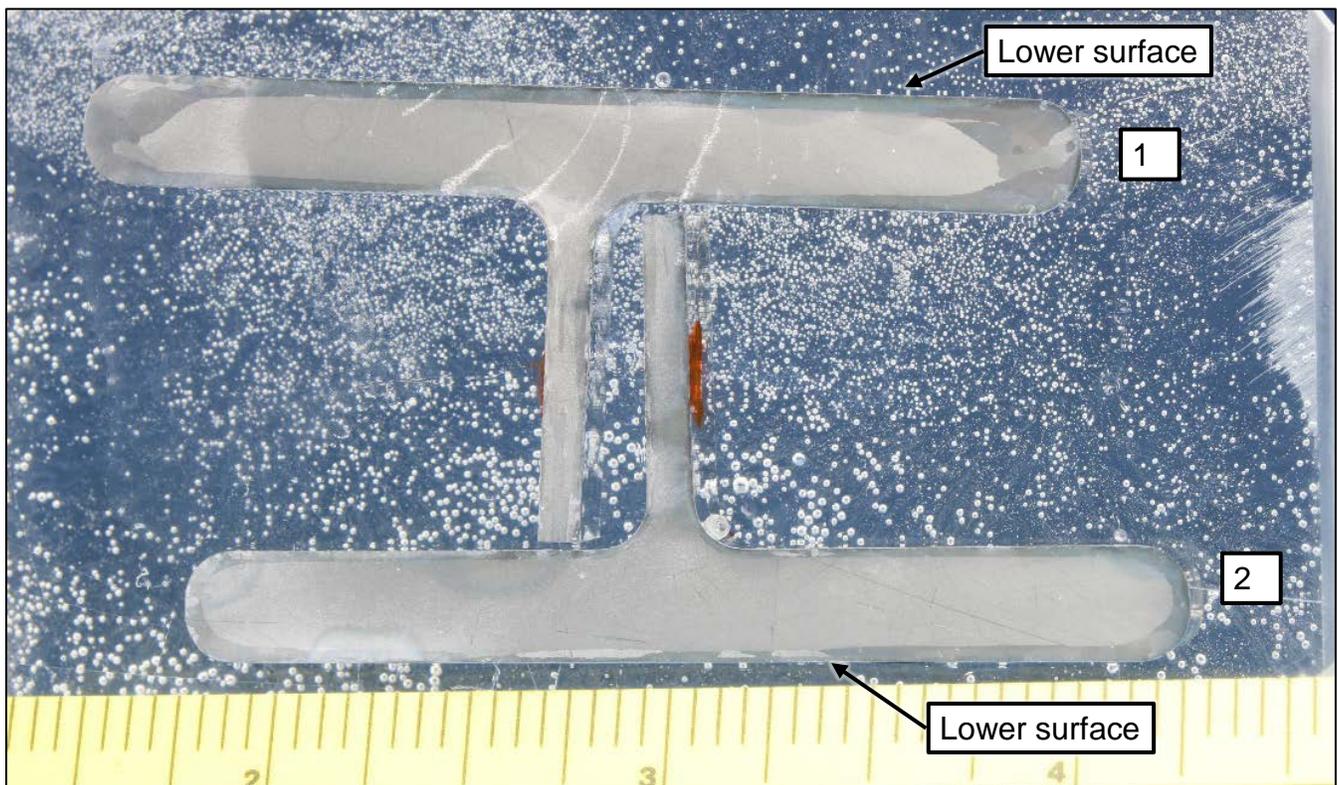
examination. The spar cap pieces from new spars 1 and 2 were mounted in one epoxy form for convenience, and new spar 3 was mounted in a separate epoxy form. The mounted samples were polished and etched by immersion in Keller's reagent. Macrographs of the etched cross-sections are shown in figures 27 and 28. The microstructure in spar caps consisted of large surface grains surrounding a finer-grain core. Micrographs of the new spar 1 cross-section shown in figure 29 represent the typical microstructure observed on the new spar caps.

Hardness and conductivity measurements were made on the lower spar caps of each new spar piece. The average hardness measured 80.0 HRBW, 80.4 HRBW, and 80.0 HRBW on new spar pieces 1, 2, and 3, respectively. The average hardness value for each spar was calculated from 5 measurements at the middle of the spar cap cross-sections shown in figures 27 and 28. Each of the new spar pieces had the same value for conductivity (29.8% IACS) measured on the lower surface of each spar.

Figure 27. Optical macrograph of the polished and etched cross-sections of new wing main spar lower spar caps numbered 1 and 2 in figure 26. The spar caps were mounted together for convenience during polishing, and the lower surface on each spar cap is indicated. Etched by immersion in Keller's reagent.

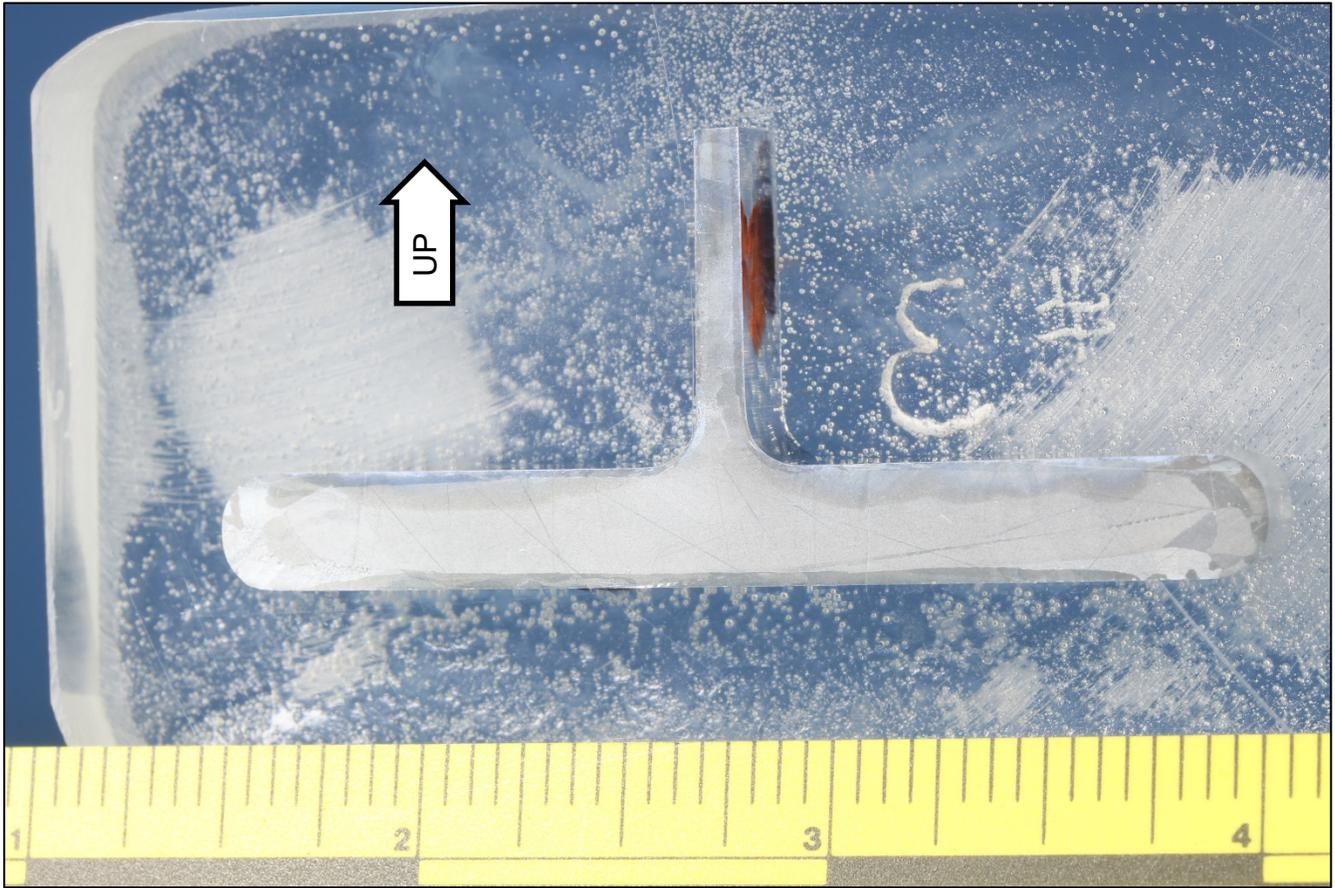
Figure 28. Optical macrograph of the polished and etched cross-section of new wing main spar lower spar cap numbered 3 in figure 26. Etched by immersion in Keller's reagent.

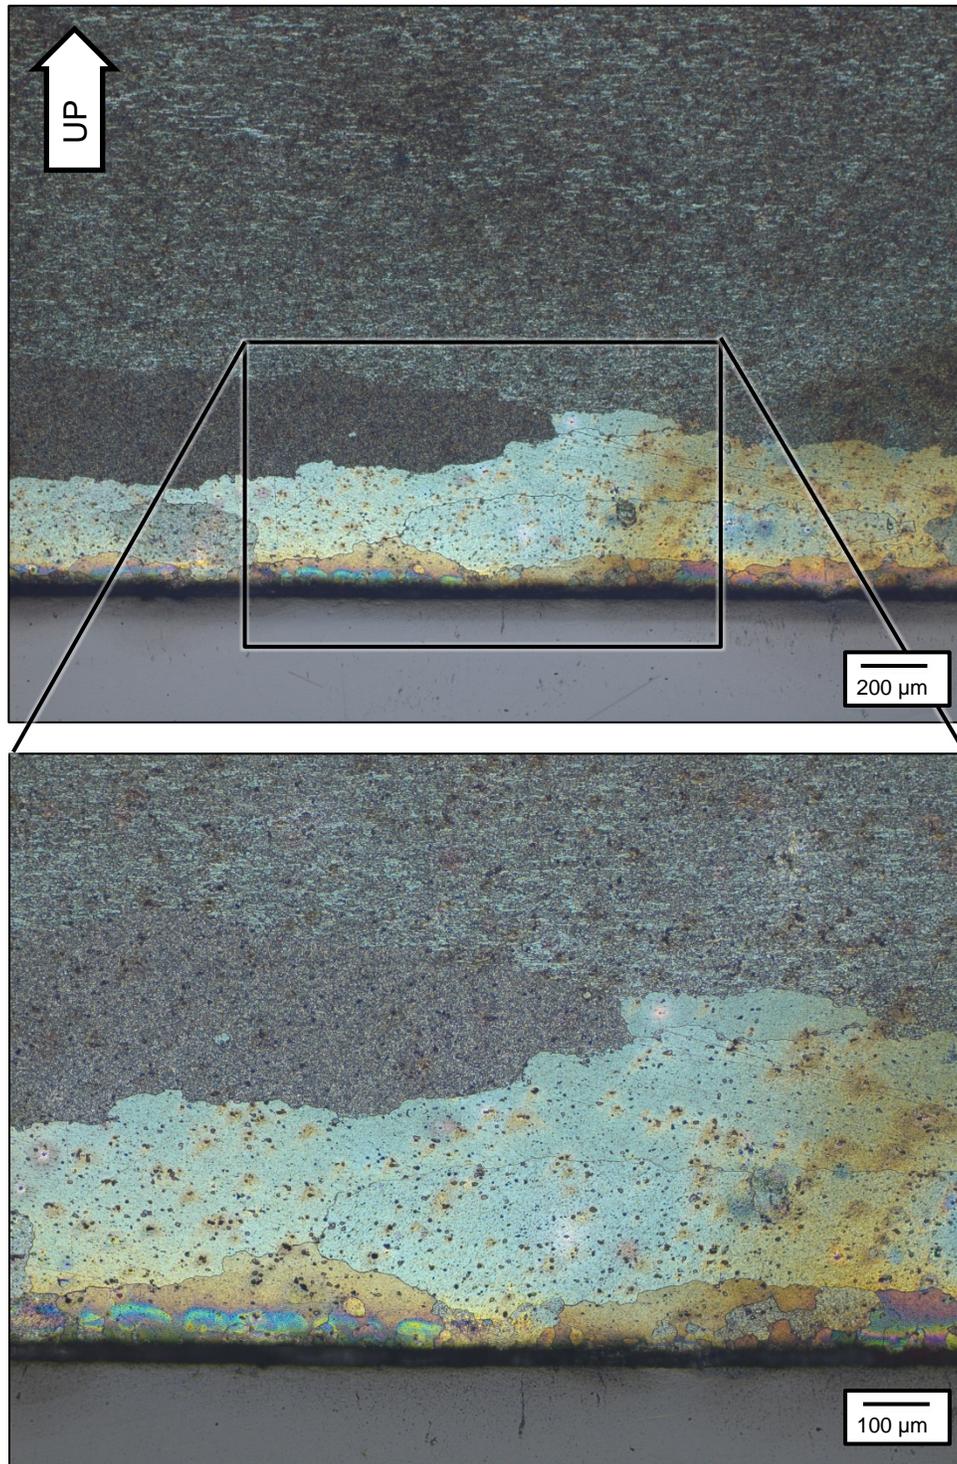
Figure 29. Optical micrographs of the polished and etched microstructure at the lower surface of new wing main spar piece number 1. Etched by immersion in Keller's reagent.
