Location:	Olathe, KS	Accident Number:	CEN22FA119
Date & Time:	February 13, 2022, 10:20 Local	Registration:	N2445F
Aircraft:	PIPER AIRCRAFT INC PA46-500TP	Injuries:	1 Fatal
Flight Conducted Under:	Part 91: General aviation - Personal

CEN22FA119

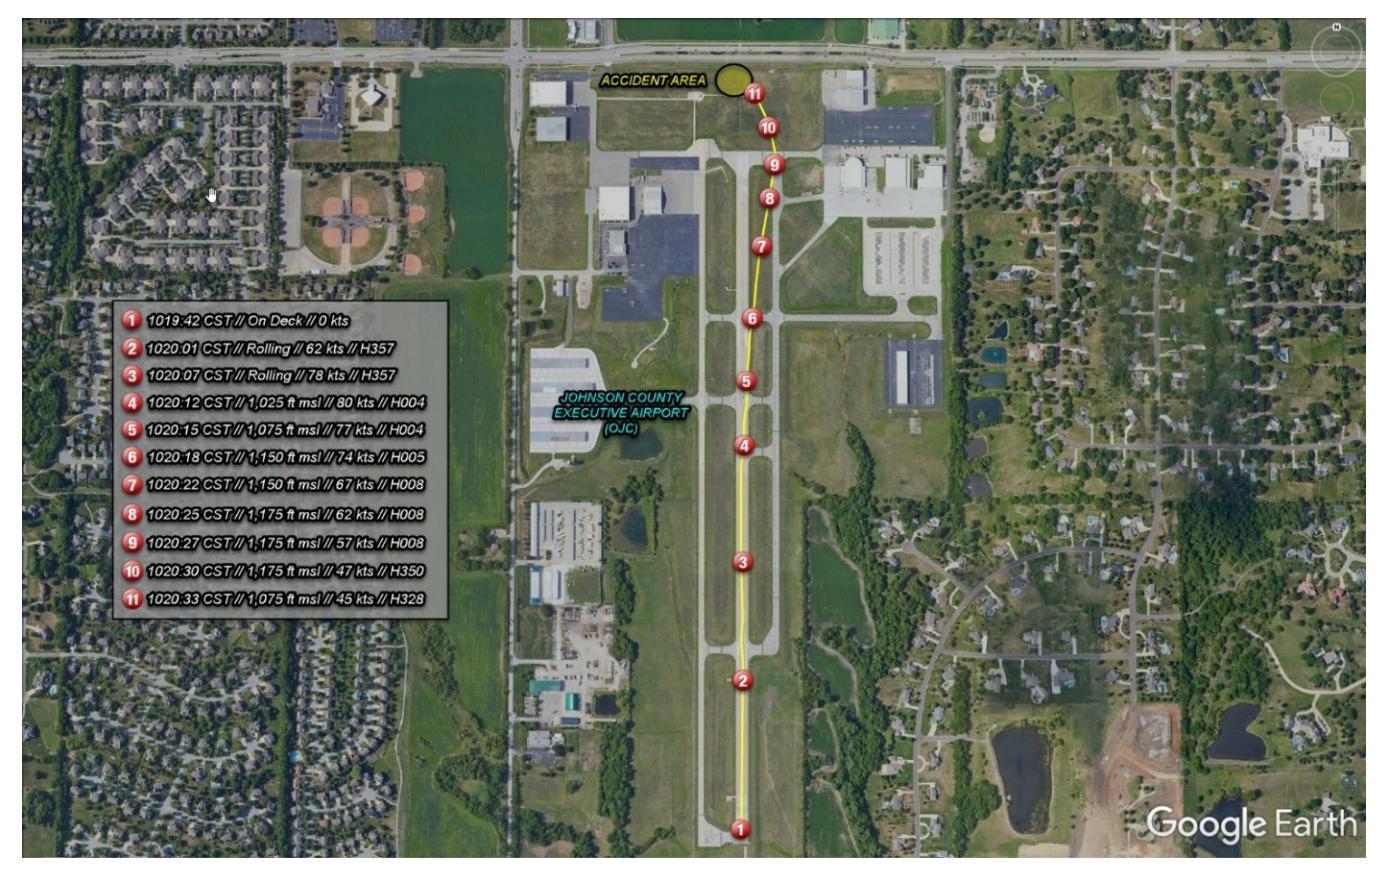
Flight track data for the accident flight showed that the airplane began the takeoff roll on runway 36 at OJC at 1019:42. The airplane accelerated, reaching a peak ground speed of 80 kts about 2,250 ft. down the 4,097 ft. long runway. The airplane then drifted slightly to the right and slowed before turning back toward the left. The airplane's groundspeed continued to decrease throughout the remainder of the data. The final recorded position was about 100 ft southeast of the initial impact point.

Figure 1. Overview of accident flight track with time, altitude, ground speed, and heading information.

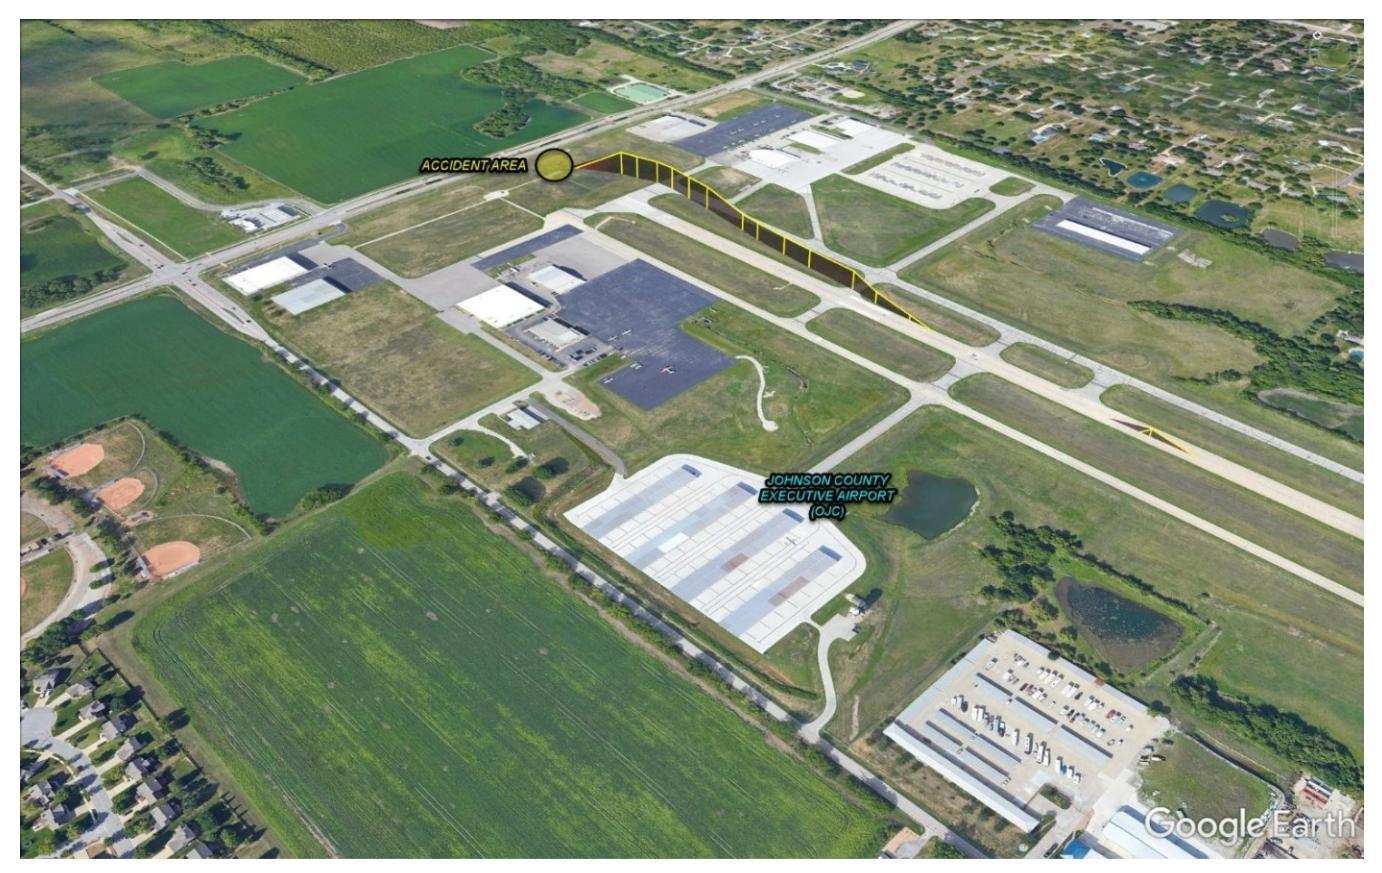
Figure 2. Final segment of accident flight track in profile view looking from SW to NE.

The airplane impacted the ground on the extended runway centerline about 400 ft. past the departure end of runway 36. The airplane came to rest upright with its fuselage oriented in a southeasterly direction. There was a postimpact fire that burned the wings and forward fuselage aft to the rear spar carry-through structure. The fuselage aft of the cabin, including the empennage, was intact. There was a fan shaped burn area on the ground that extended from the aircraft wreckage in a southerly direction.

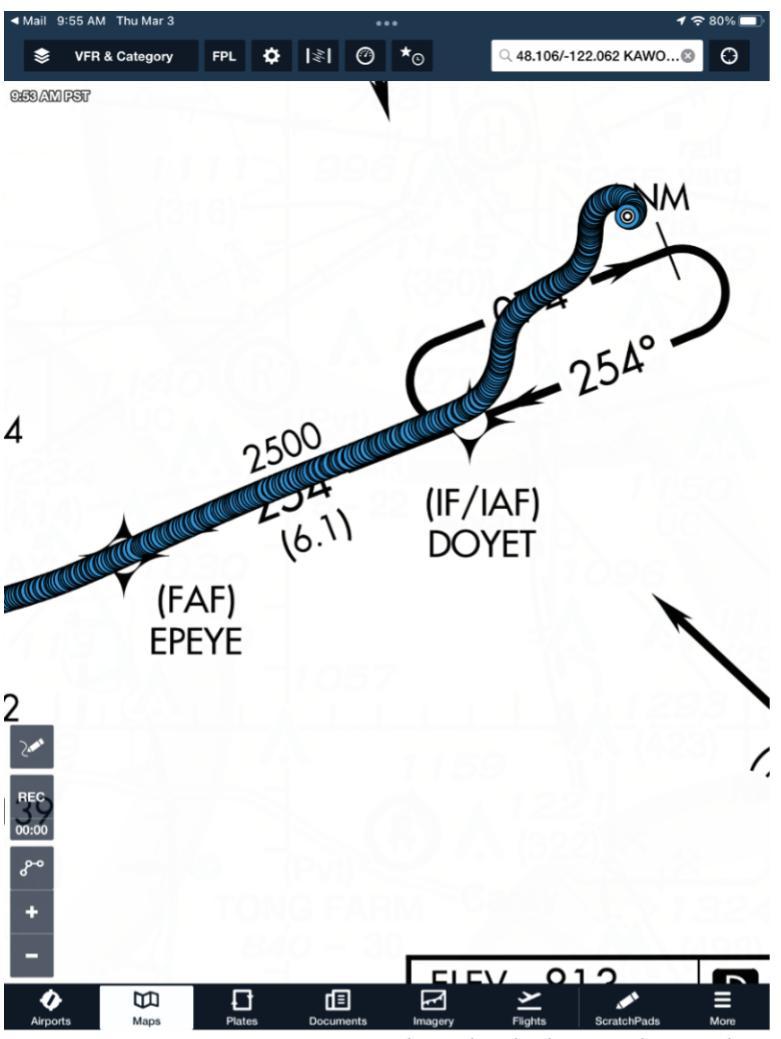
After passing DOYET, the airplane turned left about 45°, consistent with a teardrop entry into the procedure turn, before it turned back right, and paralleled the inbound course of the procedure turn. About 4 nautical miles (nm) from DOYET, the airplane turned right, as if to intercept the inbound course, but descended rapidly in a spiral and impacted terrain on a 340° heading (see Figure 2).

Figure 2: Instrument Approach with Flight Track Overlay

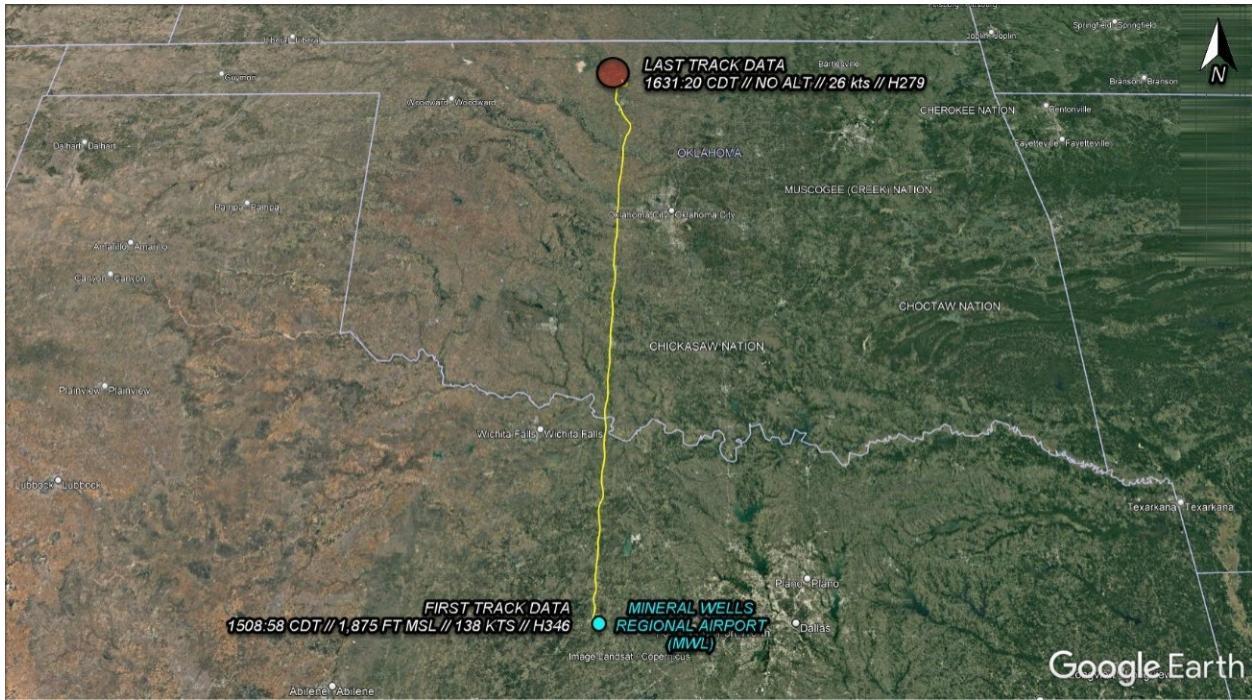
Preliminary radar and Automatic Dependent Surveillance-Broadcast (ADS-B) data indicated that the airplane first appeared at 1509 about 1.5 nautical miles west of the Mineral Wells Regional Airport (MWL), Mineral Wells, Texas. The airplane tracked north and climbed initially to a cruise altitude of 8,500 ft and then later climbed to 16,500 ft. The airplane began a descent after it passed over Vance Air Force Base (END), Enid, Oklahoma, and turned momentarily to the east. The airplane then turned west and back to the north while it descended. The ground speed decreased from over 200 kts to under 100 kts. About 1631, and 5 miles southwest of Pond Creek, Mode C position reporting data was lost followed by the loss of all track data.

Figure 1. ADS-B Flight Track.

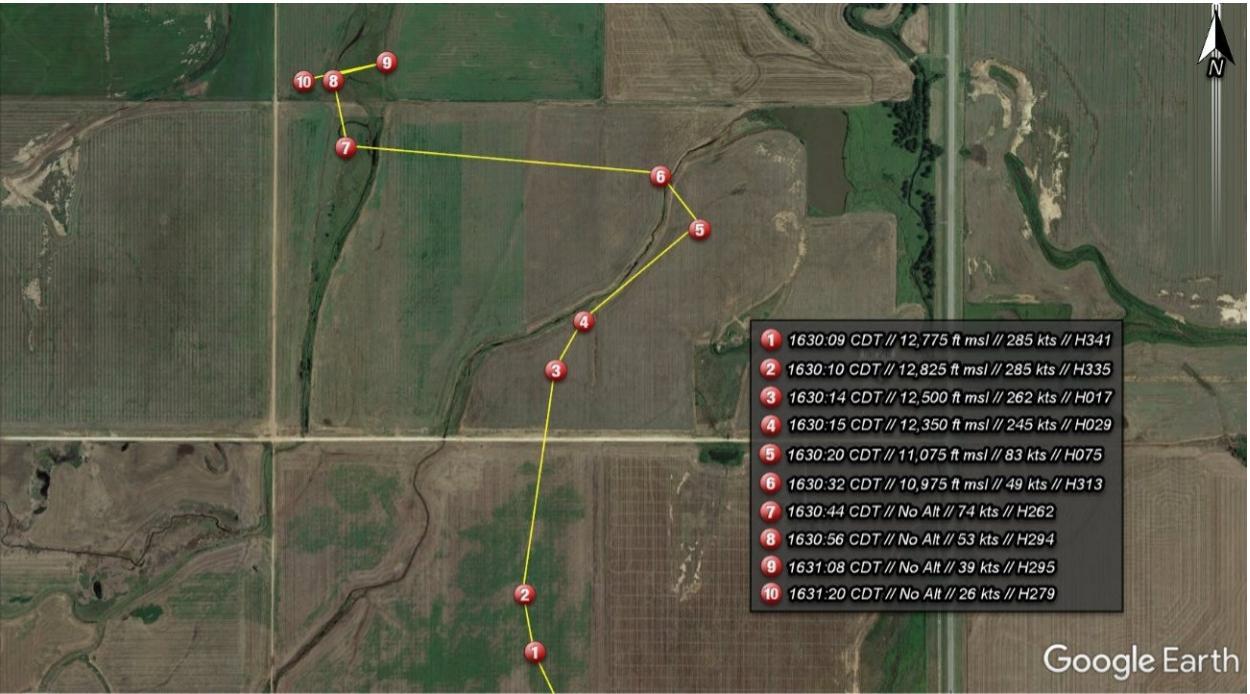
Figure 2. Radar Depiction of the End of the Flight Track.

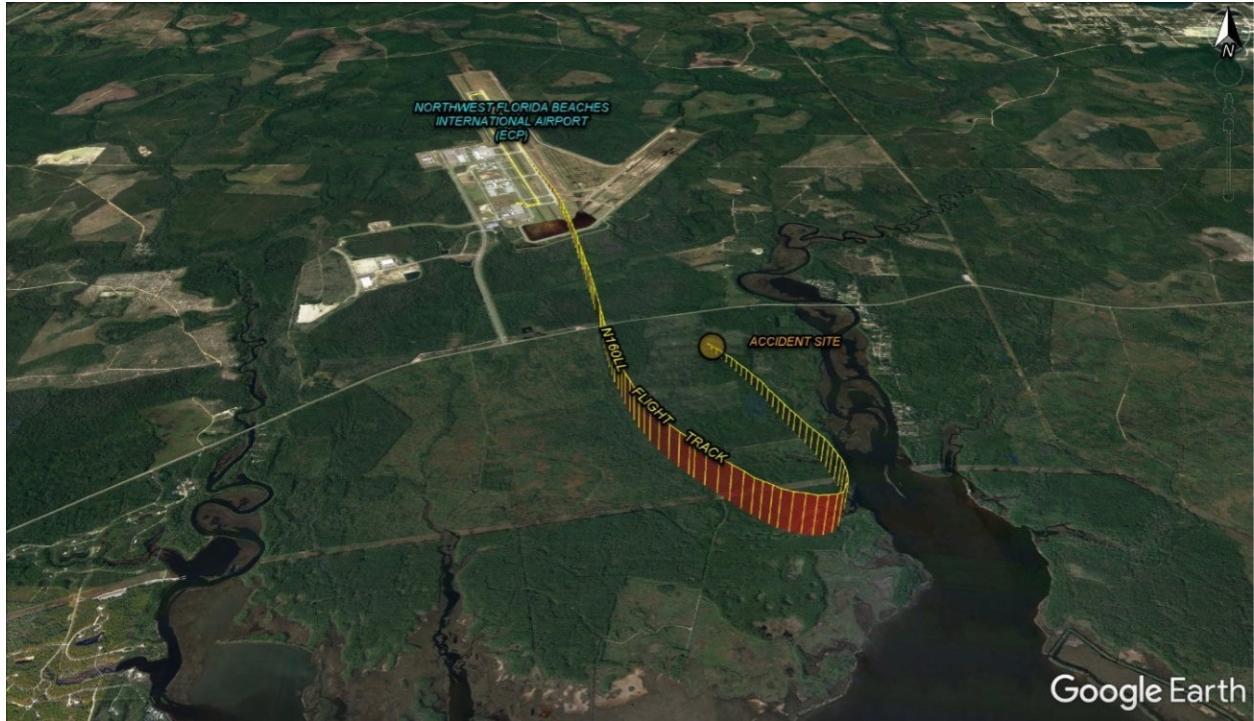
According to preliminary Automatic Dependent System Broadcast (ADS-B) data, which began at 1551:55, the airplane began the takeoff roll about 1606. After the airplane reached a peak altitude of about 1,200 ft mean sea level (msl) it began to descend and initiated a 180° left turn. The airplane completed the turn, continued to descend, and impacted trees and terrain about 1.7 miles from the threshold of runway 34. The ADS-B data ended about 190 ft south of the main wreckage.

Figure 1. Preliminary ADS-B data of the accident flight track. The flight path is in yellow.

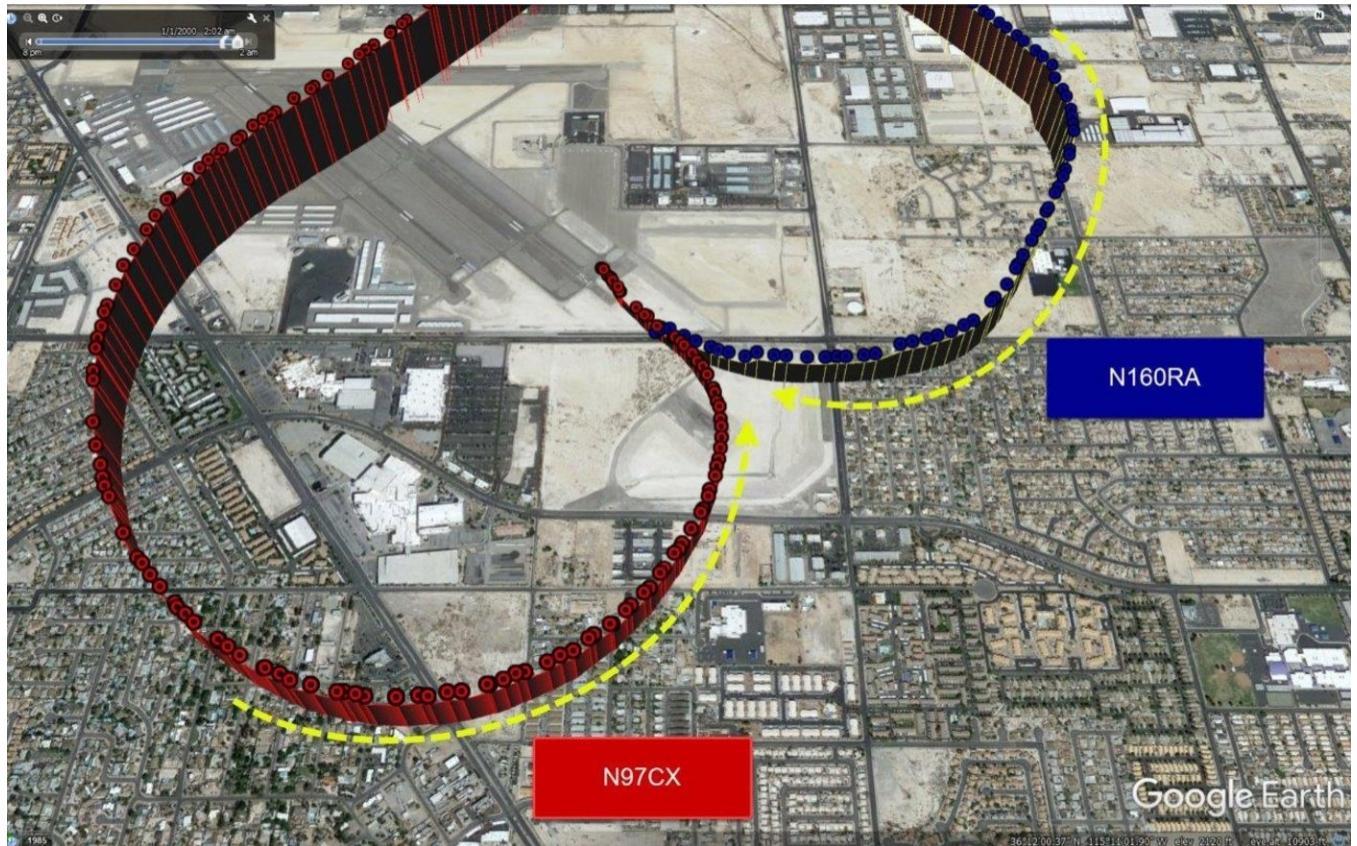
Both airplanes were maneuvering to land at North Las Vegas Airport (VGT), Las Vegas Nevada, when the accident occurred. N97CX had been instructed by air traffic control (ATC) to fly left traffic for runway 30L and N160RA had been instructed to fly right traffic for runway 30R. The airplanes collided about 0.25 nautical miles from the approach end of runway 30R. Figure 1 shows a simplified flight path diagram for the accident flights based on Federal Aviation Administration Automatic Dependent Surveillance – Broadcast (ADS-B) data.

Figure 1. ADS-B Flight Paths for N97CX (PA-46) and N160RA (Cessna 172)

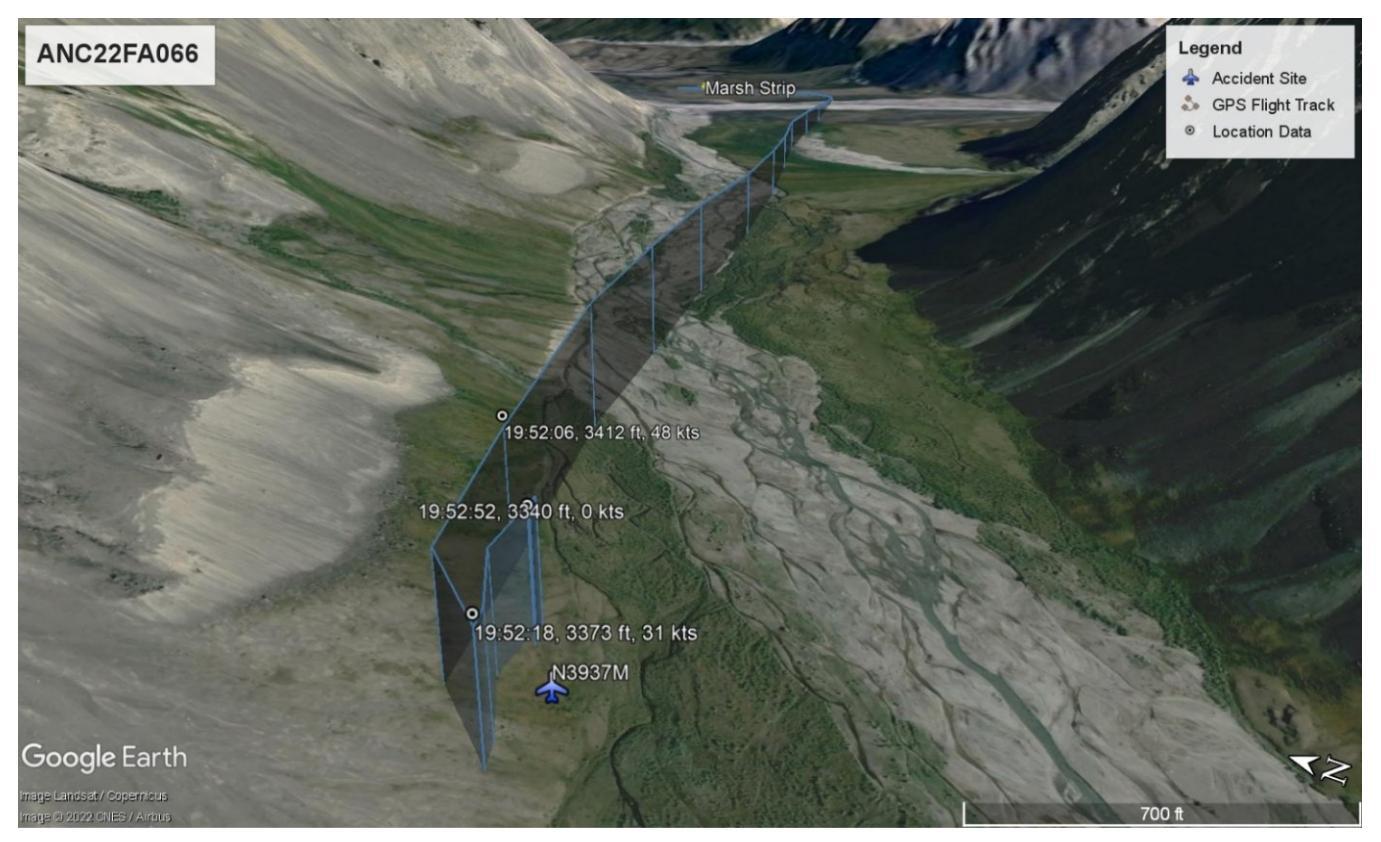
A review of the data from a pilot's GPS revealed that at 1149 the airplane departed Marsh Strip to the south and then made a right turn into the valley as seen in Figure 1. The flight track continued up the valley about 300 to 400 ft above ground level (agl) for about 2.5 nm, then made a sharp left turn and descended to the ground. Figure 1 shows the end of the GPS flight track and the estimated accident location overlaid onto Google Earth. The weather and lighting conditions in Google Earth are not necessarily the weather and lighting conditions present at the time of the recording. Due to data buffering on the GPS unit, the data recording may have ended before the accident event.

Figure 1. GPS flight track and accident location on Google Earth (time = coordinated universal time (UTC), altitude = ft above mean sea level (msl), groundspeed = kts)
